# Asbestos Management Survey

Dale and Valley House, Longfield Road, Bishop Auckland, DL14 6XB

**Project No:** 32531

**Survey Date:** 02/08/2017

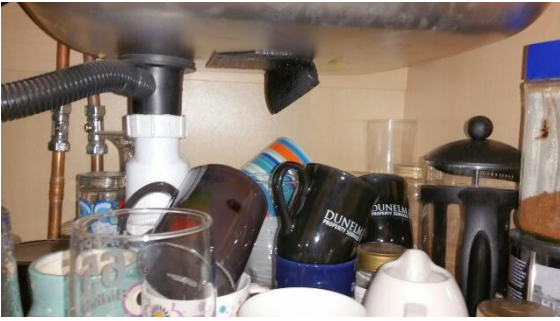
Main Site, 0/07 - Kitchen  
Under Sink Mat - Modern

LAB CODE	SAMPLE NO	SAMPLE DETAILS/LOCATION/DESCRIPTION *	RESULT
<b>Michael Evans - 04/08/2017</b>			
744995	1	0/07, Kitchen, Under Sink Mat Modern	NAD
