ASBESTOS REINSPECTION REPORT

Client	Believe Housing
Site	20 Wheatbottom Community Centre, Crook, DL15 9HB
Date report issued	5th December 2023
Date of Survey	4 Dec 2023
Recommended Date for Reinspection	
Survey reference	J962001
Lead surveyor	Kevin Russell
Assistant surveyor	N/A
UPRN	2CH00632

20 Wheatbottom Community Centre, Crook, DL15 9HB

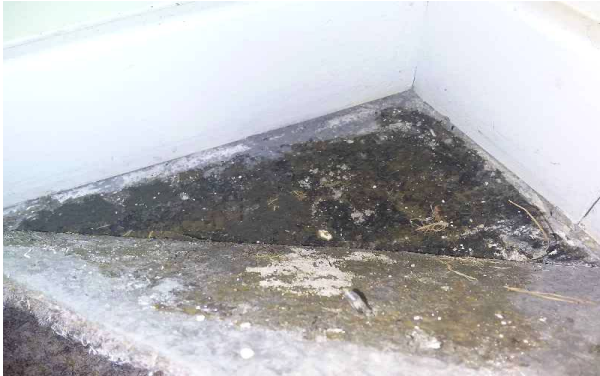
Item / Inspection Ref:	#1	Material Assessment	Product type:	1 - Bitumen Products

Sample Ref:	1 (TB003715)		Condition / Damage:	(1) Low Damage	
Survey date:	04/12/2023		Surface Treatment:	(0) Reinforced plastics, resins, vinyl tiles, well bound materials, bitumen adhesives, damp proof co	
Date last inspected:			Asbestos Type:	1 - Chrysotile	
Next inspection due:	4th December 2024		Material Score:	3	
Building:	Community Hub, 20 Wheatbottom, Crook, DL15 9HB	Priority Assessment	Occupant Activity:	1	
Floor level:	Ground Floor		Location:	2	
Room:	Lounge		Accessibility:	0	
Position:	Floor		Extent/amount:	2 38m ²

Item Description:	Adhesive		Number of Occupants:	2	
Level of Identification:	SAMPLED		Frequency of Use:	3	
Action:	Monitor and manage		Time in Area:	2	
RISK CODE:	C		Maintenance activity:	0	
		Frequency of Maintenance:	0		
		Priority Score:	6		
		Total Score:	9		
Comments:	Beneath Carpet			Material Status Change:	No Change

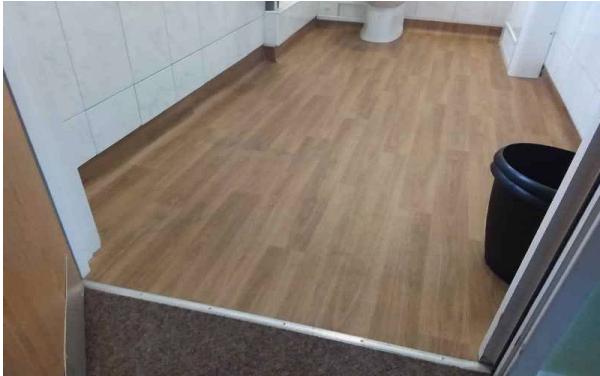
Item / Inspection Ref:	#2	Material Assessment	Product type:	1 - Bitumen Products

Sample Ref:	1 (TB003716)		Condition / Damage:	(1) Low Damage	
Survey date:	04/12/2023		Surface Treatment:	(0) Reinforced plastics, resins, vinyl tiles, well bound materials, bitumen adhesives, damp proof co	
Date last inspected:			Asbestos Type:	1 - Chrysotile	
Next inspection due:	4th December 2024		Material Score:	3	
Building:	Community Hub, 20 Wheatbottom, Crook, DL15 9HB	Priority Assessment	Occupant Activity:	0	
Floor level:	Ground Floor		Location:	2	
Room:	Disabled W.C.		Accessibility:	0	
Position:	Floor		Extent/amount:	1 4m ²

Item Description:	Adhesive		Number of Occupants:	1	
Level of Identification:	SAMPLED		Frequency of Use:	3	
Action:	Monitor and manage		Time in Area:	0	
RISK CODE:	D		Maintenance activity:	0	
		Frequency of Maintenance:	0		
		Priority Score:	3		
		Total Score:	6		
Comments:	Beneath Screed			Material Status Change:	No Change

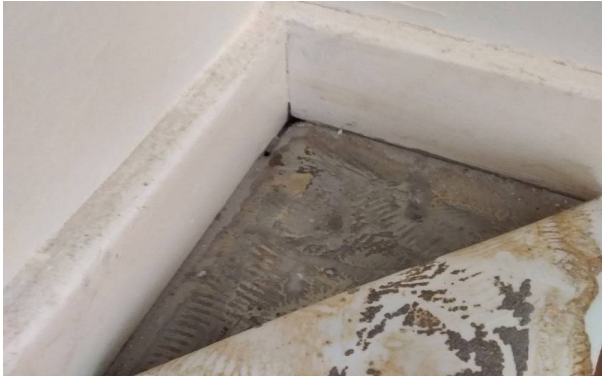
Item / Inspection Ref:	#3	Material Assessment	Product type:	1 - Bitumen Products

Sample Ref:	1 {TB003717}		Condition / Damage:	(1) Low Damage	
Survey date:	04/12/2023		Surface Treatment:	(0) Reinforced plastics, resins, vinyl tiles, well bound materials, bitumen adhesives, damp proof co	
Date last inspected:			Asbestos Type:	1 - Chrysotile	
Next inspection due:	4th December 2024		Material Score:	3	
Building:	Community Hub, 20 Wheatbottom, Crook, DL15 9HB	Priority Assessment	Occupant Activity:	0	
Floor level:	Ground Floor		Location:	2	
Room:	Boiler cupboard		Accessibility:	0	
Position:	Floor		Extent/amount:	1 2.5m ²

Item Description:	Adhesive		Number of Occupants:	0	
Level of Identification:	SAMPLED		Frequency of Use:	0	
Action:	Monitor and manage		Time in Area:	0	
			Maintenance activity:	0	
RISK CODE:	D	Frequency of Maintenance:	0		
		Priority Score:	1		
Comments:	Beneath Screed	Total Score:	4	Material Status Change:	
				No Change

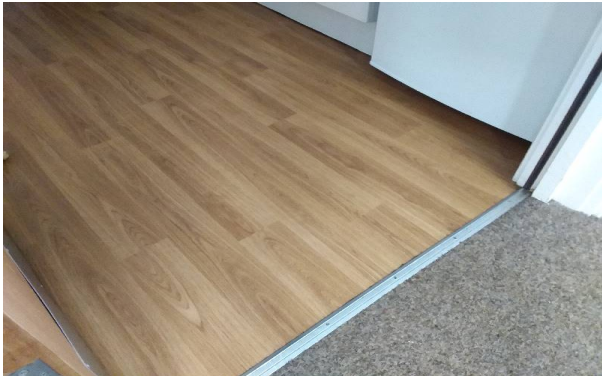
Item / Inspection Ref:	#4	Material Assessment	Product type:	1 - Bitumen Products

Sample Ref:	1 {TB003718}		Condition / Damage:	(1) Low Damage	
Survey date:	04/12/2023		Surface Treatment:	(0) Reinforced plastics, resins, vinyl tiles, well bound materials, bitumen adhesives, damp proof co	
Date last inspected:			Asbestos Type:	1 - Chrysotile	
Next inspection due:	4th December 2024		Material Score:	3	
Building:	Community Hub, 20 Wheatbottom, Crook, DL15 9HB	Priority Assessment	Occupant Activity:	1	
Floor level:	Ground Floor		Location:	2	
Room:	Kitchen		Accessibility:	0	
Position:	Floor		Extent/amount:	1 3.5m ²

Item Description:	Adhesive		Number of Occupants:	1	
Level of Identification:	SAMPLED		Frequency of Use:	3	
Action:	Monitor and manage		Time in Area:	1	
			Maintenance activity:	0	
RISK CODE:	D	Frequency of Maintenance:	0		
		Priority Score:	4		
Comments:	Beneath Screed	Total Score:	7	Material Status Change:	
				No Change

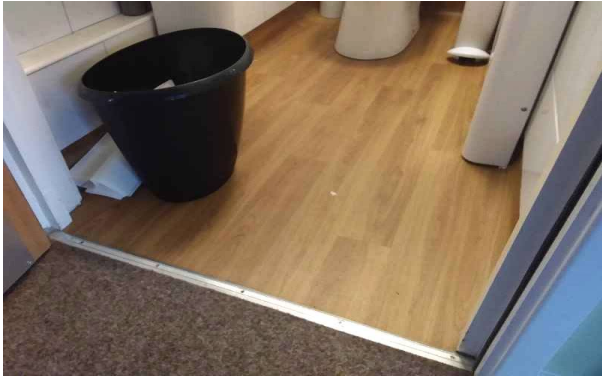
Item / Inspection Ref:	#5	Material Assessment	Product type:	1 - Bitumen Products

Sample Ref:	1 {TB003719}		Condition / Damage:	(1) Low Damage	
Survey date:	04/12/2023		Surface Treatment:	(0) Reinforced plastics, resins, vinyl tiles, well bound materials, bitumen adhesives, damp proof co	
Date last inspected:			Asbestos Type:	1 - Chrysotile	
Next inspection due:	4th December 2024		Material Score:	3	
Building:	Community Hub, 20 Wheatbottom, Crook, DL15 9HB	Priority Assessment	Occupant Activity:	1	
Floor level:	Ground Floor		Location:	2	
Room:	W.C.		Accessibility:	0	
Position:	Floor		Extent/amount:	1 1.5m ²

Item Description:	Adhesive		Number of Occupants:	1	
Level of Identification:	SAMPLED		Frequency of Use:	3	
Action:	Monitor and manage		Time in Area:	0	
RISK CODE:	D		Maintenance activity:	0	
Comments:	Beneath Screed	Frequency of Maintenance:	0	Material Status Change:	No Change
		Priority Score:	4		
		Total Score:	7

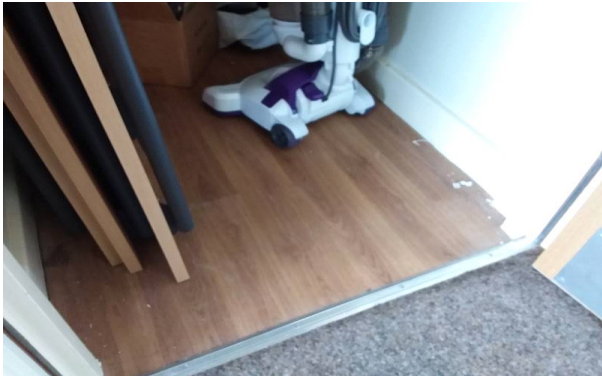
Item / Inspection Ref:	#6	Material Assessment	Product type:	1 - Bitumen Products

Sample Ref:	1 {TB003720}		Condition / Damage:	(1) Low Damage	
Survey date:	04/12/2023		Surface Treatment:	(0) Reinforced plastics, resins, vinyl tiles, well bound materials, bitumen adhesives, damp proof co	
Date last inspected:			Asbestos Type:	1 - Chrysotile	
Next inspection due:	4th December 2024		Material Score:	3	
Building:	Community Hub, 20 Wheatbottom, Crook, DL15 9HB	Priority Assessment	Occupant Activity:	0	
Floor level:	Ground Floor		Location:	2	
Room:	Cupboard		Accessibility:	0	
Position:	Floor		Extent/amount:	1 1.5m ²

Item Description:	Adhesive		Number of Occupants:	0	
Level of Identification:	SAMPLED		Frequency of Use:	0	
Action:	Monitor and manage		Time in Area:	0	
RISK CODE:	D		Maintenance activity:	0	
Comments:	Beneath Screed	Frequency of Maintenance:	0	Material Status Change:	No Change
		Priority Score:	1		
		Total Score:	4

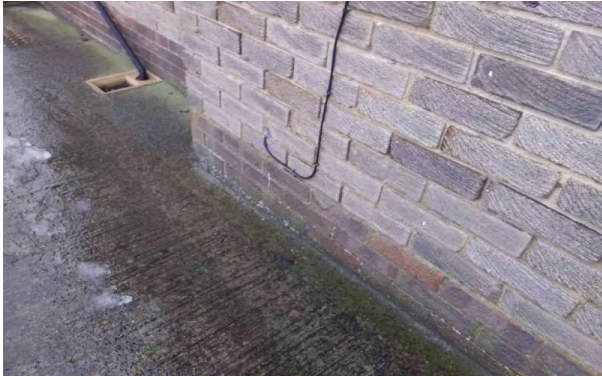
Item / Inspection Ref:	#7	Material Assessment	Product type:	1 - Bitumen Products

Sample Ref:	P (TB003721)		Condition / Damage:	(1) Low Damage		
Survey date:	04/12/2023		Surface Treatment:	(0) Reinforced plastics, resins, vinyl tiles, well bound materials, bitumen adhesives, damp proof co		
Date last inspected:			Asbestos Type:	1 - Chrysotile		
Next inspection due:	4th December 2024		Material Score:	3		
Building:	Community Hub, 20 Wheatbottom, Crook, DL15 9HB		Priority Assessment	Occupant Activity:		0
Floor level:	External			Location:		0
Room:	External elements			Accessibility:		0
Position:	Walls			Extent/amount:		2 Throughout

Item Description:	Damp proof course			Number of Occupants:		0
Level of Identification:	SAMPLED	Frequency of Use:		0		
Action:	Monitor and manage	Time in Area:		0		
		Maintenance activity:		0		
		Frequency of Maintenance:		0		
RISK CODE:	D	Priority Score:		1		
		Total Score:	4			
Comments:				Material Status Change: No Change

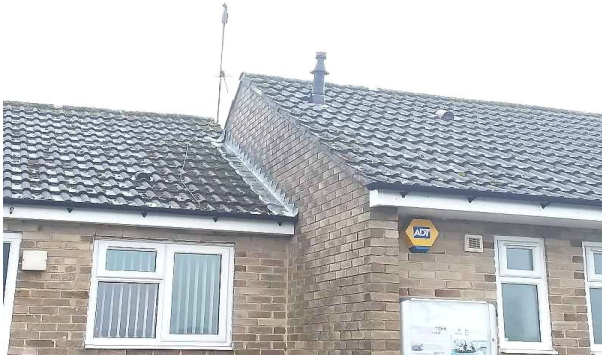
Item / Inspection Ref:	#8	Material Assessment	Product type:	1 - Asbestos Cement

Sample Ref:	2 (TB003722)		Condition / Damage:	(1) Low Damage		
Survey date:	04/12/2023		Surface Treatment:	(1) Enclosed sprays and lagging, Sealed AIB, asbestos cement, textured coating, gasket		
Date last inspected:			Asbestos Type:	1 - Chrysotile		
Next inspection due:	4th December 2024		Material Score:	4		
Building:	Community Hub, 20 Wheatbottom, Crook, DL15 9HB		Priority Assessment	Occupant Activity:		0
Floor level:	External			Location:		0
Room:	External elements			Accessibility:		0
Position:	Roof			Extent/amount:		2 14m

Item Description:	Under cloak			Number of Occupants:		0
Level of Identification:	SAMPLED	Frequency of Use:		0		
Action:	Monitor and manage	Time in Area:		0		
		Maintenance activity:		1		
		Frequency of Maintenance:		0		
RISK CODE:	D	Priority Score:		2		
		Total Score:	6			
Comments:				Material Status Change: No Change
