Asbestos Reinspection Survey (MA and PA)

Client Details	believe housing, Coast House, Spectrum 4, Spectrum Business Park, Seaham,SR7 7TT
Site Details	Block 34 - 35 (COMMUNITY CENTRE BELOW) Grey Gardens Coundon Bishop Auckland Co Durham , DL14 8LZ UPRN: 2GREY1_Ext_Com
Date(s) of Surveys	12 Apr 2024
Report Reference Number	J088306
Brief Survey Scope of Works	Re-inspection Survey

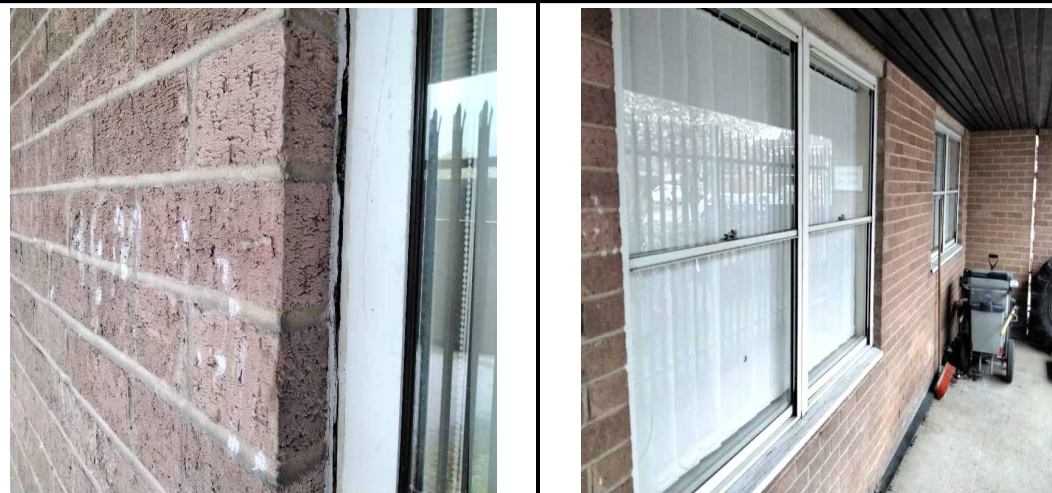
Item No: 2	Sample No: TH002914 {J000306}* Level of ID: Identified	Building ID: Block 34 - 35 (COMMUNITY CENTRE BELOW) Grey Gardens	Location: External elements, E/01
---------------	---	--	-----------------------------------

Item Description: Sealant - Wall		
Comments: Residual mastic to windows and doors,		Extent: <1m ²
Reinspection State / Register Update: No change		
Product Type:	Reinforced Composite	1
Extent of Damage:	Low Damage	1
Surface Treatment:		0
Asbestos Type:	Chrysotile	1

Location	External	0	Number of occupants	4 to 10	2
Accessibility	Usually inaccessible or unlikely to be disturbed	0	Frequency of use of area	Daily	3
Extent / Amount	10m ² - 50m ² or 10m - 50m pipe run	2	Average time area is in use	>6 hours	3
Likelihood of disturbance	Average Score	1	Human exposure potential	Average Score	3

Normal occupant activity:	Periodic disturbance	2	Material Assessment Score	3
Type of maintenance activity	Minor disturbance	0	Priority Assessment Score (*)	8
Frequency of maintenance activity	>1 per month	3	Total Risk Score (*)	Low Risk (11)
Maintenance activity	Average Score	2	Recommendation: Manage & Monitor

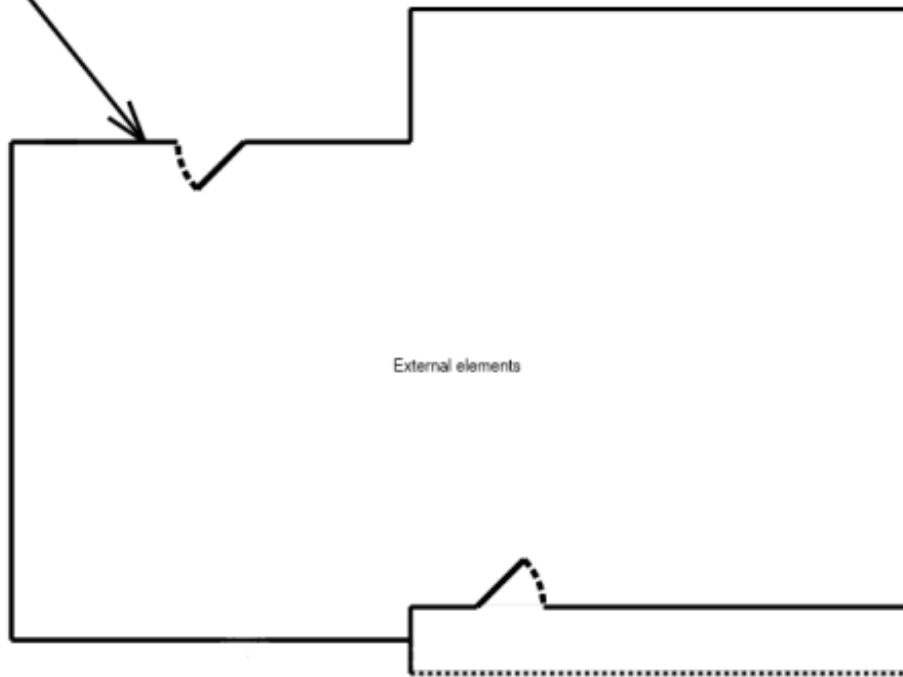
Inspection 2

Location:		External elements E/01		Floor:	External		Building ID:		Block 34 - 35 (COMMUNITY CENTRE BELOW) Grey Gardens	
Item no:	Sample Ref:	Item Description:	Extent	Product Type	Condition	Surface Treatment	Asbestos Type	Material Score	Priority Risk Score, (Total score) (*)	Photo
2	TH002914 {IJ000306}*	Sealant - Wall	<1m ²	1	1	0	1	3	8 (11)
