## Asbestos Reinspection Survey (MA and PA)

Client Details	believe housing, Coast House, Spectrum 4, Spectrum Business Park, Seaham, SR7 7TT
Site Details	(LEASED) 34 Grey Gardens Community Centre Coundon , DL14 8LZ UPRN: 2CH00622
Date(s) of Surveys	24 Apr 2024
Report Reference Number	J089521
Brief Survey Scope of Works	Re-inspection Survey

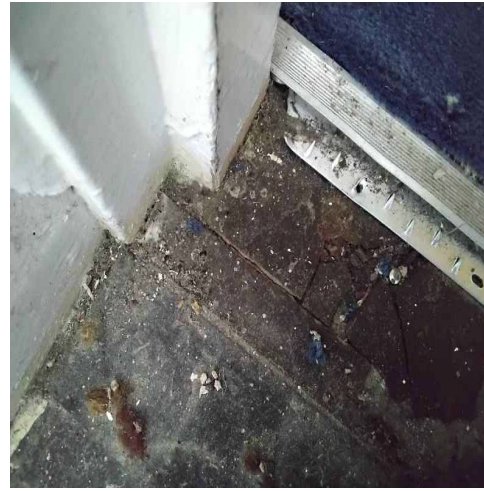
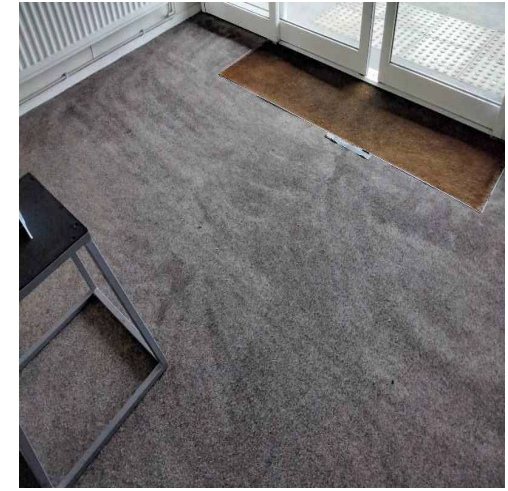
Item Description: Floor tiles - Floor		
Comments: Beneath carpet ,		Extent: 10m <sup>2</sup>
Reinspection State / Register Update: No change		
Product Type:	Reinforced Composite	1
Extent of Damage:	Low Damage	1
Surface Treatment:		0
Asbestos Type:	Chrysotile	1

Location	Rooms up to 100m <sup>2</sup>	2	Number of occupants	4 to 10	2
Accessibility	Usually inaccessible or unlikely to be disturbed	0	Frequency of use of area	Daily	3
Extent / Amount	10m <sup>2</sup> - 50m <sup>2</sup> or 10m - 50m pipe run	2	Average time area is in use	>6 hours	3
<b>Likelihood of disturbance</b>	<b>Average Score</b>	<b>2</b>	<b>Human exposure potential</b>	<b>Average Score</b>	<b>3</b>

<b>Normal occupant activity:</b>	<b>Low disturbance</b>	<b>1</b>	Material Assessment Score	<b>3</b>
Type of maintenance activity	Minor disturbance	0	Priority Assessment Score (*)	<b>8</b>
Frequency of maintenance activity	>1 per month	3	Total Risk Score (*)	<b>Low Risk (11)</b>
<b>Maintenance activity</b>	<b>Average Score</b>	<b>2</b>	<b>Recommendation: Manage &amp; Monitor</b>

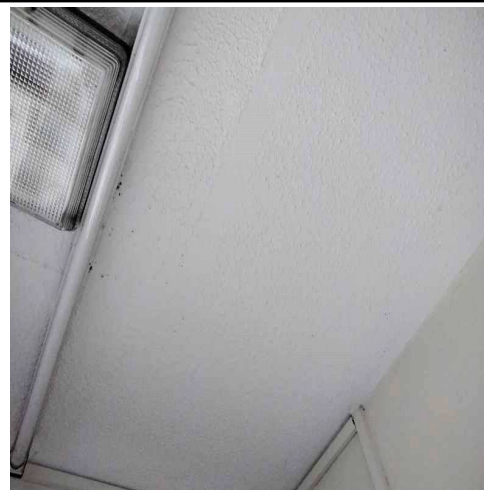
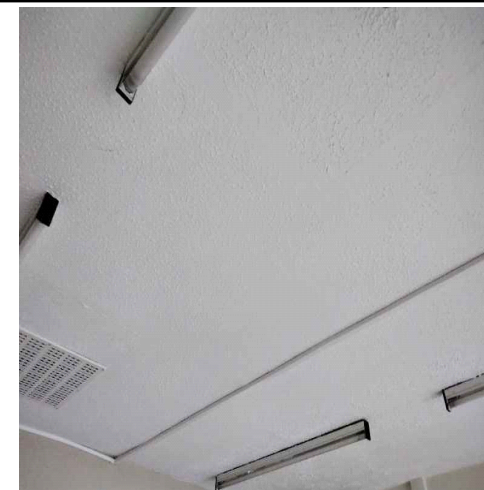
Product Type:	Textured Coating	1
Extent of Damage:	Good Condition	0
Surface Treatment:		1
Asbestos Type:	Chrysotile	1

Location	Rooms up to 100m <sup>2</sup>	2	Number of occupants	4 to 10	2
Accessibility	Occasionally likely to be disturbed	1	Frequency of use of area	Daily	3
Extent / Amount	10m <sup>2</sup> - 50m <sup>2</sup> or 10m - 50m pipe run	2	Average time area is in use	>6 hours	3
<b>Likelihood of disturbance</b>	<b>Average Score</b>	<b>2</b>	<b>Human exposure potential</b>	<b>Average Score</b>	<b>3</b>

<b>Normal occupant activity:</b>	<b>Low disturbance</b>	<b>1</b>	Material Assessment Score	<b>3</b>
Type of maintenance activity	Minor disturbance	0	Priority Assessment Score (*)	8
Frequency of maintenance activity	>1 per month	3	Total Risk Score (*)	Low Risk (11)
<b>Maintenance activity</b>	<b>Average Score</b>	<b>2</b>	<b>Recommendation: Manage &amp; Monitor</b>

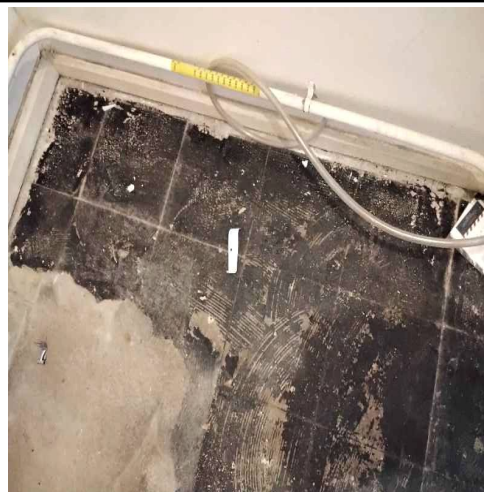
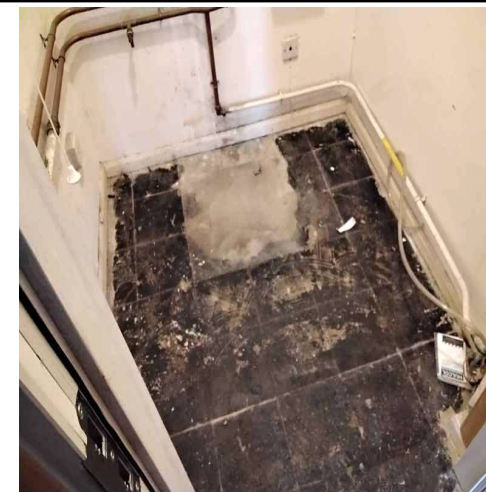
Product Type:	Removed	—
Extent of Damage:	—	—
Surface Treatment:		—
Asbestos Type:	Removed	—

<b>Normal occupant activity:</b>	—	0	Material Assessment Score	—
Type of maintenance activity	—	0	Priority Assessment Score (*)	—
Frequency of maintenance activity	—	0	Total Risk Score (*)	—
<b>Maintenance activity</b>	<b>Average Score</b>	<b>0</b>	Recommendation: Removed

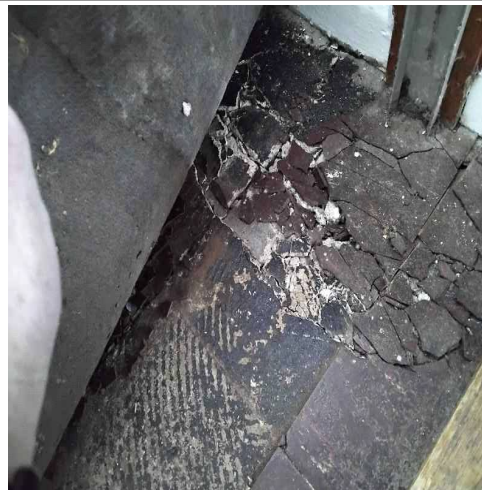
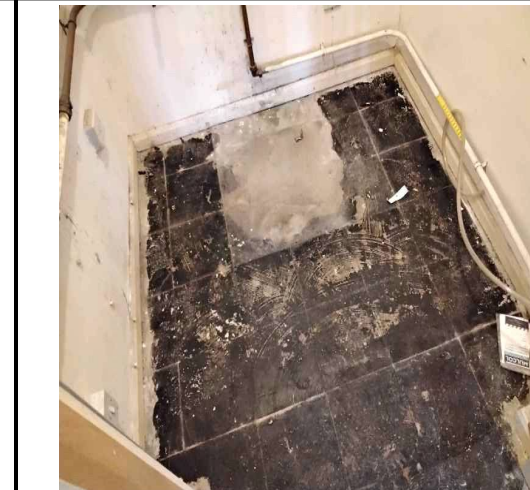
Product Type:	Reinforced Composite	1
Extent of Damage:	Low Damage	1
Surface Treatment:		0
Asbestos Type:	SP: Chrysotile	1

Location	Rooms up to 100m <sup>2</sup>	2	Number of occupants	>10	3
Accessibility	Usually inaccessible or unlikely to be disturbed	0	Frequency of use of area	Daily	3
Extent / Amount	10m <sup>2</sup> - 50m <sup>2</sup> or 10m - 50m pipe run	2	Average time area is in use	>6 hours	3
<b>Likelihood of disturbance</b>	<b>Average Score</b>	<b>2</b>	<b>Human exposure potential</b>	<b>Average Score</b>	<b>3</b>

<b>Normal occupant activity:</b>	<b>High level of disturbance</b>	<b>3</b>	Material Assessment Score	<b>3</b>
Type of maintenance activity	Minor disturbance	0	Priority Assessment Score (*)	10
Frequency of maintenance activity	>1 per month	3	Total Risk Score (*)	Medium Risk (13)
<b>Maintenance activity</b>	<b>Average Score</b>	<b>2</b>	<b>Recommendation: Manage &amp; Monitor</b>

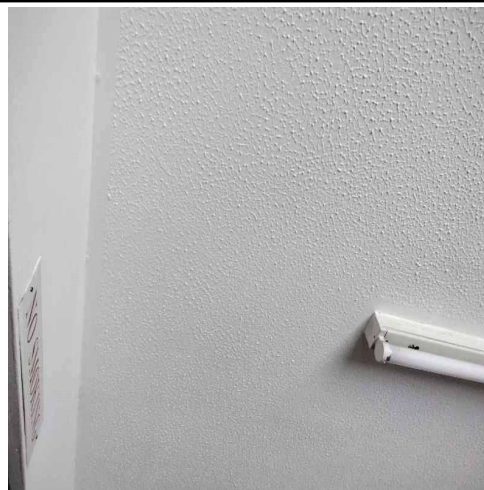
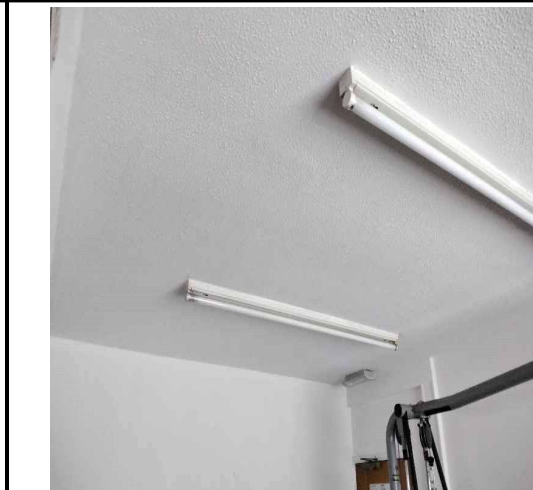
Product Type:	Textured Coating	1
Extent of Damage:	Low Damage	1
Surface Treatment:		1
Asbestos Type:	SP: Chrysotile	1

Location	Rooms up to 100m <sup>2</sup>	2	Number of occupants	>10	3
Accessibility	Occasionally likely to be disturbed	1	Frequency of use of area	Daily	3
Extent / Amount	10m <sup>2</sup> - 50m <sup>2</sup> or 10m - 50m pipe run	2	Average time area is in use	>6 hours	3
<b>Likelihood of disturbance</b>	<b>Average Score</b>	<b>2</b>	<b>Human exposure potential</b>	<b>Average Score</b>	<b>3</b>

<b>Normal occupant activity:</b>	<b>High level of disturbance</b>	<b>3</b>	Material Assessment Score	4
Type of maintenance activity	Minor disturbance	0	Priority Assessment Score (*)	10
Frequency of maintenance activity	>1 per month	3	Total Risk Score (*)	Medium Risk (14)
<b>Maintenance activity</b>	<b>Average Score</b>	<b>2</b>	<b>Recommendation: Manage &amp; Monitor</b>

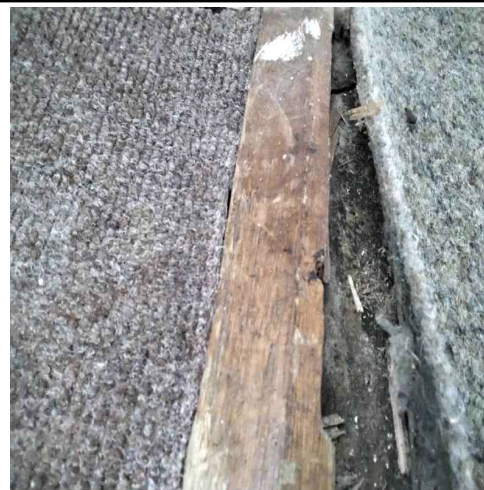
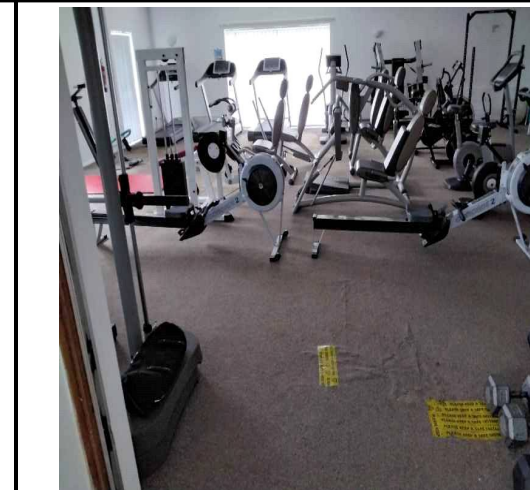
Product Type:	Reinforced Composite	1
Extent of Damage:	Low Damage	1
Surface Treatment:		0
Asbestos Type:	SP: Chrysotile	1

Location	Rooms up to 100m <sup>2</sup>	2	Number of occupants	>10	3
Accessibility	Usually inaccessible or unlikely to be disturbed	0	Frequency of use of area	Daily	3
Extent / Amount	10m <sup>2</sup> - 50m <sup>2</sup> or 10m - 50m pipe run	2	Average time area is in use	>6 hours	3
<b>Likelihood of disturbance</b>	<b>Average Score</b>	<b>2</b>	<b>Human exposure potential</b>	<b>Average Score</b>	<b>3</b>

<b>Normal occupant activity:</b>	<b>High level of disturbance</b>	<b>3</b>	Material Assessment Score	<b>3</b>
Type of maintenance activity	Minor disturbance	0	Priority Assessment Score (*)	<b>10</b>
Frequency of maintenance activity	>1 per month	3	Total Risk Score (*)	<b>Medium Risk (13)</b>
<b>Maintenance activity</b>	<b>Average Score</b>	<b>2</b>	<b>Recommendation: Manage &amp; Monitor</b>

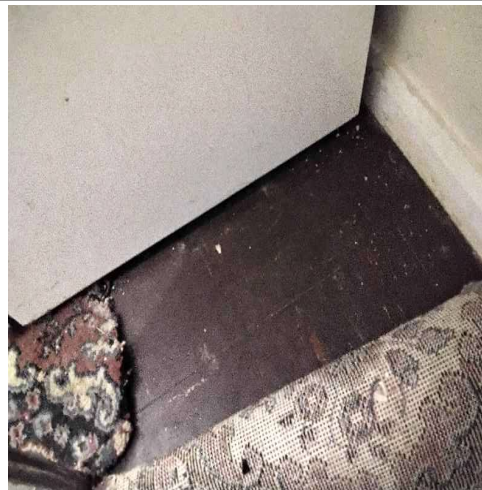
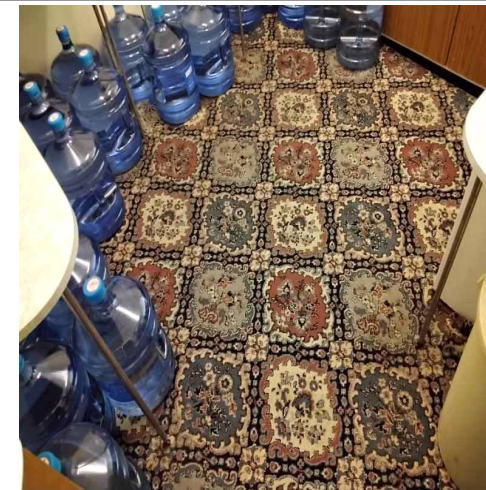
Product Type:	Reinforced Composite	1
Extent of Damage:	Low Damage	1
Surface Treatment:		0
Asbestos Type:	SP: Chrysotile	1

Location	Rooms up to 100m <sup>2</sup>	2	Number of occupants	4 to 10	2
Accessibility	Usually inaccessible or unlikely to be disturbed	0	Frequency of use of area	Daily	3
Extent / Amount	10m <sup>2</sup> - 50m <sup>2</sup> or 10m - 50m pipe run	2	Average time area is in use	3 to 6 hours	2
<b>Likelihood of disturbance</b>	<b>Average Score</b>	<b>2</b>	<b>Human exposure potential</b>	<b>Average Score</b>	<b>3</b>

<b>Normal occupant activity:</b>	<b>Low disturbance</b>	<b>1</b>	Material Assessment Score	<b>3</b>
Type of maintenance activity	Minor disturbance	0	Priority Assessment Score (*)	<b>8</b>
Frequency of maintenance activity	>1 per month	3	Total Risk Score (*)	<b>Low Risk (11)</b>
<b>Maintenance activity</b>	<b>Average Score</b>	<b>2</b>	<b>Recommendation: Manage &amp; Monitor</b>

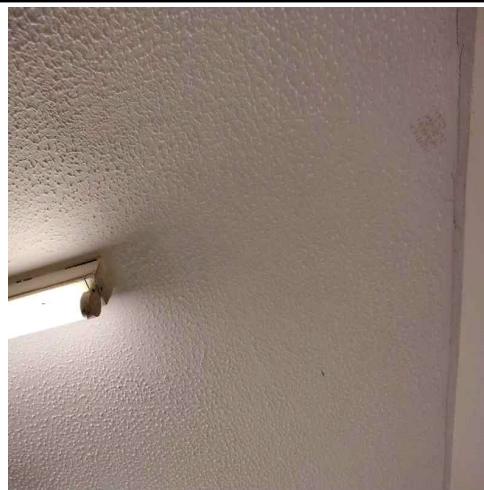
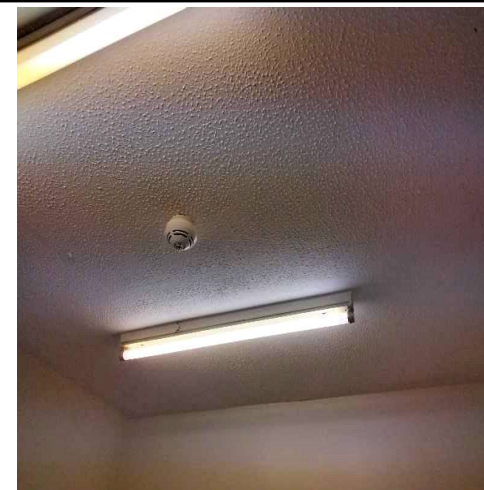
Product Type:	Textured Coating	1
Extent of Damage:	Low Damage	1
Surface Treatment:		1
Asbestos Type:	SP: Chrysotile	1

Location	Rooms up to 100m <sup>2</sup>	2	Number of occupants	4 to 10	2
Accessibility	Occasionally likely to be disturbed	1	Frequency of use of area	Daily	3
Extent / Amount	10m <sup>2</sup> - 50m <sup>2</sup> or 10m - 50m pipe run	2	Average time area is in use	3 to 6 hours	2
<b>Likelihood of disturbance</b>	<b>Average Score</b>	<b>2</b>	<b>Human exposure potential</b>	<b>Average Score</b>	<b>3</b>

<b>Normal occupant activity:</b>	<b>Low disturbance</b>	<b>1</b>	Material Assessment Score	<b>4</b>
Type of maintenance activity	Minor disturbance	0	Priority Assessment Score (*)	<b>8</b>
Frequency of maintenance activity	>1 per month	3	Total Risk Score (*)	<b>Low Risk (12)</b>
<b>Maintenance activity</b>	<b>Average Score</b>	<b>2</b>	<b>Recommendation: Manage &amp; Monitor</b>

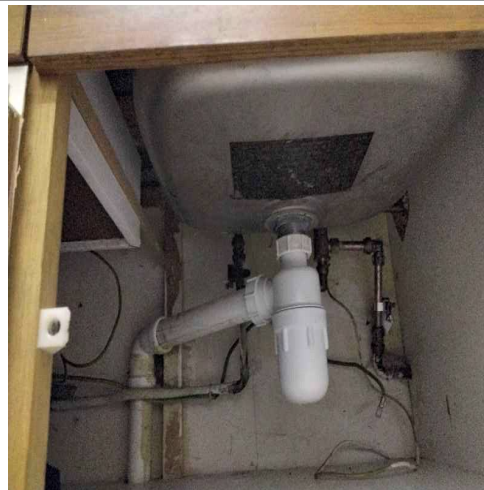
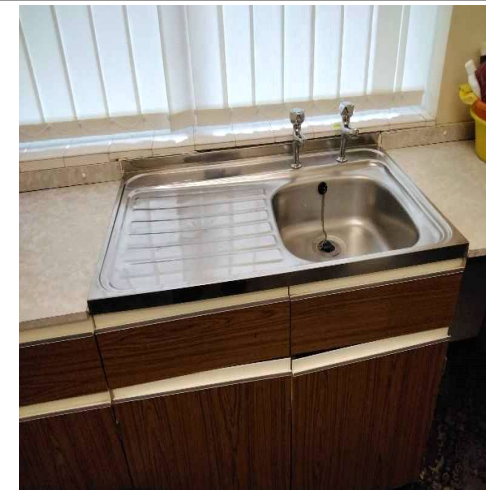
Product Type:	Reinforced Composite	1
Extent of Damage:	Low Damage	1
Surface Treatment:		0
Asbestos Type:	Chrysotile	1

Location	Rooms up to 100m <sup>2</sup>	2	Number of occupants	4 to 10	2
Accessibility	Occasionally likely to be disturbed	1	Frequency of use of area	Daily	3
Extent / Amount	10m <sup>2</sup> - 50m <sup>2</sup> or 10m - 50m pipe run	2	Average time area is in use	3 to 6 hours	2
<b>Likelihood of disturbance</b>	<b>Average Score</b>	<b>2</b>	<b>Human exposure potential</b>	<b>Average Score</b>	<b>3</b>

<b>Normal occupant activity:</b>	<b>Low disturbance</b>	<b>1</b>	Material Assessment Score	<b>3</b>
Type of maintenance activity	Minor disturbance	0	Priority Assessment Score (*)	8
Frequency of maintenance activity	>1 per month	3	Total Risk Score (*)	Low Risk (11)
<b>Maintenance activity</b>	<b>Average Score</b>	<b>2</b>	<b>Recommendation: Manage &amp; Monitor</b>

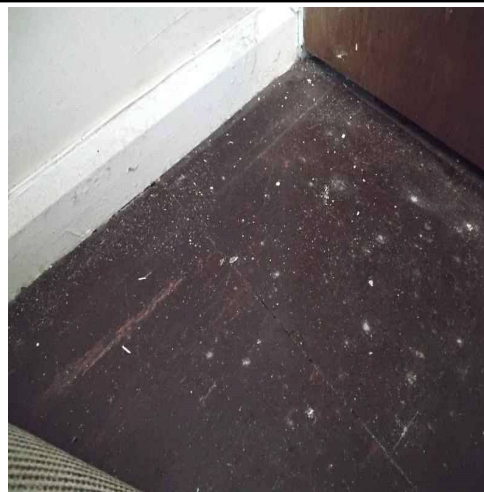
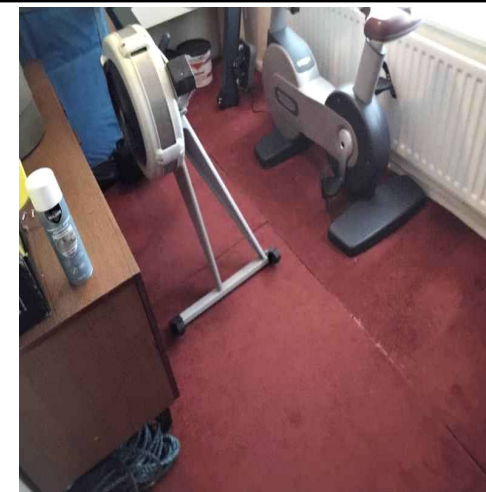
Product Type:	Reinforced Composite	1
Extent of Damage:	Low Damage	1
Surface Treatment:		0
Asbestos Type:	SP: Chrysotile	1

Location	Rooms up to 100m <sup>2</sup>	2	Number of occupants	None	0
Accessibility	Usually inaccessible or unlikely to be disturbed	0	Frequency of use of area	Daily	3
Extent / Amount	10m <sup>2</sup> - 50m <sup>2</sup> or 10m - 50m pipe run	2	Average time area is in use	1 to 3 hours	1
<b>Likelihood of disturbance</b>	<b>Average Score</b>	<b>2</b>	<b>Human exposure potential</b>	<b>Average Score</b>	<b>2</b>

<b>Normal occupant activity:</b>	<b>Rare disturbance</b>	<b>0</b>	Material Assessment Score	<b>3</b>
Type of maintenance activity	Minor disturbance	0	Priority Assessment Score (*)	<b>6</b>
Frequency of maintenance activity	>1 per month	3	Total Risk Score (*)	<b>Low Risk (9)</b>
<b>Maintenance activity</b>	<b>Average Score</b>	<b>2</b>	<b>Recommendation: Manage &amp; Monitor</b>

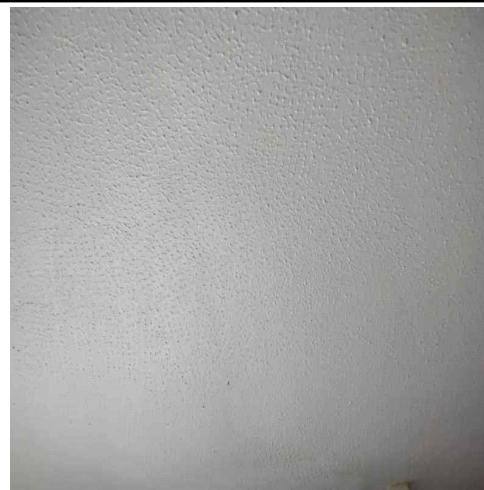
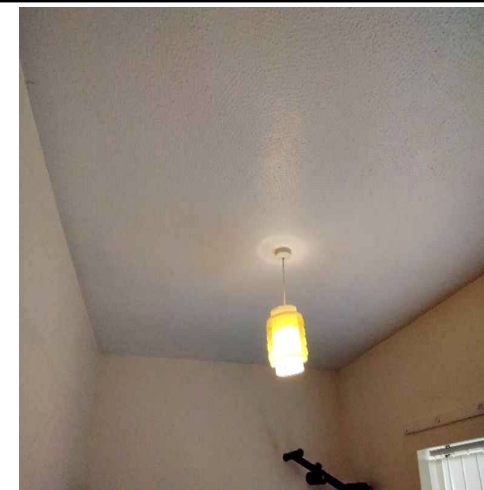
Product Type:	Textured Coating	1
Extent of Damage:	Low Damage	1
Surface Treatment:		1
Asbestos Type:	SP: Chrysotile	1

Location	Rooms up to 100m <sup>2</sup>	2	Number of occupants	None	0
Accessibility	Occasionally likely to be disturbed	1	Frequency of use of area	Daily	3
Extent / Amount	10m <sup>2</sup> - 50m <sup>2</sup> or 10m - 50m pipe run	2	Average time area is in use	1 to 3 hours	1
<b>Likelihood of disturbance</b>	<b>Average Score</b>	<b>2</b>	<b>Human exposure potential</b>	<b>Average Score</b>	<b>2</b>

<b>Normal occupant activity:</b>	<b>Rare disturbance</b>	<b>0</b>	Material Assessment Score	<b>4</b>
Type of maintenance activity	Minor disturbance	0	Priority Assessment Score (*)	<b>6</b>
Frequency of maintenance activity	>1 per month	3	Total Risk Score (*)	<b>Low Risk (10)</b>
<b>Maintenance activity</b>	<b>Average Score</b>	<b>2</b>	<b>Recommendation: Manage &amp; Monitor</b>

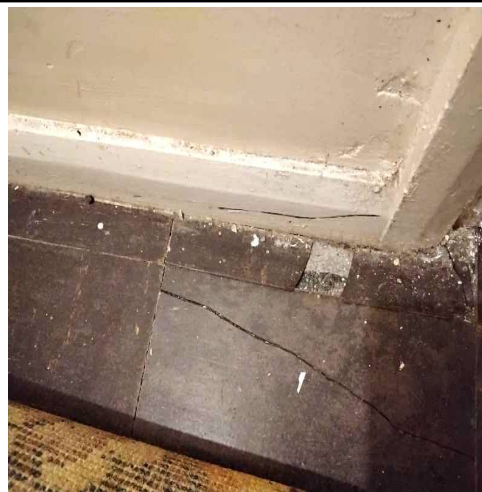
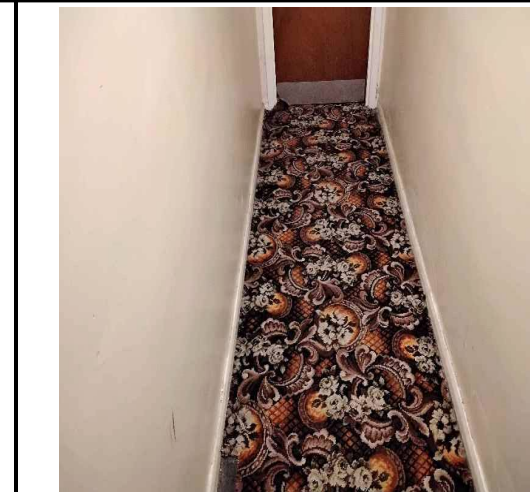
Product Type:	Reinforced Composite	1
Extent of Damage:	Low Damage	1
Surface Treatment:		0
Asbestos Type:	SP: Chrysotile	1

Location	Rooms up to 100m <sup>2</sup>	2	Number of occupants	>10	3
Accessibility	Usually inaccessible or unlikely to be disturbed	0	Frequency of use of area	Daily	3
Extent / Amount	10m <sup>2</sup> - 50m <sup>2</sup> or 10m - 50m pipe run	2	Average time area is in use	>6 hours	3
<b>Likelihood of disturbance</b>	<b>Average Score</b>	<b>2</b>	<b>Human exposure potential</b>	<b>Average Score</b>	<b>3</b>

<b>Normal occupant activity:</b>	<b>Low disturbance</b>	<b>1</b>	Material Assessment Score	<b>3</b>
Type of maintenance activity	Minor disturbance	0	Priority Assessment Score (*)	<b>8</b>
Frequency of maintenance activity	>1 per month	3	Total Risk Score (*)	<b>Low Risk (11)</b>
<b>Maintenance activity</b>	<b>Average Score</b>	<b>2</b>	<b>Recommendation: Manage &amp; Monitor</b>

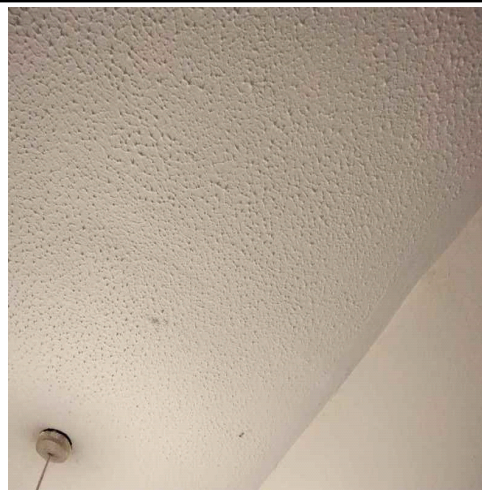
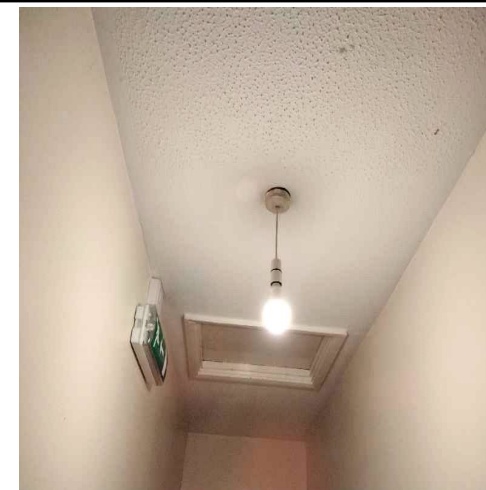
Product Type:	Textured Coating	1
Extent of Damage:	Low Damage	1
Surface Treatment:		1
Asbestos Type:	SP: Chrysotile	1

Location	Rooms up to 100m <sup>2</sup>	2	Number of occupants	>10	3
Accessibility	Occasionally likely to be disturbed	1	Frequency of use of area	Daily	3
Extent / Amount	10m <sup>2</sup> - 50m <sup>2</sup> or 10m - 50m pipe run	2	Average time area is in use	>6 hours	3
<b>Likelihood of disturbance</b>	<b>Average Score</b>	<b>2</b>	<b>Human exposure potential</b>	<b>Average Score</b>	<b>3</b>

<b>Normal occupant activity:</b>	<b>Low disturbance</b>	<b>1</b>	Material Assessment Score	<b>4</b>
Type of maintenance activity	Minor disturbance	0	Priority Assessment Score (*)	<b>8</b>
Frequency of maintenance activity	>1 per month	3	Total Risk Score (*)	<b>Low Risk (12)</b>
<b>Maintenance activity</b>	<b>Average Score</b>	<b>2</b>	<b>Recommendation: Manage &amp; Monitor</b>

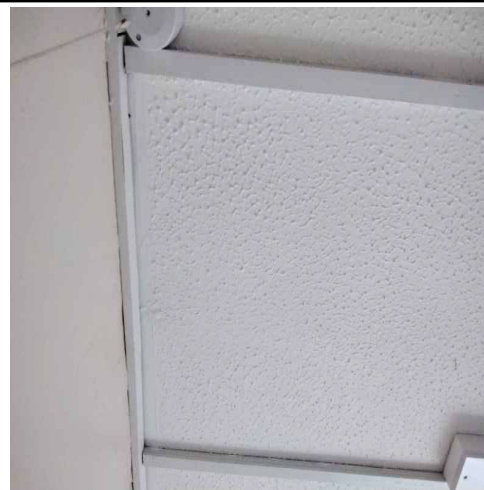
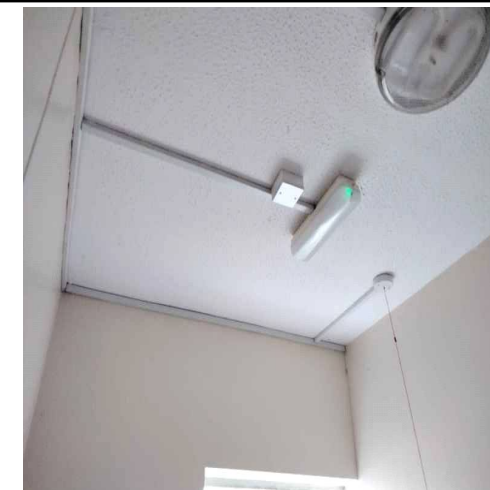
Product Type:	Textured Coating	1
Extent of Damage:	Good Condition	0
Surface Treatment:		1
Asbestos Type:	SP: Chrysotile	1

Location	Rooms up to 100m <sup>2</sup>	2	Number of occupants	>10	3
Accessibility	Occasionally likely to be disturbed	1	Frequency of use of area	Daily	3
Extent / Amount	10m <sup>2</sup> - 50m <sup>2</sup> or 10m - 50m pipe run	2	Average time area is in use	>6 hours	3
<b>Likelihood of disturbance</b>	<b>Average Score</b>	<b>2</b>	<b>Human exposure potential</b>	<b>Average Score</b>	<b>3</b>

<b>Normal occupant activity:</b>	<b>Low disturbance</b>	<b>1</b>	Material Assessment Score	<b>3</b>
Type of maintenance activity	Minor disturbance	0	Priority Assessment Score (*)	8
Frequency of maintenance activity	>1 per month	3	Total Risk Score (*)	Low Risk (11)
<b>Maintenance activity</b>	<b>Average Score</b>	<b>2</b>	<b>Recommendation: Manage &amp; Monitor</b>

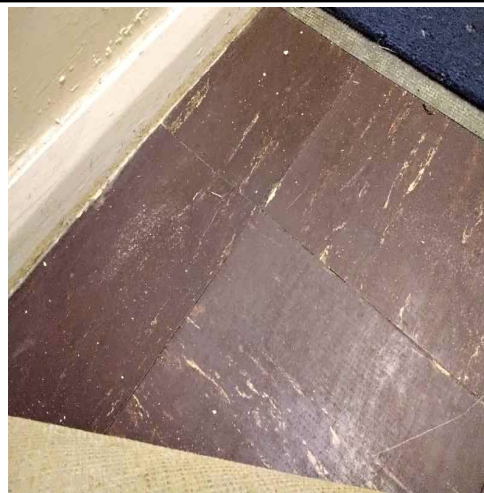
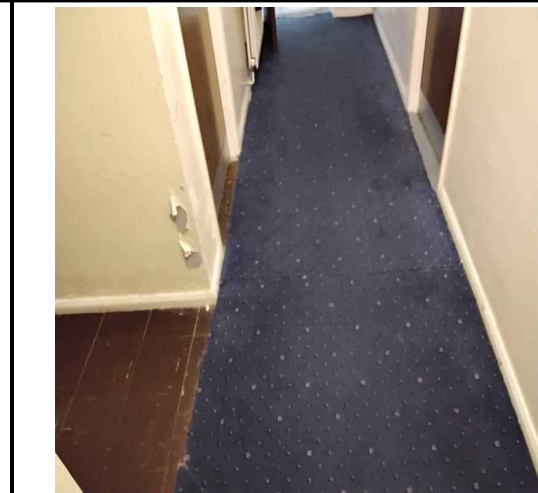
Product Type:	Reinforced Composite	1
Extent of Damage:	Low Damage	1
Surface Treatment:		0
Asbestos Type:	SP: Chrysotile	1

Location	Rooms up to 100m <sup>2</sup>	2	Number of occupants	>10	3
Accessibility	Usually inaccessible or unlikely to be disturbed	0	Frequency of use of area	Daily	3
Extent / Amount	10m <sup>2</sup> - 50m <sup>2</sup> or 10m - 50m pipe run	2	Average time area is in use	>6 hours	3
<b>Likelihood of disturbance</b>	<b>Average Score</b>	<b>2</b>	<b>Human exposure potential</b>	<b>Average Score</b>	<b>3</b>

<b>Normal occupant activity:</b>	<b>Low disturbance</b>	<b>1</b>	Material Assessment Score	<b>3</b>
Type of maintenance activity	Minor disturbance	0	Priority Assessment Score (*)	<b>8</b>
Frequency of maintenance activity	>1 per month	3	Total Risk Score (*)	<b>Low Risk (11)</b>
<b>Maintenance activity</b>	<b>Average Score</b>	<b>2</b>	<b>Recommendation: Manage &amp; Monitor</b>

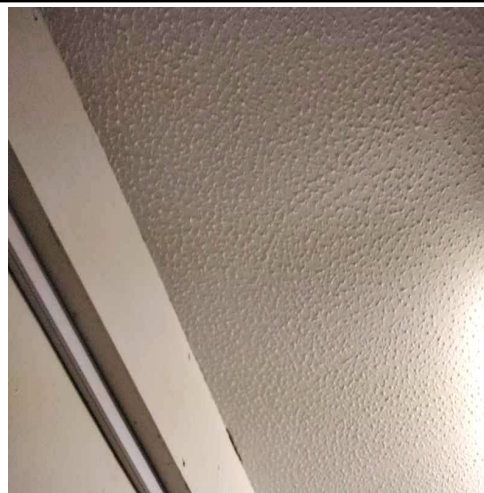
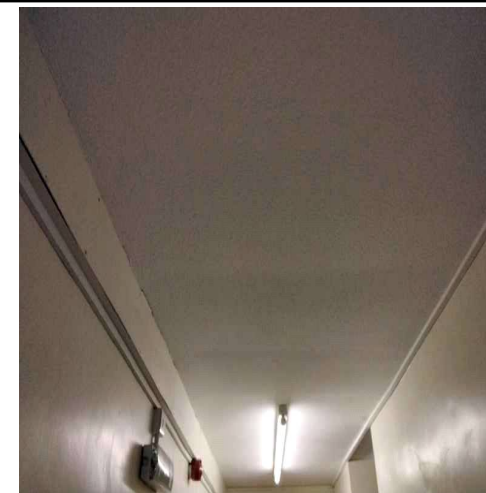
Product Type:	Textured Coating	1
Extent of Damage:	Good Condition	0
Surface Treatment:		1
Asbestos Type:	SP: Chrysotile	1

Location	Rooms up to 100m <sup>2</sup>	2	Number of occupants	>10	3
Accessibility	Occasionally likely to be disturbed	1	Frequency of use of area	Daily	3
Extent / Amount	10m <sup>2</sup> - 50m <sup>2</sup> or 10m - 50m pipe run	2	Average time area is in use	>6 hours	3
<b>Likelihood of disturbance</b>	<b>Average Score</b>	<b>2</b>	<b>Human exposure potential</b>	<b>Average Score</b>	<b>3</b>

<b>Normal occupant activity:</b>	<b>Low disturbance</b>	<b>1</b>	Material Assessment Score	<b>3</b>
Type of maintenance activity	Minor disturbance	0	Priority Assessment Score (*)	<b>8</b>
Frequency of maintenance activity	>1 per month	3	Total Risk Score (*)	<b>Low Risk (11)</b>
<b>Maintenance activity</b>	<b>Average Score</b>	<b>2</b>	<b>Recommendation: Manage &amp; Monitor</b>

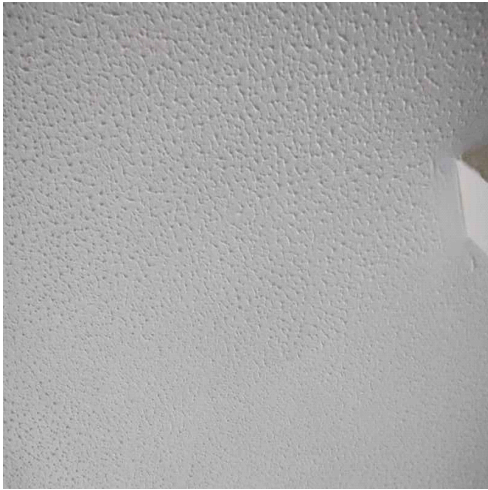
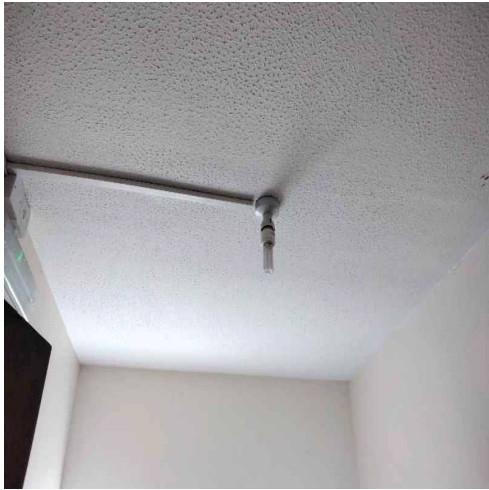
Item Description: Decorative coating - Ceiling

Comments: ,		Extent: 6.5m <sup>2</sup>		
Reinspection State / Register Update: No change				
Product Type:	Textured Coating	1		
Extent of Damage:	Good Condition	0		
Surface Treatment:		1		
Asbestos Type:	SP: Chrysotile	1

<b>Normal occupant activity:</b>	<b>Low disturbance</b>	<b>1</b>	Material Assessment Score	<b>3</b>
Type of maintenance activity	Minor disturbance	0	Priority Assessment Score (*)	8
Frequency of maintenance activity	>1 per month	3	Total Risk Score (*)	Low Risk (11)
<b>Maintenance activity</b>	<b>Average Score</b>	<b>2</b>	<b>Recommendation: Manage &amp; Monitor</b>

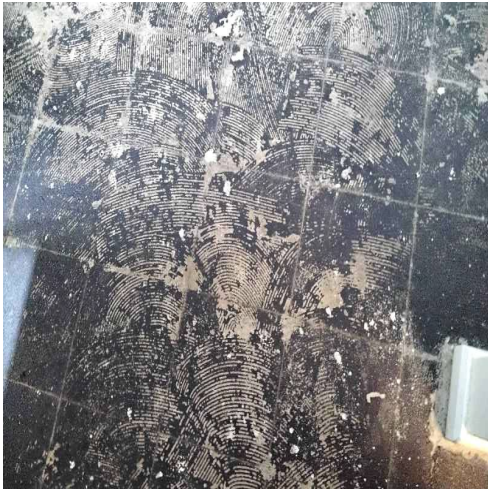
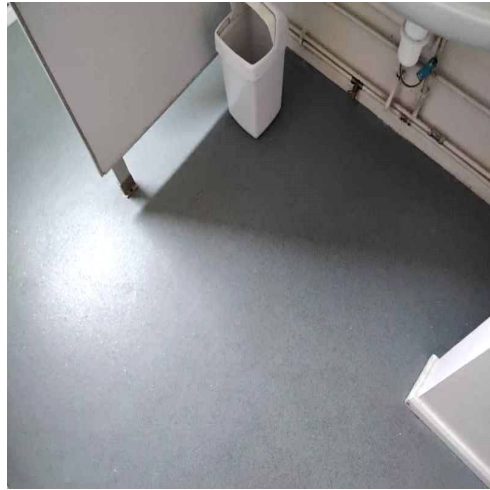
Item Description: Floor tiles - Floor

Comments: Tiles removed - bitumen adhesive remains.,		Extent: 10m <sup>2</sup>		
Reinspection State / Register Update: No change				
Product Type:	Reinforced Composite	1		
Extent of Damage:	Low Damage	1		
Surface Treatment:		0		
Asbestos Type:	SP: Chrysotile	1

<b>Normal occupant activity:</b>	<b>Low disturbance</b>	<b>1</b>	Material Assessment Score	<b>3</b>
Type of maintenance activity	Minor disturbance	0	Priority Assessment Score (*)	<b>8</b>
Frequency of maintenance activity	>1 per month	3	Total Risk Score (*)	<b>Low Risk (11)</b>
<b>Maintenance activity</b>	<b>Average Score</b>	<b>2</b>	<b>Recommendation: Manage &amp; Monitor</b>

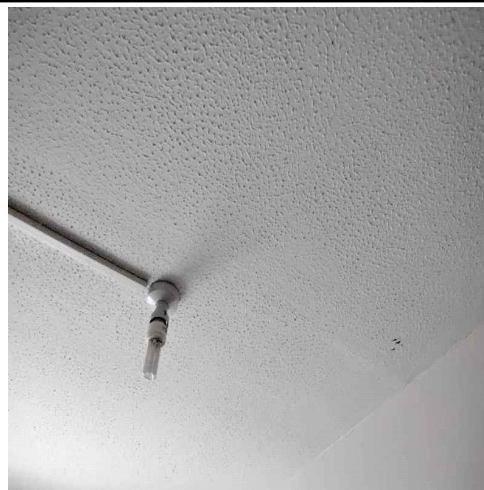
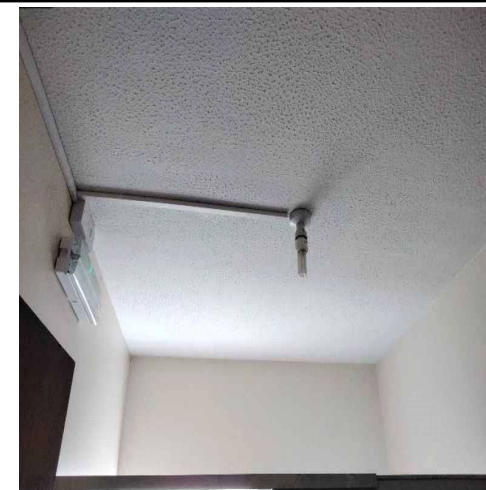
Product Type:	Textured Coating	1
Extent of Damage:	Good Condition	0
Surface Treatment:		1
Asbestos Type:	SP: Chrysotile	1

Location	Rooms up to 100m <sup>2</sup>	2	Number of occupants	>10	3
Accessibility	Occasionally likely to be disturbed	1	Frequency of use of area	Daily	3
Extent / Amount	10m <sup>2</sup> - 50m <sup>2</sup> or 10m - 50m pipe run	2	Average time area is in use	>6 hours	3
<b>Likelihood of disturbance</b>	<b>Average Score</b>	<b>2</b>	<b>Human exposure potential</b>	<b>Average Score</b>	<b>3</b>

<b>Normal occupant activity:</b>	<b>Low disturbance</b>	<b>1</b>	Material Assessment Score	<b>3</b>
Type of maintenance activity	Minor disturbance	0	Priority Assessment Score (*)	8
Frequency of maintenance activity	>1 per month	3	Total Risk Score (*)	Low Risk (11)
<b>Maintenance activity</b>	<b>Average Score</b>	<b>2</b>	<b>Recommendation: Manage &amp; Monitor</b>

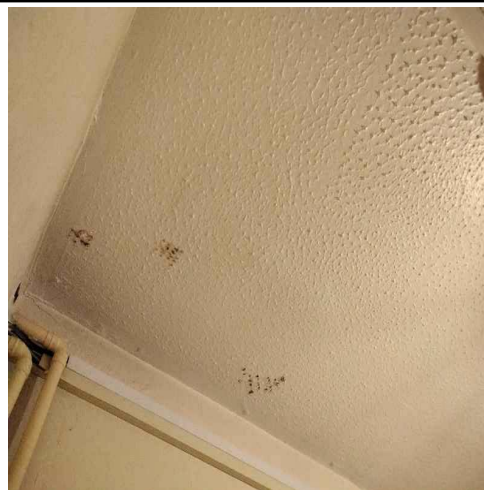
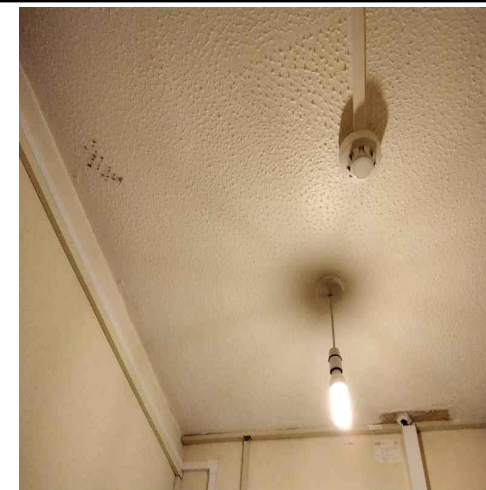
Product Type:	Textured Coating	1
Extent of Damage:	Good Condition	0
Surface Treatment:		1
Asbestos Type:	SP: Chrysotile	1

Location	Confined spaces	3	Number of occupants	None	0
Accessibility	Occasionally likely to be disturbed	1	Frequency of use of area	Infrequent	0
Extent / Amount	<10m <sup>2</sup> or <10m pipe run	1	Average time area is in use	<1 hour	0
<b>Likelihood of disturbance</b>	<b>Average Score</b>	<b>2</b>	<b>Human exposure potential</b>	<b>Average Score</b>	<b>0</b>

<b>Normal occupant activity:</b>	<b>Periodic disturbance</b>	<b>2</b>	Material Assessment Score	<b>3</b>
Type of maintenance activity	Minor disturbance	0	Priority Assessment Score (*)	<b>6</b>
Frequency of maintenance activity	>1 per month	3	Total Risk Score (*)	<b>Low Risk (9)</b>
<b>Maintenance activity</b>	<b>Average Score</b>	<b>2</b>	<b>Recommendation: Manage &amp; Monitor</b>

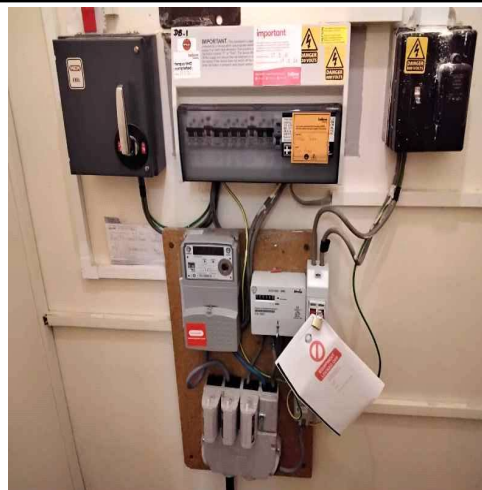
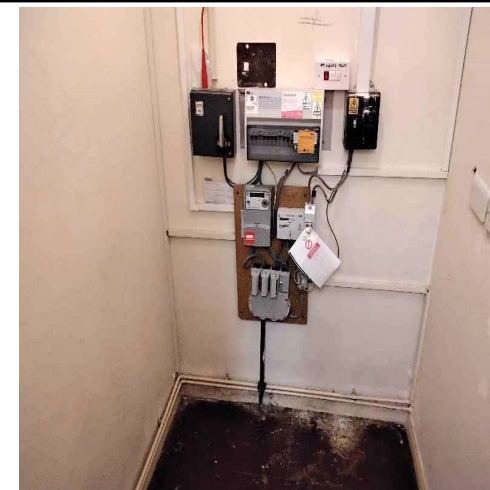
Product Type:	Textiles/Paper	2
Extent of Damage:	Low Damage	1
Surface Treatment:		2
Asbestos Type:	P: Chrysotile	1

Location	Confined spaces	3	Number of occupants	None	0
Accessibility	Usually inaccessible or unlikely to be disturbed	0	Frequency of use of area	Infrequent	0
Extent / Amount	<10m <sup>2</sup> or <10m pipe run	1	Average time area is in use	<1 hour	0
<b>Likelihood of disturbance</b>	<b>Average Score</b>	<b>2</b>	<b>Human exposure potential</b>	<b>Average Score</b>	<b>0</b>

<b>Normal occupant activity:</b>	<b>Periodic disturbance</b>	<b>2</b>	Material Assessment Score	6
Type of maintenance activity	Minor disturbance	0	Priority Assessment Score (*)	6
Frequency of maintenance activity	>1 per month	3	Total Risk Score (*)	Low Risk (12)
<b>Maintenance activity</b>	<b>Average Score</b>	<b>2</b>	<b>Recommendation: Manage &amp; Monitor</b>

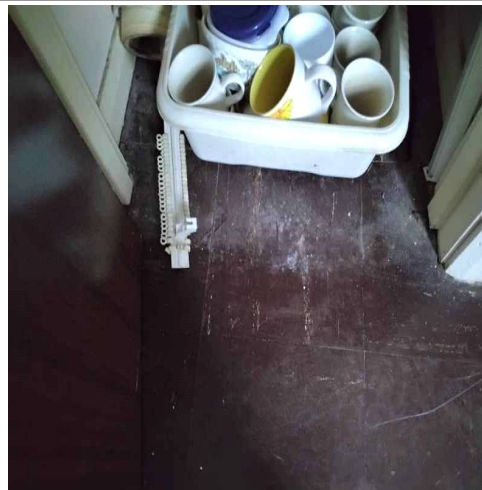
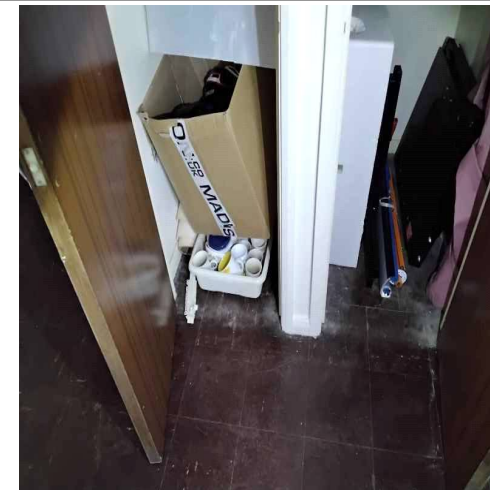
Product Type:	Reinforced Composite	1
Extent of Damage:	Low Damage	1
Surface Treatment:		0
Asbestos Type:	SP: Chrysotile	1

Location	Confined spaces	3	Number of occupants	4 to 10	2
Accessibility	Usually inaccessible or unlikely to be disturbed	0	Frequency of use of area	Daily	3
Extent / Amount	<10m <sup>2</sup> or <10m pipe run	1	Average time area is in use	1 to 3 hours	1
<b>Likelihood of disturbance</b>	<b>Average Score</b>	<b>2</b>	<b>Human exposure potential</b>	<b>Average Score</b>	<b>2</b>

<b>Normal occupant activity:</b>	<b>Low disturbance</b>	<b>1</b>	Material Assessment Score	<b>3</b>
Type of maintenance activity	Minor disturbance	0	Priority Assessment Score (*)	<b>7</b>
Frequency of maintenance activity	>1 per month	3	Total Risk Score (*)	<b>Low Risk (10)</b>
<b>Maintenance activity</b>	<b>Average Score</b>	<b>2</b>	<b>Recommendation: Manage &amp; Monitor</b>

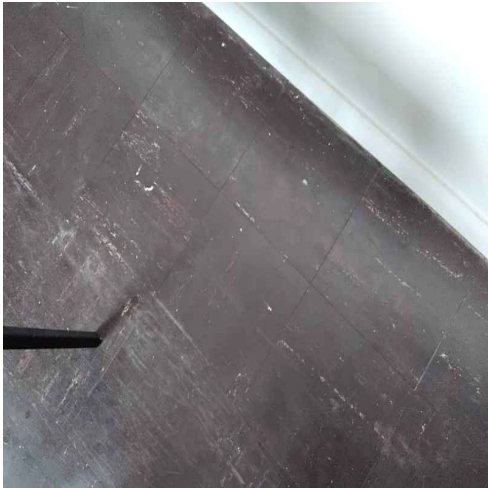
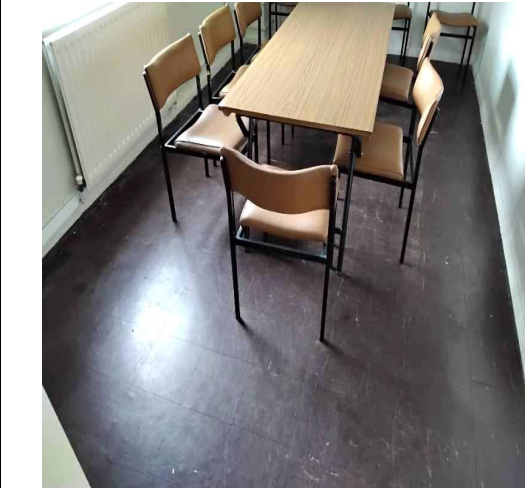
Item Description: Floor tiles - Floor

Comments: ,		Extent: 14m <sup>2</sup>		
Reinspection State / Register Update: No change				
Product Type:	Reinforced Composite	1		
Extent of Damage:	Low Damage	1		
Surface Treatment:		0		
Asbestos Type:	SP: Chrysotile	1

<b>Normal occupant activity:</b>	<b>Low disturbance</b>	<b>1</b>	Material Assessment Score	<b>3</b>
Type of maintenance activity	Minor disturbance	0	Priority Assessment Score (*)	<b>8</b>
Frequency of maintenance activity	>1 per month	3	Total Risk Score (*)	Low Risk (11)
<b>Maintenance activity</b>	<b>Average Score</b>	<b>2</b>	<b>Recommendation: Manage &amp; Monitor</b>

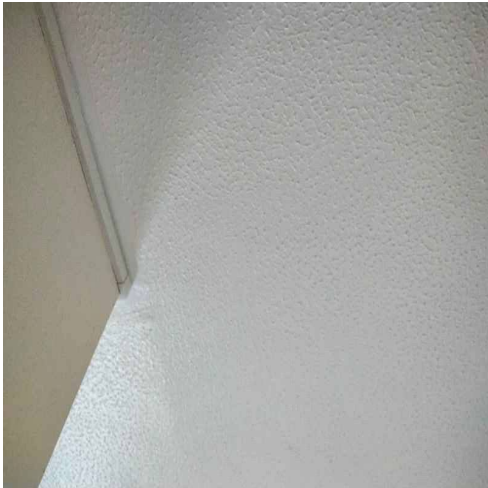
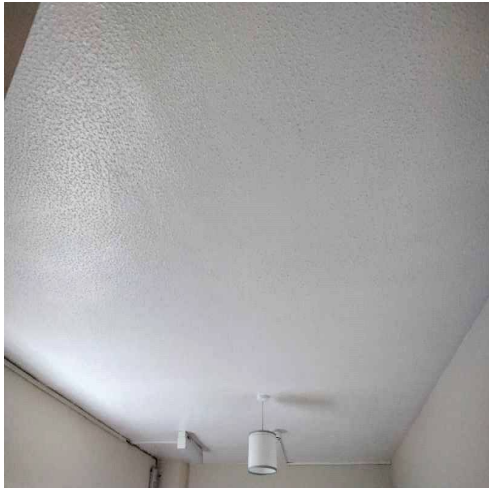
Item Description: Decorative coating - Ceiling

Comments: ,	Extent: 14m <sup>2</sup>		
Reinspection State / Register Update: No change			
Product Type:	Textured Coating	1	
Extent of Damage:	Good Condition	0	
Surface Treatment:	1		
Asbestos Type:	SP: Chrysotile	1

<b>Normal occupant activity:</b>	<b>Low disturbance</b>	<b>1</b>	Material Assessment Score	<b>3</b>
Type of maintenance activity	Minor disturbance	0	Priority Assessment Score (*)	8
Frequency of maintenance activity	>1 per month	3	Total Risk Score (*)	Low Risk (11)
<b>Maintenance activity</b>	<b>Average Score</b>	<b>2</b>	<b>Recommendation: Manage &amp; Monitor</b>

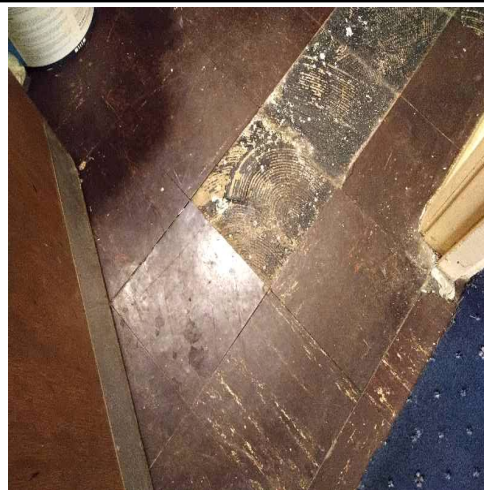
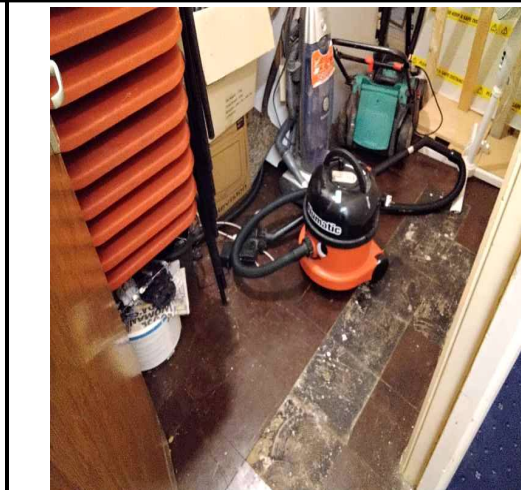
Product Type:	Reinforced Composite	1
Extent of Damage:	Low Damage	1
Surface Treatment:		0
Asbestos Type:	SP: Chrysotile	1

Location	Rooms up to 100m <sup>2</sup>	2	Number of occupants	None	0
Accessibility	Usually inaccessible or unlikely to be disturbed	0	Frequency of use of area	Daily	3
Extent / Amount	10m <sup>2</sup> - 50m <sup>2</sup> or 10m - 50m pipe run	2	Average time area is in use	1 to 3 hours	1
<b>Likelihood of disturbance</b>	<b>Average Score</b>	<b>2</b>	<b>Human exposure potential</b>	<b>Average Score</b>	<b>2</b>

<b>Normal occupant activity:</b>	<b>Rare disturbance</b>	<b>0</b>	Material Assessment Score	<b>3</b>
Type of maintenance activity	Minor disturbance	0	Priority Assessment Score (*)	<b>6</b>
Frequency of maintenance activity	>1 per month	3	Total Risk Score (*)	<b>Low Risk (9)</b>
<b>Maintenance activity</b>	<b>Average Score</b>	<b>2</b>	<b>Recommendation: Manage &amp; Monitor</b>

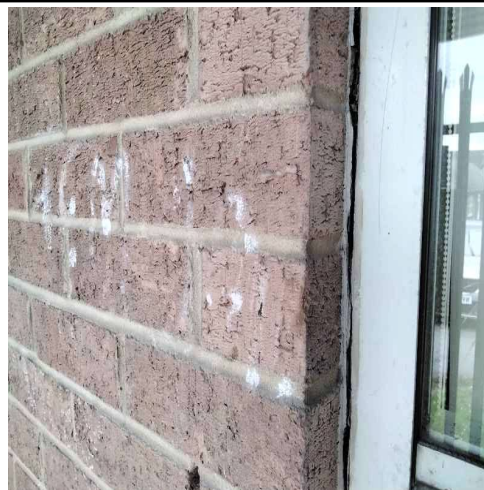
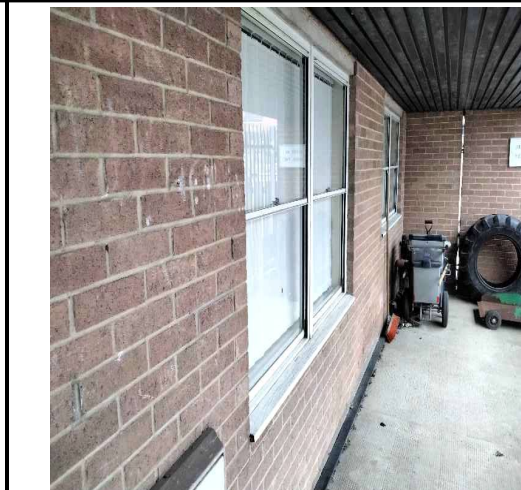
Product Type:	Reinforced Composite	1
Extent of Damage:	Low Damage	1
Surface Treatment:		0
Asbestos Type:	Chrysotile	1

Location	External	0	Number of occupants	4 to 10	2
Accessibility	Usually inaccessible or unlikely to be disturbed	0	Frequency of use of area	Daily	3
Extent / Amount	10m <sup>2</sup> - 50m <sup>2</sup> or 10m - 50m pipe run	2	Average time area is in use	>6 hours	3
<b>Likelihood of disturbance</b>	<b>Average Score</b>	<b>1</b>	<b>Human exposure potential</b>	<b>Average Score</b>	<b>3</b>

<b>Normal occupant activity:</b>	<b>Periodic disturbance</b>	<b>2</b>	Material Assessment Score	<b>3</b>
Type of maintenance activity	Minor disturbance	0	Priority Assessment Score (*)	<b>8</b>
Frequency of maintenance activity	>1 per month	3	Total Risk Score (*)	<b>Low Risk (11)</b>
<b>Maintenance activity</b>	<b>Average Score</b>	<b>2</b>	<b>Recommendation: Manage &amp; Monitor</b>
