Asbestos Reinspection Survey (MA and PA)

Client Details	believe housing, Coast House, Spectrum 4, Spectrum Business Park, Seaham, SR7 7TT
Site Details	Byron Lodge Community Centre, 61a Byron Lodge Estate, Seaham, County Durham, SR7 0JY UPRN: 3CH00809
Date(s) of Surveys	29 May 2024
Report Reference Number	J090619
Brief Survey Scope of Works	Re-inspection Survey

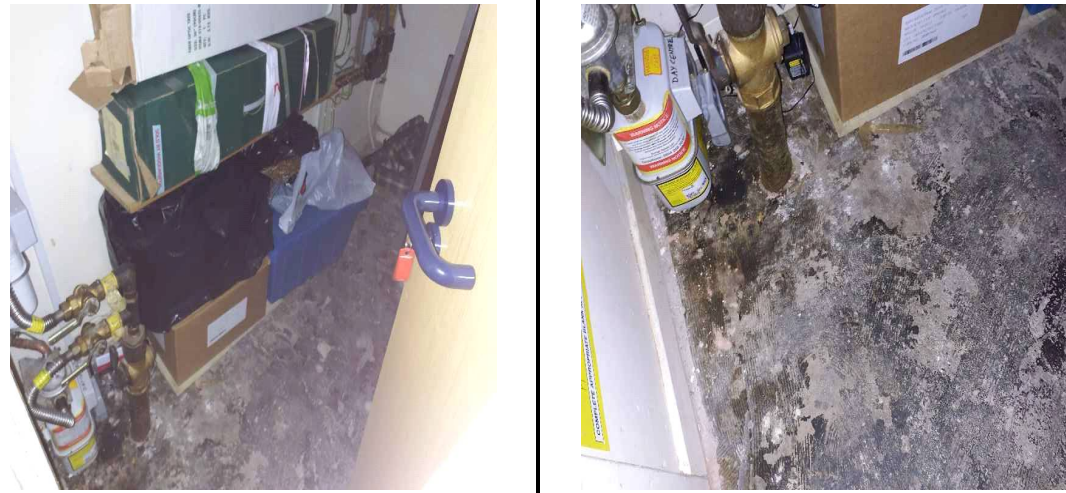
Item No: 10	Sample No: TB011645 {IJ000841}* Level of ID: Identified	Building ID: Byron Lodge Community Centre	Location: Meter cupboard, G/01
----------------	--	---	--------------------------------

Item Description: Adhesive - Floor

Comments: ,		Extent: 3m ²	
Reinspection State / Register Update: No change			
Product Type:	Bituminous	1	
Extent of Damage:	Low Damage	1	
Surface Treatment:		0	
Asbestos Type:	Chrysotile	1

Normal occupant activity:	Periodic disturbance	2	Material Assessment Score	3
Type of maintenance activity	Minor disturbance	0	Priority Assessment Score (*)	7
Frequency of maintenance activity	>1 per month	3	Total Risk Score (*)	Low Risk (10)
Maintenance activity	Average Score	2	Recommendation: Manage & Monitor

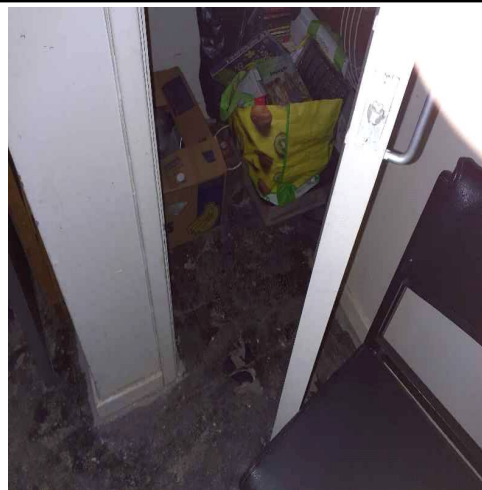
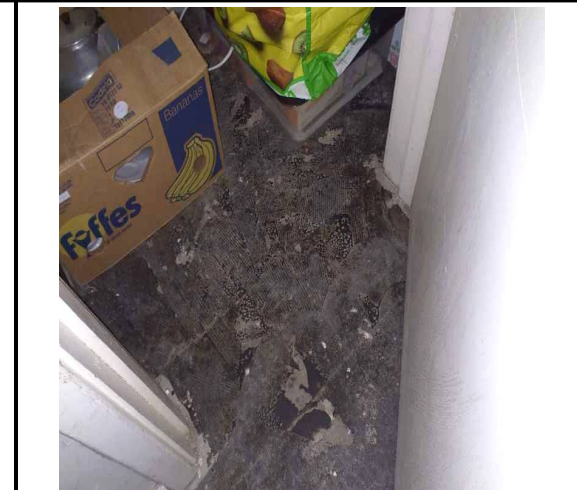
Item No: 12	Sample No: As TB011645 {IJ000841}* Level of ID: Strongly Presumed	Building ID: Byron Lodge Community Centre	Location: Cupboard, G/02
----------------	--	---	--------------------------

Item Description: Adhesive - Floor

Extent:
1.5m²

Reinspection State / Register Update: No change

Product Type:	Bituminous	1
Extent of Damage:	Low Damage	1
Surface Treatment:		0
Asbestos Type:	SP: Chrysotile	1

Normal occupant activity:	Low disturbance	1	Material Assessment Score	3
Type of maintenance activity	Minor disturbance	0	Priority Assessment Score (*)	7
Frequency of maintenance activity	>1 per month	3	Total Risk Score (*)	Low Risk (10)
Maintenance activity	Average Score	2	Recommendation: Manage & Monitor
