Asbestos Management Plan

UPRN:	3ROBI1_Ext_Com
Location:	B27 ROBINSON HOUSE (1 - 27), HORDEN, SR8 4DD
Survey Date:	27/03/2024
Surveyed By:	Franks
Survey Reference:	J087891
Responsible Person:	Emma Jorgenson – Compliance Manager
Reinspection Frequency	12 months
Reinspection Due:	27/03/2025

Revision: 003

Date: 08/04/2024

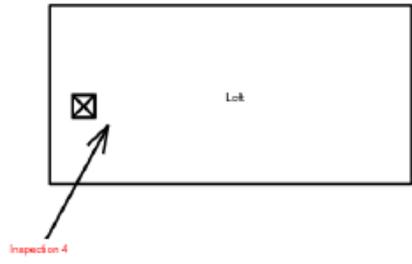
Accessed from ground
floor male w.c.
