Asbestos Reinspection Survey (MA and PA)

<p>Client Details</p>	<p>believe housing, Coast House, Spectrum 4, Spectrum Business Park, Seaham, SR7 7TT</p>
	<p>Site Details</p>	<p>Alcote House, Shotton Colliery, Durham, County Durham, DH6 2RB UPRN: 3CH00808</p>
	<p>Date(s) of Surveys</p>	<p>30 Jan 2025</p>
	<p>Report Reference Number</p>	<p>J109758</p>
	<p>Brief Survey Scope of Works</p>	<p>Re-inspection Survey</p>

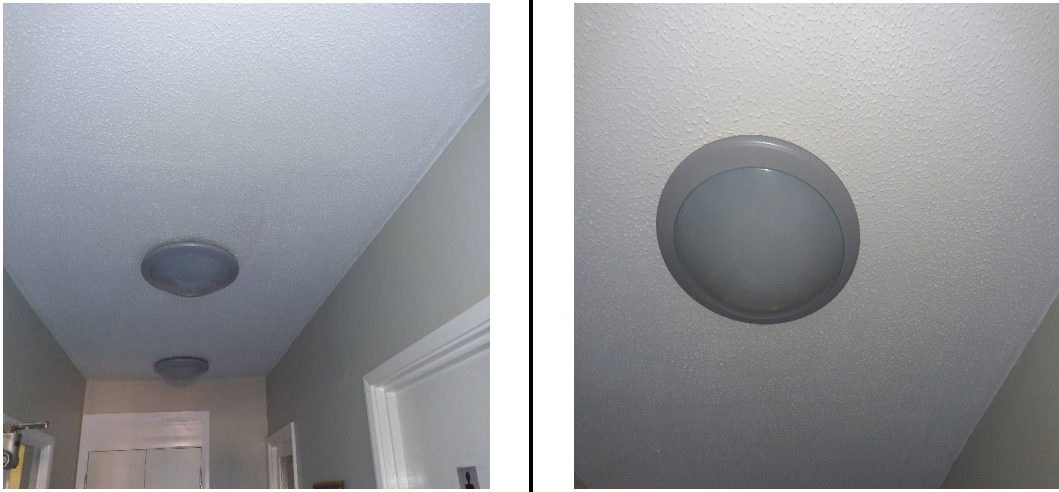
Item No: 5	Sample No: TB003728 {KO000017}* Level of ID: Identified	Building ID: Alcote House	Location: Entrance front, G/01	
Item Description: Decorative coating - Ceiling

Comments: , Small crack in ceiling	Extent: 9m ²			
Reinspection State / Register Update: No change				
Product Type:	Textured Coating			1
Extent of Damage:	Low Damage			1
Surface Treatment:				1
Asbestos Type:	Chrysotile			1

Normal occupant activity:	Low disturbance	1	Material Assessment Score	4
Type of maintenance activity	Minor disturbance	0	Priority Assessment Score (*)	8
Frequency of maintenance activity	>1 per month	3	Total Risk Score (*)	Low Risk (12)
Maintenance activity	Average Score	2	Recommendation: Manage & Monitor

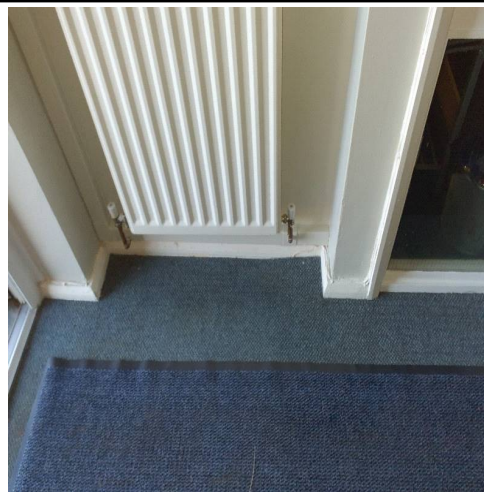
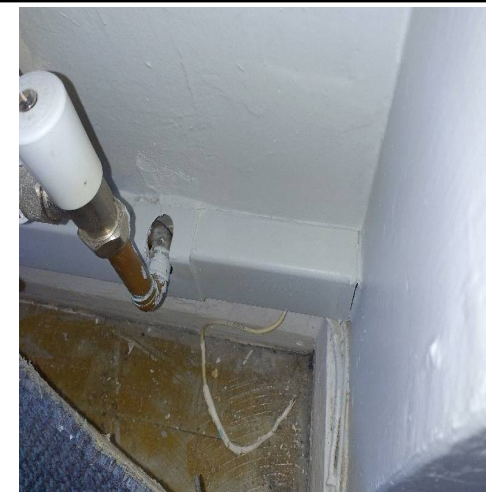
Product Type:	Vinyl Tile	1
Extent of Damage:	Good Condition	0
Surface Treatment:		0
Asbestos Type:	Chrysotile	1

Normal occupant activity:	Low disturbance	1	Material Assessment Score	2
Type of maintenance activity	Minor disturbance	0	Priority Assessment Score (*)	8
Frequency of maintenance activity	>1 per month	3	Total Risk Score (*)	Low Risk (10)
Maintenance activity	Average Score	2	Recommendation: Manage & Monitor

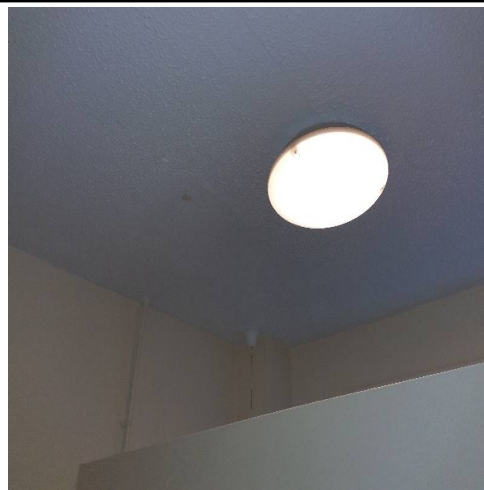
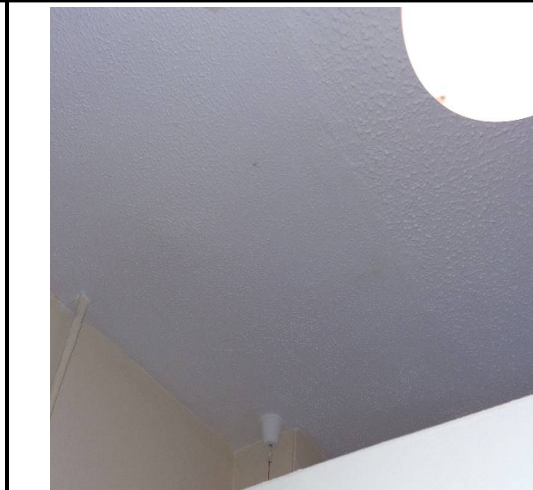
Product Type:	Textured Coating	1
Extent of Damage:	Low Damage	1
Surface Treatment:		1
Asbestos Type:	SP: Chrysotile	1

Normal occupant activity:	Low disturbance	1	Material Assessment Score	4
Type of maintenance activity	Minor disturbance	0	Priority Assessment Score (*)	8
Frequency of maintenance activity	>1 per month	3	Total Risk Score (*)	Low Risk (12)
Maintenance activity	Average Score	2	Recommendation: Manage & Monitor

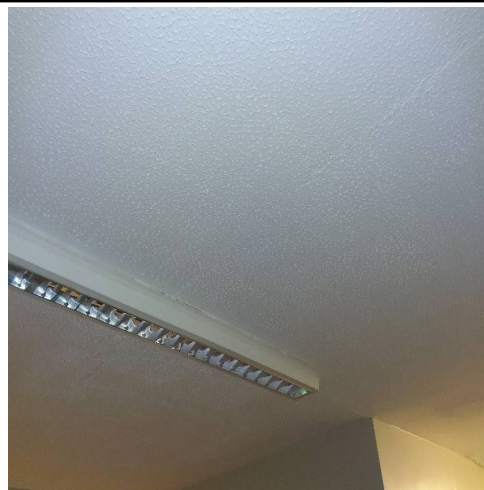
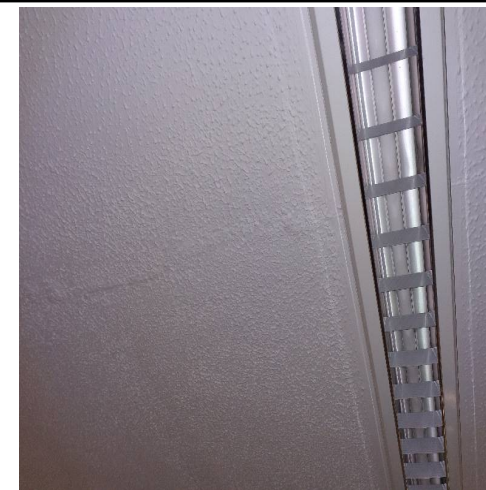
Product Type:	Textured Coating	1
Extent of Damage:	Low Damage	1
Surface Treatment:		1
Asbestos Type:	SP: Chrysotile	1

Normal occupant activity:	Low disturbance	1	Material Assessment Score	4
Type of maintenance activity	Minor disturbance	0	Priority Assessment Score (*)	7
Frequency of maintenance activity	>1 per month	3	Total Risk Score (*)	Low Risk (11)
Maintenance activity	Average Score	2	Recommendation: Manage & Monitor

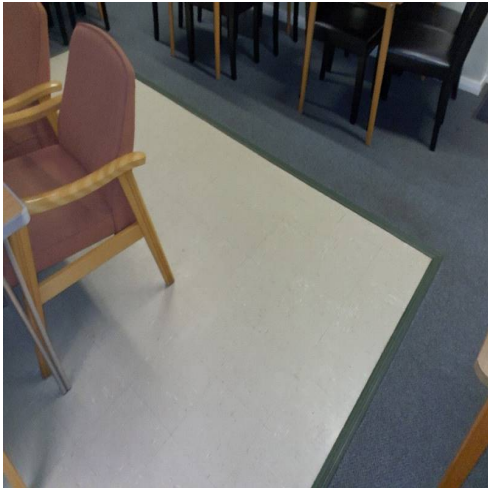
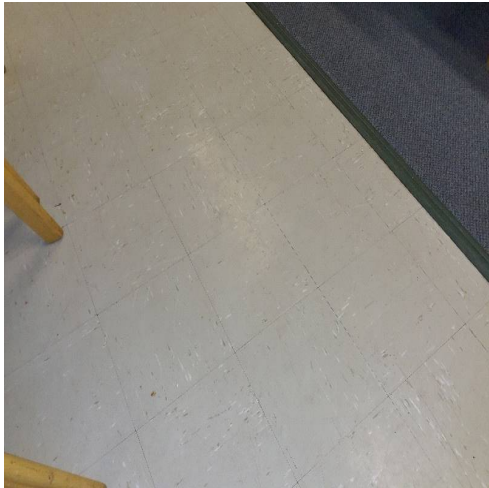
Item Description: Floor tiles - Floor

Comments: ,	Extent: 50m ²			
Reinspection State / Register Update: No change				
Product Type:	Vinyl Tile	1		
Extent of Damage:	Good Condition	0		
Surface Treatment:		0		
Asbestos Type:	SP: Chrysotile	1

Normal occupant activity:	Low disturbance	1	Material Assessment Score	2
Type of maintenance activity	Minor disturbance	0	Priority Assessment Score (*)	7
Frequency of maintenance activity	>1 per month	3	Total Risk Score (*)	Low Risk (9)
Maintenance activity	Average Score	2	Recommendation: Manage & Monitor

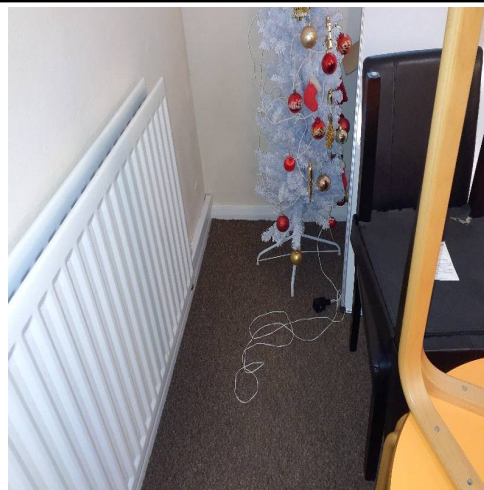
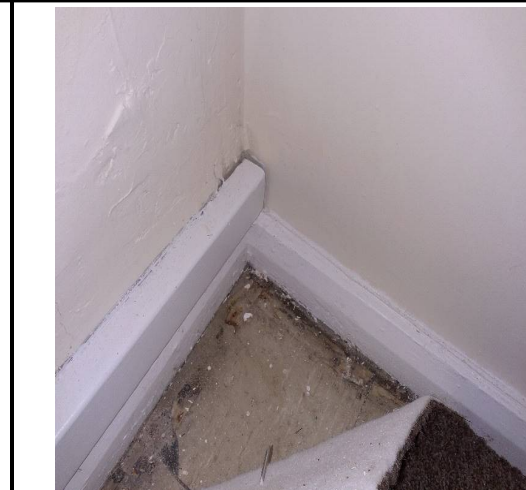
Product Type:	Vinyl Tile	1
Extent of Damage:	Low Damage	1
Surface Treatment:		0
Asbestos Type:	SP: Chrysotile	1

Normal occupant activity:	Low disturbance	1	Material Assessment Score	3
Type of maintenance activity	Minor disturbance	0	Priority Assessment Score (*)	8
Frequency of maintenance activity	>1 per month	3	Total Risk Score (*)	Low Risk (11)
Maintenance activity	Average Score	2	Recommendation: Manage & Monitor

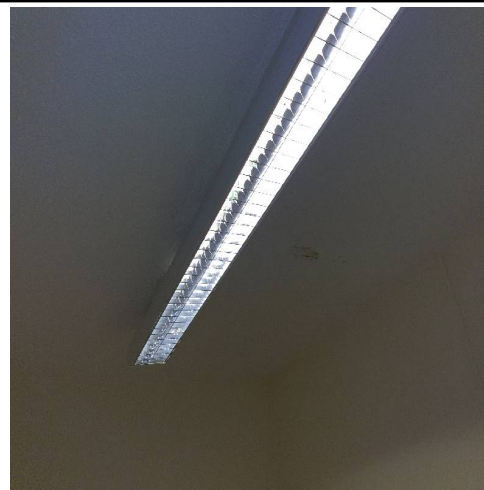
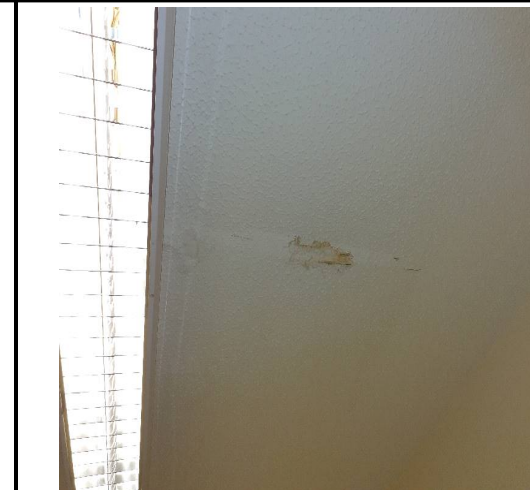
Reinspection State / Register Update: Damaged

Product Type:	Textured Coating	1
Extent of Damage:	Medium Damage	2
Surface Treatment:		1
Asbestos Type:	SP: Chrysotile	1

Normal occupant activity:	Low disturbance	1	Material Assessment Score	5
Type of maintenance activity	Minor disturbance	0	Priority Assessment Score (*)	7
Frequency of maintenance activity	>1 per month	3	Total Risk Score (*)	Low Risk (12)
Maintenance activity	Average Score	2	Recommendation: Encapsulate & Manage

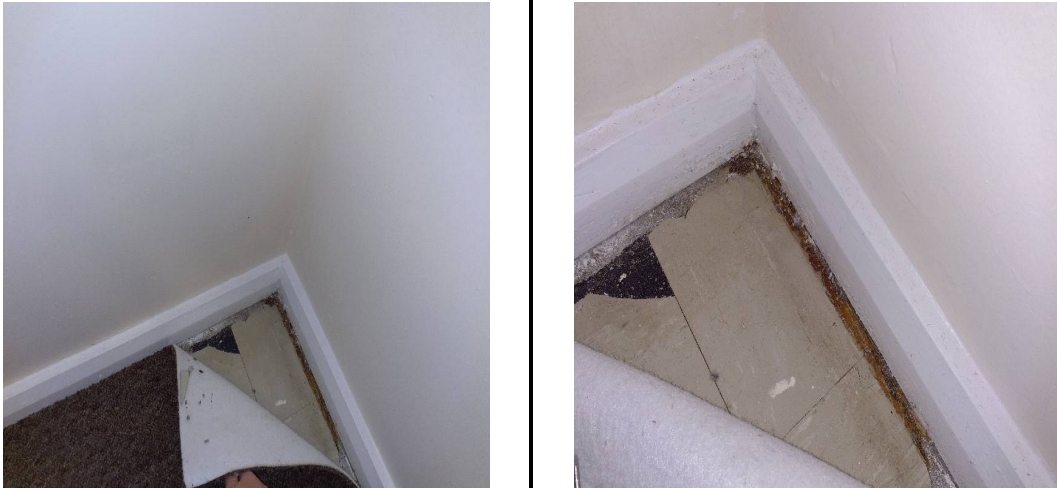
Item Description: Floor tiles - Floor

Comments: ,	Extent: 8m ²		
Reinspection State / Register Update: No change			
Product Type:	Vinyl Tile	1	
Extent of Damage:	Low Damage	1	
Surface Treatment:		0	
Asbestos Type:	SP: Chrysotile	1

Normal occupant activity:	Low disturbance	1	Material Assessment Score	3
Type of maintenance activity	Minor disturbance	0	Priority Assessment Score (*)	7
Frequency of maintenance activity	>1 per month	3	Total Risk Score (*)	Low Risk (10)
Maintenance activity	Average Score	2	Recommendation: Manage & Monitor

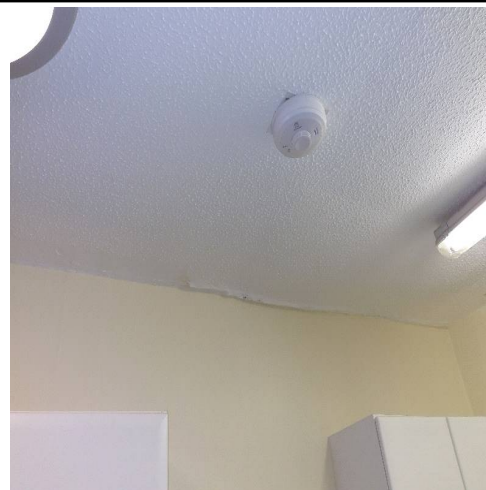
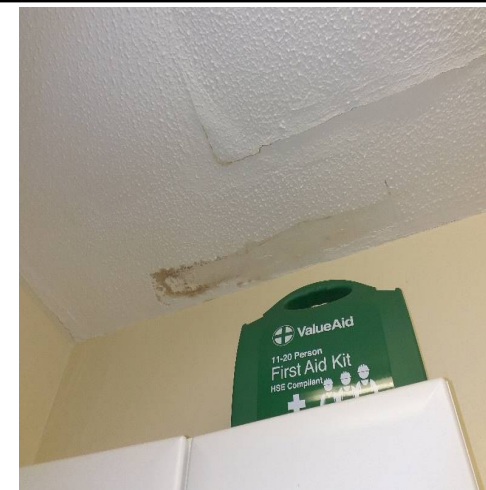
Reinspection State / Register Update: Damaged

Product Type:	Textured Coating	1
Extent of Damage:	Medium Damage	2
Surface Treatment:		1
Asbestos Type:	SP: Chrysotile	1

Normal occupant activity:	Low disturbance	1	Material Assessment Score	5
Type of maintenance activity	Minor disturbance	0	Priority Assessment Score (*)	8
Frequency of maintenance activity	>1 per month	3	Total Risk Score (*)	Medium Risk (13)
Maintenance activity	Average Score	2	Recommendation: Encapsulate & Manage

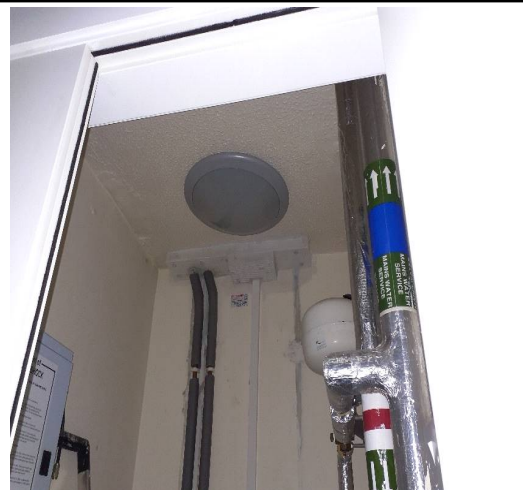
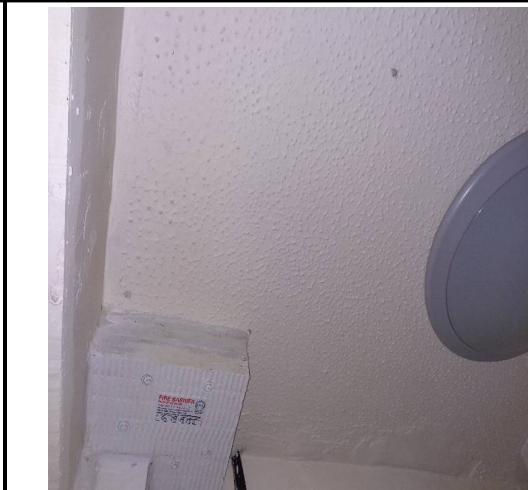
Product Type:	Textured Coating	1
Extent of Damage:	Low Damage	1
Surface Treatment:		1
Asbestos Type:	SP: Chrysotile	1

Normal occupant activity:	Periodic disturbance	2	Material Assessment Score	4
Type of maintenance activity	Minor disturbance	0	Priority Assessment Score (*)	7
Frequency of maintenance activity	>1 per month	3	Total Risk Score (*)	Low Risk (11)
Maintenance activity	Average Score	2	Recommendation: Manage & Monitor

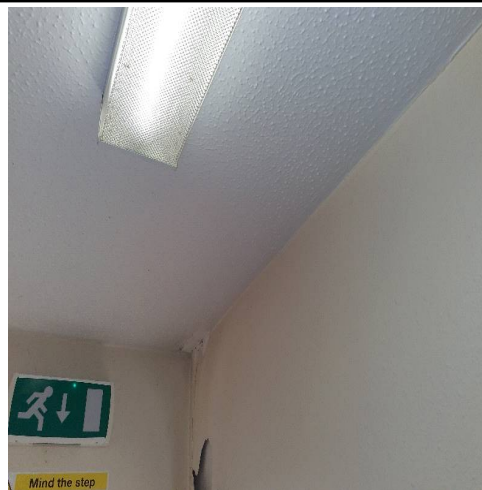
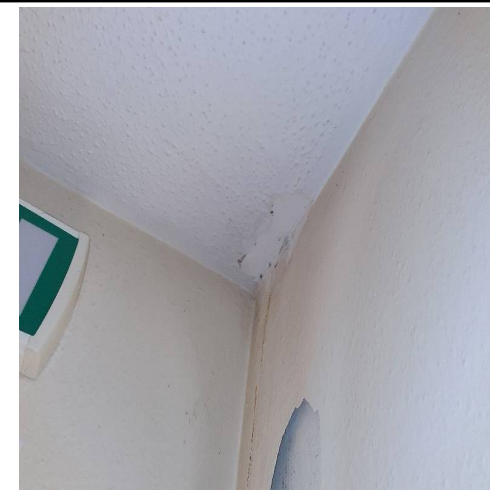
Reinspection State / Register Update: Damaged

Product Type:	Textured Coating	1
Extent of Damage:	Medium Damage	2
Surface Treatment:		1
Asbestos Type:	SP: Chrysotile	1

Normal occupant activity:	Low disturbance	1	Material Assessment Score	5
Type of maintenance activity	Minor disturbance	0	Priority Assessment Score (*)	8
Frequency of maintenance activity	>1 per month	3	Total Risk Score (*)	Medium Risk (13)
Maintenance activity	Average Score	2	Recommendation: Encapsulate & Manage

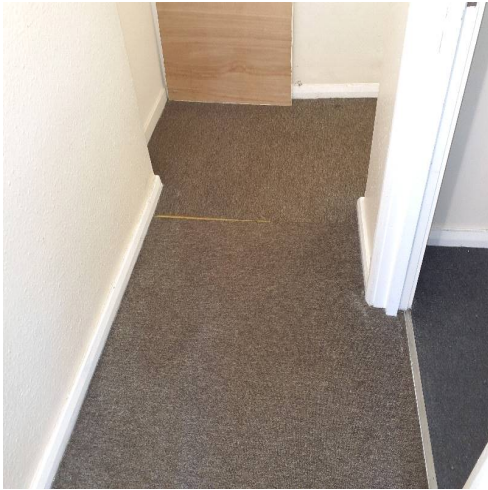
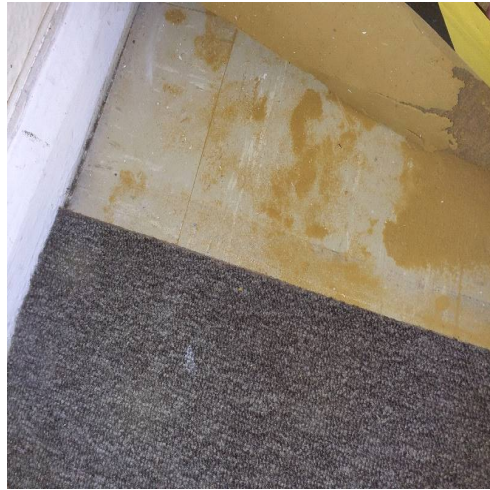
Item Description: Floor tiles - Floor

Comments: ,	Extent: 8m²		
Reinspection State / Register Update: No change			
Product Type:	Vinyl Tile	1	
Extent of Damage:	Low Damage	1	
Surface Treatment:	0		
Asbestos Type:	SP: Chrysotile	1

Normal occupant activity:	Low disturbance	1	Material Assessment Score	3
Type of maintenance activity	Minor disturbance	0	Priority Assessment Score (*)	8
Frequency of maintenance activity	>1 per month	3	Total Risk Score (*)	Low Risk (11)
Maintenance activity	Average Score	2	Recommendation: Manage & Monitor

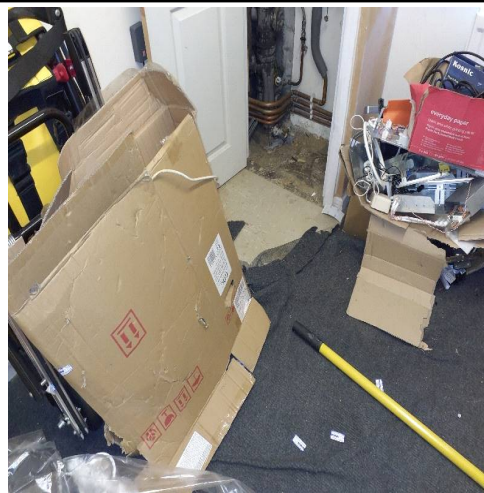
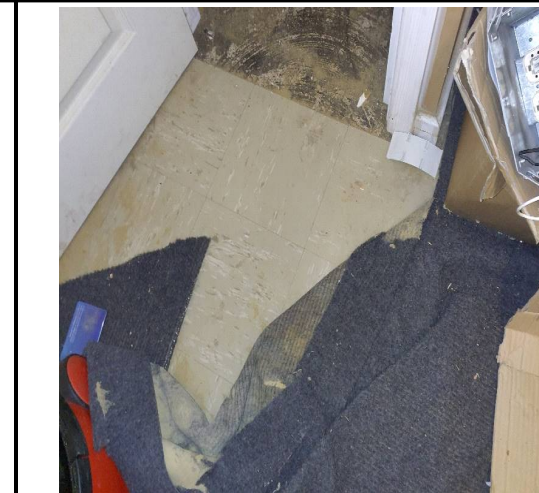
Product Type:	Vinyl Tile	1
Extent of Damage:	Low Damage	1
Surface Treatment:		0
Asbestos Type:	Chrysotile	1

Normal occupant activity:	Rare disturbance	0	Material Assessment Score	3
Type of maintenance activity	Minor disturbance	0	Priority Assessment Score (*)	6
Frequency of maintenance activity	>1 per month	3	Total Risk Score (*)	Low Risk (9)
Maintenance activity	Average Score	2	Recommendation: Manage & Monitor

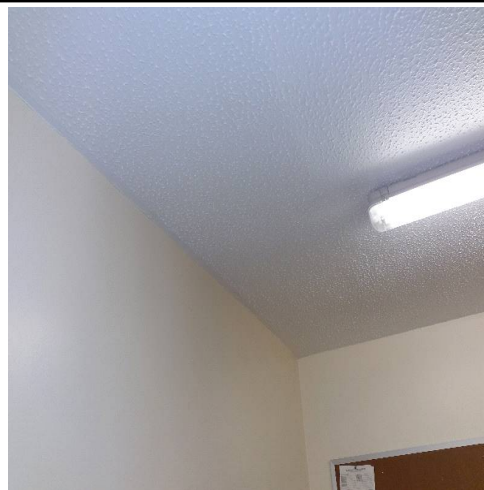
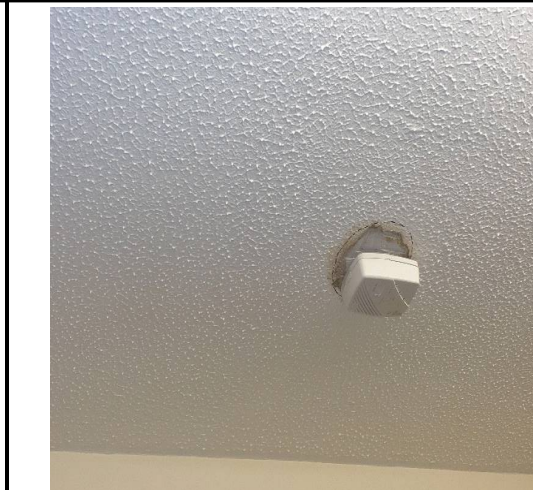
Product Type:	Textured Coating	1
Extent of Damage:	Low Damage	1
Surface Treatment:		1
Asbestos Type:	Chrysotile	1

Normal occupant activity:	Rare disturbance	0	Material Assessment Score	4
Type of maintenance activity	Minor disturbance	0	Priority Assessment Score (*)	6
Frequency of maintenance activity	>1 per month	3	Total Risk Score (*)	Low Risk (10)
Maintenance activity	Average Score	2	Recommendation: Manage & Monitor

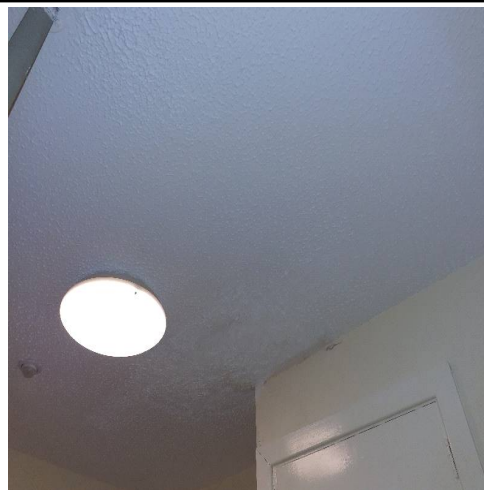
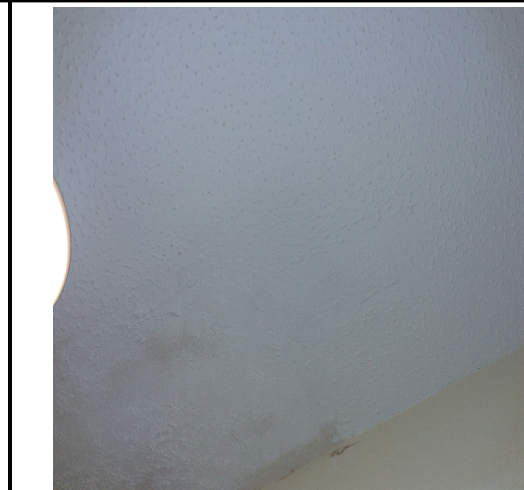
Product Type:	Textured Coating	1
Extent of Damage:	Low Damage	1
Surface Treatment:		1
Asbestos Type:	SP: Chrysotile	1

Normal occupant activity:	Low disturbance	1	Material Assessment Score	4
Type of maintenance activity	Minor disturbance	0	Priority Assessment Score (*)	8
Frequency of maintenance activity	>1 per month	3	Total Risk Score (*)	Low Risk (12)
Maintenance activity	Average Score	2	Recommendation: Manage & Monitor

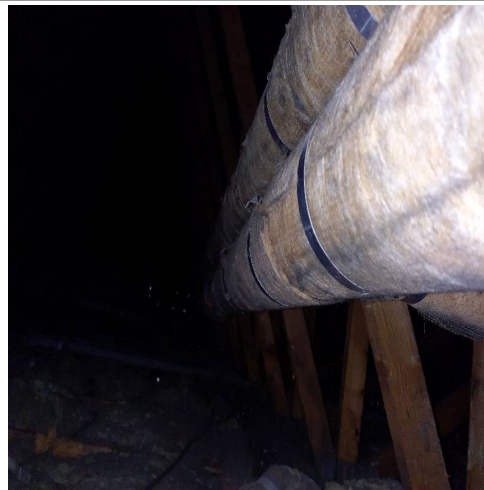
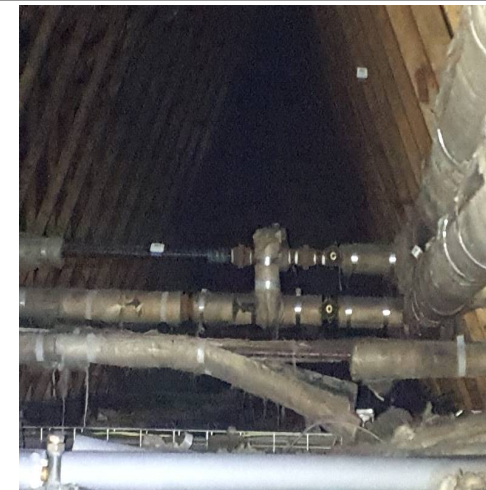
Item Description: Gasket - Pipework		
Comments: ,	Extent: 2no.	
Reinspection State / Register Update: No change		
Product Type:	Gasket	2
Extent of Damage:	Good Condition	0
Surface Treatment:		1
Asbestos Type:	Chrysotile	1

Normal occupant activity:	Rare disturbance	0	Material Assessment Score	4
Type of maintenance activity	Minor disturbance	0	Priority Assessment Score (*)	5
Frequency of maintenance activity	>1 per month	3	Total Risk Score (*)	Low Risk (9)
Maintenance activity	Average Score	2	Recommendation: Manage & Monitor

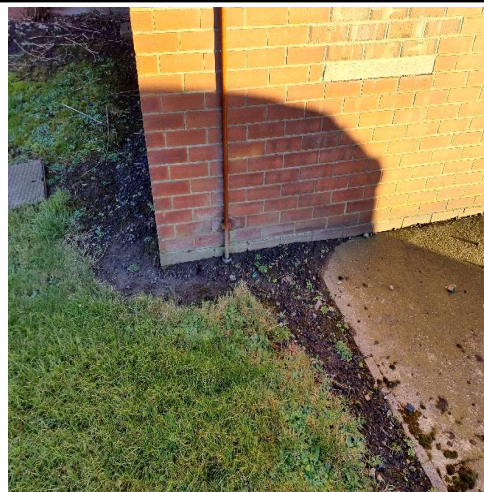
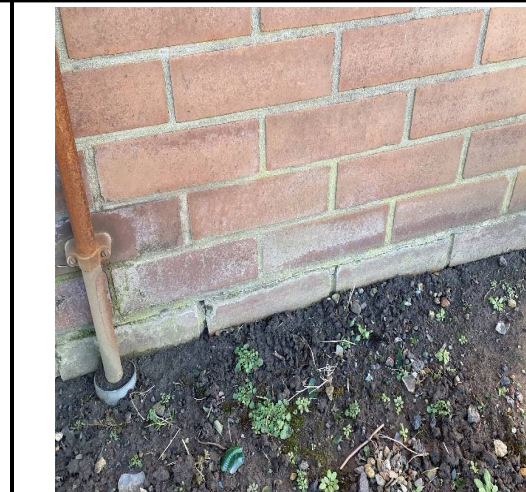
Product Type:	Bituminous	1
Extent of Damage:	Good Condition	0
Surface Treatment:		0
Asbestos Type:	Chrysotile	1

Normal occupant activity:	Periodic disturbance	2	Material Assessment Score	2
Type of maintenance activity	Minor disturbance	0	Priority Assessment Score (*)	8
Frequency of maintenance activity	>1 per month	3	Total Risk Score (*)	Low Risk (10)
Maintenance activity	Average Score	2	Recommendation: Manage & Monitor

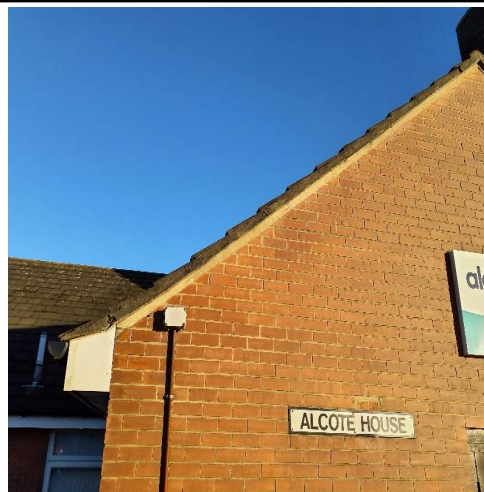
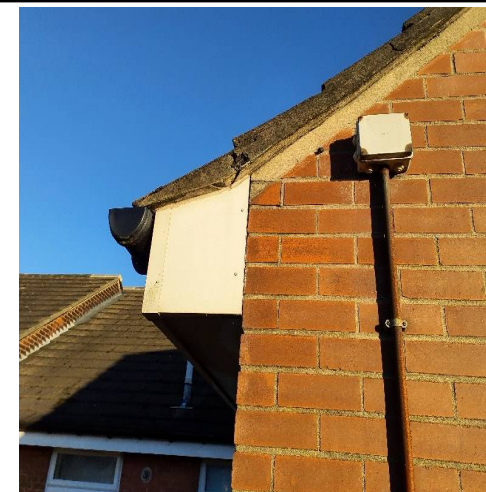
Product Type:	Cement	1
Extent of Damage:	Good Condition	0
Surface Treatment:		1
Asbestos Type:	Chrysotile	1

Normal occupant activity:	Periodic disturbance	2	Material Assessment Score	3
Type of maintenance activity	Minor disturbance	0	Priority Assessment Score (*)	8
Frequency of maintenance activity	>1 per month	3	Total Risk Score (*)	Low Risk (11)
Maintenance activity	Average Score	2	Recommendation: Manage & Monitor

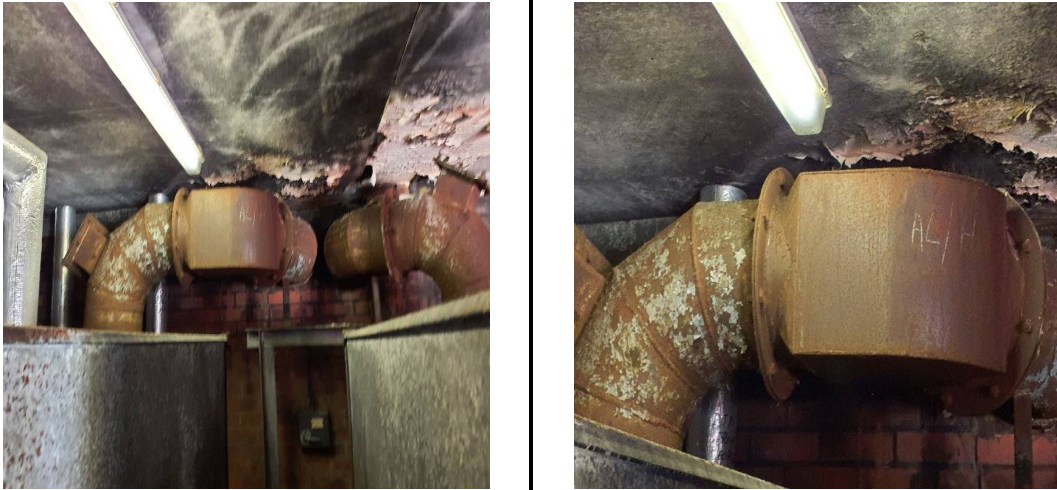
Item Description: Gasket - Ductwork

Comments: ,		Extent: 2no.	
Reinspection State / Register Update: No change			
Product Type:	Gasket	2	
Extent of Damage:	Good Condition	0	
Surface Treatment:		1	
Asbestos Type:	Chrysotile	1

Normal occupant activity:	Rare disturbance	0	Material Assessment Score	4
Type of maintenance activity	Minor disturbance	0	Priority Assessment Score (*)	5
Frequency of maintenance activity	>1 per month	3	Total Risk Score (*)	Low Risk (9)
Maintenance activity	Average Score	2	Recommendation: Manage & Monitor

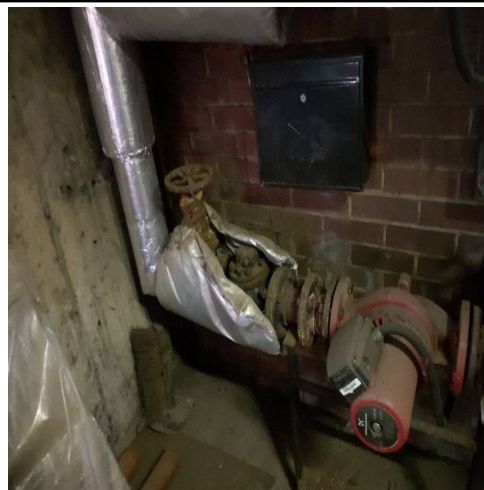
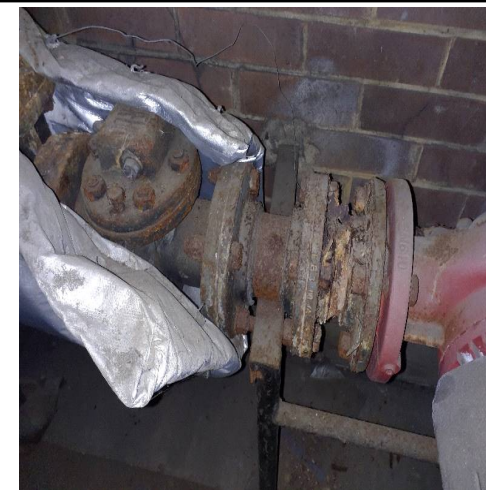
Product Type:	Gasket	2
Extent of Damage:	Good Condition	0
Surface Treatment:		1
Asbestos Type:	Chrysotile	1

Normal occupant activity:	Rare disturbance	0	Material Assessment Score	4
Type of maintenance activity	Minor disturbance	0	Priority Assessment Score (*)	5
Frequency of maintenance activity	>1 per month	3	Total Risk Score (*)	Low Risk (9)
Maintenance activity	Average Score	2	Recommendation: Manage & Monitor
