**FIRE RISK ASSESSMENT
1-14 JUBILEE CENTRE,
CHARLES STREET, SEAHAM,
CO DURHAM, SR7 7SG.**

DECEMBER 2024

Reference: 4560-04-24-NY

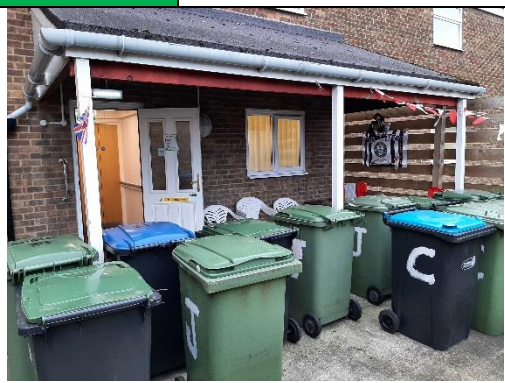
LOW	1

| 3.4 | Refuse Stored Within the Wheelie Bins: | Refuse is stored in a designated area to the east elevation. The wheely bins are migrating towards the wooden canopy. Any ignition of the wheely bins could spread to felt covered timber lean to canopy and enter the building via the corridor windows. We recommend the storage area is moved towards the rear fence. |

<p>Fire Risk Assessors Observations:</p> <p>Refuse is stored in a designated area to the east elevation. The wheely bins are migrating towards the wooden canopy. Any ignition of the wheely bins could spread to felt covered timber lean to canopy and enter the building via the corridor windows.</p>
Date First Identified:	16/12/24	<p>Recommended Action:</p> <p>We recommend the storage area is moved towards the rear fence.</p>
Date of FRA:	16/12/24	
Rectify Within: (months)	6

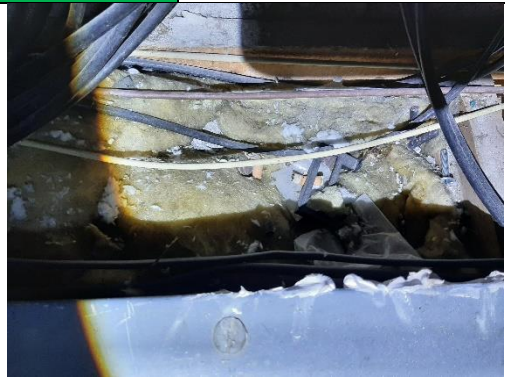
LOW	2

- 3.17 Smoking: Smoking is prohibited within the common parts and is reinforced with signage. However, cigarette butts were found in the roof void above the means of escape corridor. Although difficult to police, we

<p>Fire Risk Assessors Observations:</p> <p>There is an acceptable level of no smoking signage and is mostly observed. However, cigarette butts were found in the roof void above the means of escape corridor.</p>
Date First Identified:	16/12/24	<p>Recommended Action:</p> <p>Although difficult to police, we recommend observance of the policy is strictly enforced on contractors and maintenance staff.</p>
Date of FRA:	16/12/24	
Rectify Within: (months)	6

recommend observance of the policy is strictly enforced on contractors and maintenance staff.

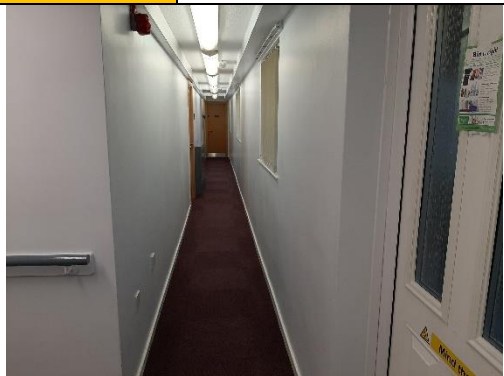
MEDIUM	3

The property was built circa 1977 and predates current building guidelines for sheltered accommodation. Both floors in the west wing have dead end conditions that exceed the current benchmark standard of 7.5 meters which may have implication for safe

<p>Fire Risk Assessors Observations:</p> <p>The property was built circa 1977 and predates current building guidelines for sheltered accommodation. Both floors in the west wing have dead end conditions that exceed the current benchmark standard of 7.5 meters which may have implication for safe simultaneous evacuation and smoke control. Both corridors have a restricted width of 900mm making the addition of cross corridor doors for smoke containment impractical.</p> <p>See main body 4.2</p>
Date First Identified:	16/12/24	<p>Recommended Action:</p> <p>We recommend the client considers the addition of a final exit door to the west end of the ground floor corridor opposite flat 7, this could be achieved by the removal of the existing window and replacing it with an outward opening exit door.</p>
Date of FRA:	16/12/24	
Rectify Within: (months)	3

We recommend the client considers the addition of a final exit door to the west end of the ground floor corridor opposite flat 7, this could be achieved by the removal of the existing window and replacing it with an outward opening exit door.

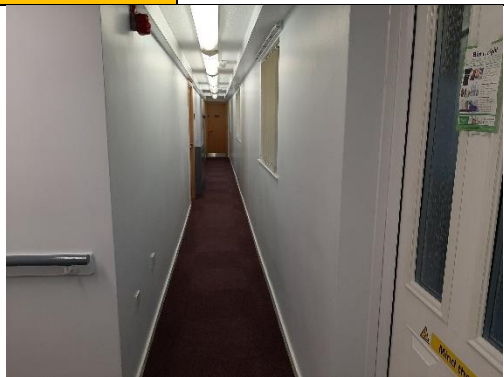
MEDIUM	4

The first-floor accommodation is less than 4.5 meters above ground level however, egress via escape window is not considered suitable in sheltered housing schemes. We recommend the client considers consulting a suitably qualified fire engineer to advise on an appropriate natural automatic opening ventilation system (AOV) to facilitate smoke control within the means of escape.

<p>Fire Risk Assessors Observations:</p> <p>The first floor is less than 4.5meters above ground level however, egress via escape window is not considered suitable in sheltered housing schemes.</p> <p>See main body 4.2</p>
Date First Identified:	16/12/24	<p>Recommended Action:</p> <p>We recommend the client considers consulting a suitably qualified fire engineer to advise on an appropriate natural automatic opening ventilation system (AOV) to facilitate smoke control.</p>
Date of FRA:	16/12/24	
Rectify Within: (months)	3

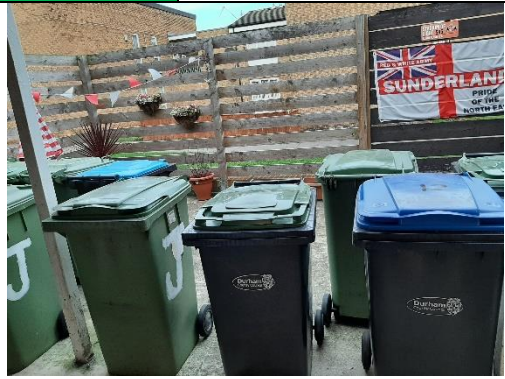
LOW		5

Fire Risk Assessors Observations: The alternative exit on the ground floor west wing terminates in an enclosed refuge yard.	
Date First Identified:	16/12/24	Recommended Action: To consider the exit as a viable means of escape we recommend the client provides an appropriately signed gate with a securing device that can be openable without the use of a key code or tool.	
Date of FRA:	16/12/24		
Rectify Within: (months)	6

To consider the exit as a viable means of escape we recommend the client provides an appropriately signed gate with a securing device that can be openable without the use of a key code or tool.

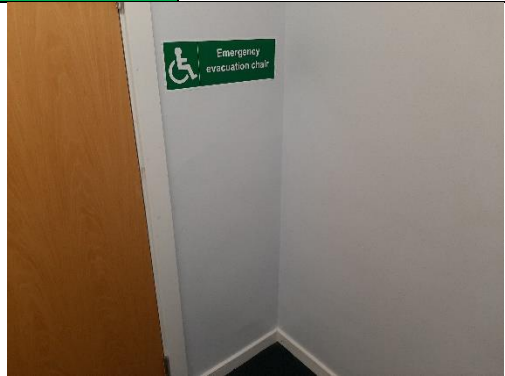
LOW		6

4.5 Disabled Person Egress: We noted evac chair signage but no specific evacuation aids or facilities for disabled occupants. Persons who have severe limited mobility are classed as vulnerable persons under the RR(FS)O. We recommend in any future upgrades the client considers installing a disabled refuge with a suitable communications device.

Fire Risk Assessors Observations: We noted evac chair signage but no specific evacuation aids or facilities for disabled occupants. Persons who have severe limited mobility are classed as vulnerable persons under the RR(FS)O. We recommend in any future upgrades the client considers installing a disabled refuge with a suitable communications device.	
Date First Identified:	16/12/24	Recommended Action: We recommend in any future upgrades the client considers installing a disabled refuge with a suitable communications device.	
Date of FRA:	16/12/24		
Rectify Within: (months)	6

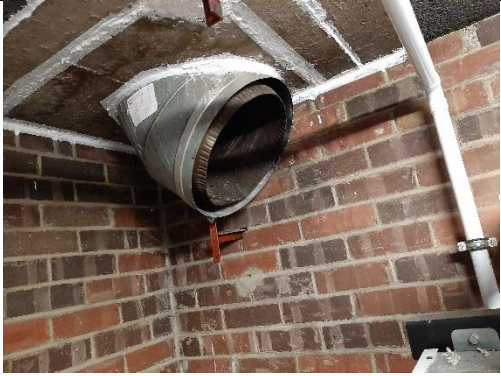
MEDIUM	8

On assessment of the boiler room accessed adjacent to the main entrance we identified a redundant non fire stopped, flue duct running vertically through the upper floor. We recommend the duct is capped at ceiling level and approved fire stopping contractor is appointed to remediate the resulting opening with an appropriate fire stopping product capable of providing the equivalent fire rating of the floor in passes through.

<p>Fire Risk Assessors Observations:</p> <p>On assessment of the boiler room accessed adjacent to the main entrance we identified a redundant non fire stopped, flue duct running vertically through the upper floor.</p>
Date First Identified:	16/12/24	<p>Recommended Action:</p> <p>We recommend the duct is capped at ceiling level and approved fire stopping contractor is appointed to remediate the resulting opening with an appropriate fire stopping product capable of providing the equivalent fire rating of the floor in passes through.</p>
Date of FRA:	16/12/24	
Rectify Within: (months)	3

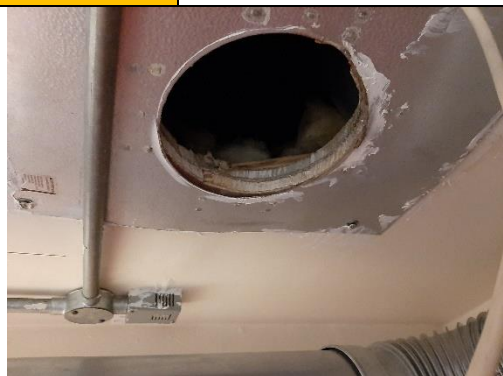
MEDIUM		9

We noted in the first-floor water cylinder cupboard a cut out in the ceiling from a removed service duct that breaches into the roof void. We recommend an approved fire stopping contractor is appointed to remediate the opening with an appropriate fire stopping product capable of providing the equivalent fire rating of the ceiling in passes through.

Fire Risk Assessors Observations: We noted in the first-floor water cylinder cupboard a cut out in the ceiling from a removed service duct that breaches into the roof void.	
Date First Identified:	16/12/24	Recommended Action: We recommend the an approved fire stopping contractor is appointed to remediate the opening with an appropriate fire stopping product capable of providing the equivalent fire rating of the ceiling in passes through.	
Date of FRA:	16/12/24		
Rectify Within: (months)	3

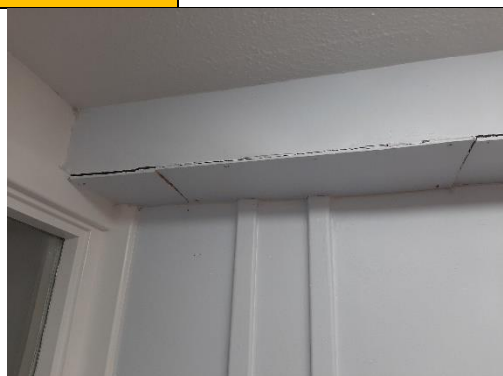
MEDIUM		10

Boxing containing services run at ceiling height along all lower floor corridors. There is evidence that some of this boxing has recently been opened and there is a potential for breaches to have been made subsequent to recent fire stopping works. We recommend the client removes the boxwork to assess if unsealed penetrations have been made to the fabric of the compartmentation walls.

Fire Risk Assessors Observations: Boxing containing services run at ceiling height along all lower floor corridors. There is evidence that some of this boxing has recently been opened and there is a potential for breaches to have been made subsequent to recent fire stopping works.	
Date First Identified:	16/12/24	Recommended Action: We recommend the client removes the boxwork to assess if unsealed penetrations have been made to the fabric of the compartmentation walls.	
Date of FRA:	16/12/24		
Rectify Within: (months)	3

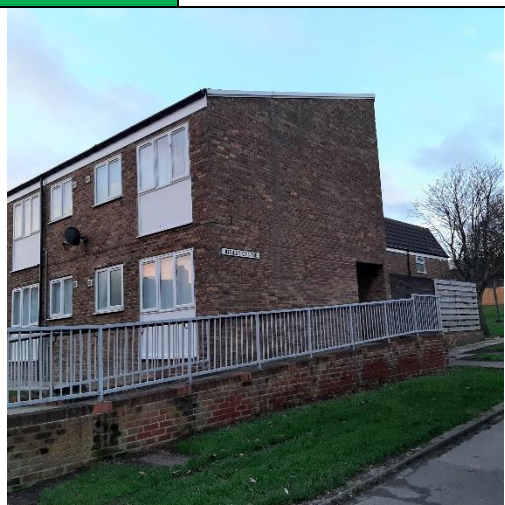
LOW	11

<p>Fire Risk Assessors Observations:</p> <p>There is emergency lighting externally above final exits, and the reliance on adequate borrowed street lighting completes the lighting requirements.</p>
		<p>Recommended Action:</p> <p>We recommend the client considers providing additional emergency lighting on the north elevation.</p>
Date First Identified:	16/12/24	
Date of FRA:	16/12/24	
Rectify Within: (months)	6

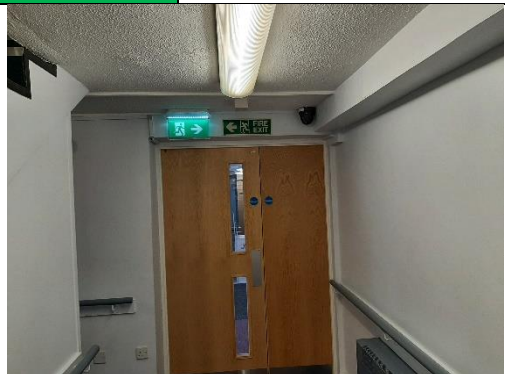
LOW	12

- 8.2 Fire Action Notices: Fire actions notices are installed in prominent positions.
- 8.3 Directional Signage: There is adequate provision of signage for a simple layout. However, the signage does not strictly comply with BS5499-4 in regard to siting and directional arrows and some are worn or duplicated. We recommend removing redundant signage and providing signage sited in accordance with the relevant standard.

<p>Fire Risk Assessors Observations:</p> <p>Signage does not strictly comply with BS5499-4.</p> <ul style="list-style-type: none"> • siting and directional arrows and some are worn and or duplicated. • Some doors are incorrectly signed or are deficient of signage. E.g. fire door keep shut on doors that should read fire door keep clear. • Fire extinguisher signage is missing from the boiler room.
		<p>Recommended Action:</p> <p>We recommend providing the correct signage and siting in accordance with the relevant standard.</p>
Date First Identified:	16/12/24	
Date of FRA:	16/12/24	
Rectify Within: (months)	6

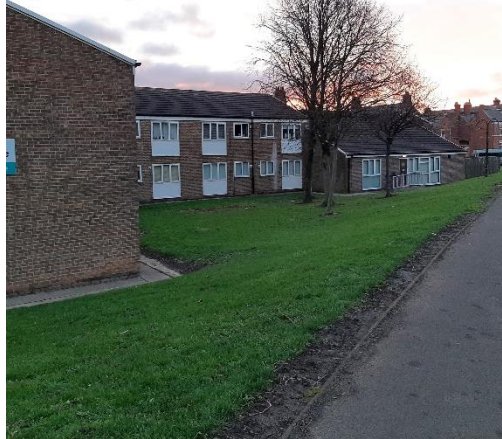
LOW	13

<p>Fire Risk Assessors Observations:</p> <p>The building was originally designed and built in the 1970s with the principles of RSET (Required Safe Egress Time) in mind to support an assumed stay-put policy which enables a person in a part unaffected by fire to remain in their flat in relative safety. Generally, most sheltered accommodation schemes employ a stay put policy. This is achieved by adequate compartmentation and protected means of escape, in conjunction with a comprehensive fire alarm and detection system specified and designed appropriately to support the strategy.</p>
		<p>Recommended Action:</p> <p>To ensure the current suitability of the building for a stay-put strategy, we recommend a thorough survey to assess the adequacy of compartmentation and assesses the specification and design of the fire alarm and detection system. This evaluation will help determine what modifications are necessary to enable a transition to a stay put evacuation policy.</p>

To ensure the current suitability of the building for a stay-put strategy, we recommend a thorough survey to assess the adequacy of compartmentation and assesses the specification and design of the fire alarm and detection system. This evaluation will help determine what modifications are necessary to enable a transition to a stay put evacuation policy.

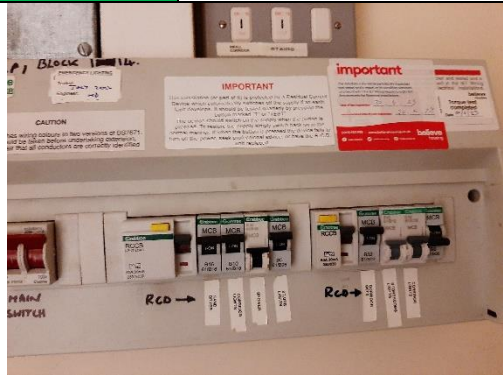
LOW		14

- We sampled a number of electric distribution boards and found most were labelled with dates that have expired between 2008 and 2024. We recommend the client examines their records to identify when the fixed wiring was last tested and inspected and if found to be out of the periodic schedule, commission an appropriately qualified electrical engineer to conduct the tests and keep all relevant records.

<p>Fire Risk Assessors Observations:</p> <p>We sampled a number of electric distribution boards and found most were labelled with dates that have expired between 2008 and 2024.</p>
Date First Identified:	16/12/24		<p>Recommended Action:</p> <p>We recommend the client examines their records to identify when the fixed wiring was last tested and inspected and if found to be out of the periodic schedule, commission an appropriately qualified electrical engineer to conduct the tests and keep all relevant records.</p>
Date of FRA:	16/12/24		
Rectify Within: (months)	6

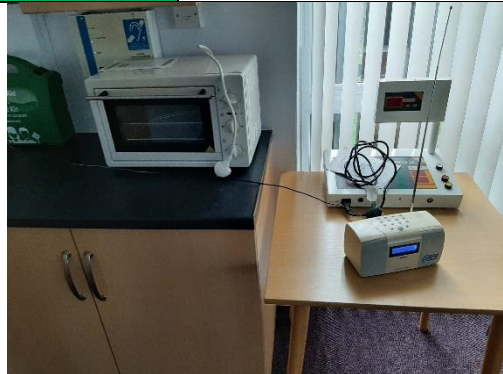
LOW		15

<p>Fire Risk Assessors Observations:</p> <p>There was no evidence to support portable appliance tests have been completed, many portable items did not have indicative labelling. We identified various portable electrical equipment within store cupboards and extension leads connecting the aerial boosting equipment.</p>
Date First Identified:	16/12/24		<p>Recommended Action:</p> <p>We advised that a survey of the portable electrical equipment is carried out and that all portable electrical equipment is included in an inventory and a system put in place to ensure that all the equipment is subject to an annual test. Hard wiring of the aerial booster equipment to a switched fused connection unit would alleviate the necessity of a PAT test for this equipment.</p>
Date of FRA:	16/12/24		
Rectify Within: (months)	6
