ASBESTOS MANAGEMENT SURVEY REPORT

Client	Believe Housing
Site	CHARLTON HOUSE, FOREST GATE, TS28 5LG
Date report issued	11th October 2022
Date of Survey	30 Sep 2022
Recommended Date for Reinspection	30th September 2023
Survey reference	J746899
Lead surveyor	Kevin Russell
Assistant surveyor	N/A
UPRN	3CH00811

CHARLTON HOUSE, FOREST GATE, TS28 5LG

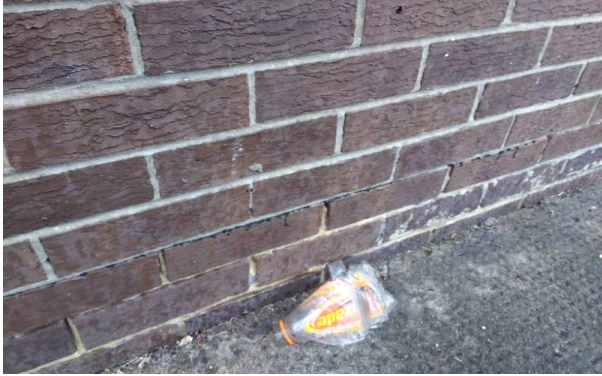
Item / Inspection Ref:	#1	Material Assessment	Product type:	-

Sample Ref:	TB011798		Condition / Damage:			
Survey date:	30/09/22		Surface Treatment:			
Analysis date:	October 07 2022		Asbestos Type:			
Building:	Charlton House, Forest Gate, Wingate. TS28 5LG		Material Score:			
Floor level:	External	Priority Assessment	Occupant Activity:			
Room:	External elements		Location:			
Position:	Walls		Accessibility:			
Item Description:	Damp proof course		Extent/amount:			
Level of Identification:	SAMPLED		Number of Occupants:			
Action:	None required		Frequency of Use:			
RISK CODE:	No Asbestos		Time in Area:			
			Maintenance activity:			
			Frequency of Maintenance:			
		Priority Score:				
		Total Score:				
Comments:

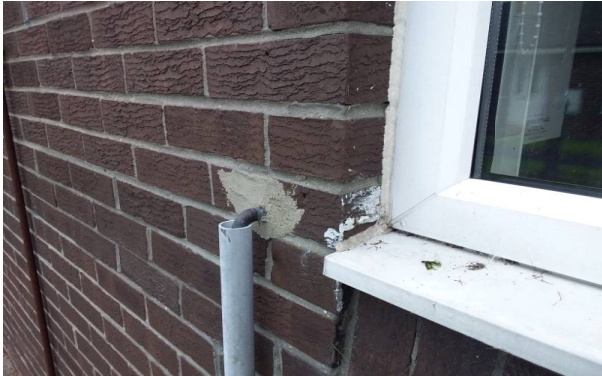
Item / Inspection Ref:	#2	Material Assessment	Product type:	1 - Mastics

Sample Ref:	TB011799		Condition / Damage:	(1) Low Damage		
Survey date:	30/09/22		Surface Treatment:	(0) Reinforced plastics, resins, vinyl tiles, well bound materials, bitumen adhesives, damp proof co		
Analysis date:	October 07 2022		Asbestos Type:	1 - Chrysotile		
Building:	Charlton House, Forest Gate, Wingate. TS28 5LG		Material Score:	3		
Floor level:	External	Priority Assessment	Occupant Activity:	0		
Room:	External elements		Location:	0		
Position:	Walls		Accessibility:	0

Item Description:	Sealant		Extent/amount:	1	<1 m²	
Level of Identification:	SAMPLED		Number of Occupants:	0		
Action:	Monitor and manage		Frequency of Use:	0		
RISK CODE:	D		Time in Area:	0		
			Maintenance activity:	0		
			Frequency of Maintenance:	0		
		Priority Score:	1			
		Total Score:	4			
Comments:	Residual Mastic to Windows

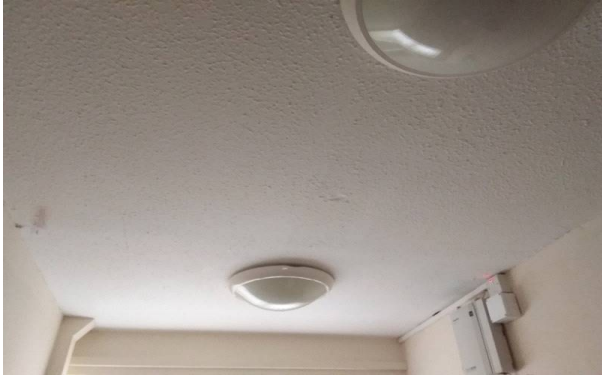
Item / Inspection Ref:	#3	Material Assessment	Product type:	-

Sample Ref:	TB011800		Condition / Damage:		
Survey date:	30/09/22		Surface Treatment:		
Analysis date:	October 07 2022		Asbestos Type:		
Building:	Charlton House, Forest Gate, Wingate. TS28 5LG		Material Score:		
Floor level:	Ground Floor	Priority Assessment	Occupant Activity:		
Room:	Office		Location:		
Position:	Ceiling		Accessibility:		
Item Description:	Decorative coating		Extent/amount:		
Level of Identification:	SAMPLED		Number of Occupants:		
Action:	None required		Frequency of Use:		
RISK CODE:	No Asbestos		Time in Area:		
			Maintenance activity:		
		Frequency of Maintenance:			
		Priority Score:			
		Total Score:			
Comments:

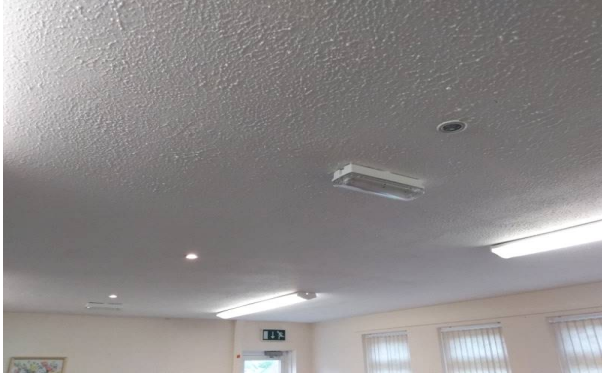
Item / Inspection Ref:	#4	Material Assessment	Product type:	-

Sample Ref:	TB011801		Condition / Damage:		
Survey date:	30/09/22		Surface Treatment:		
Analysis date:	October 07 2022		Asbestos Type:		
Building:	Charlton House, Forest Gate, Wingate. TS28 5LG		Material Score:		
Floor level:	Ground Floor	Priority Assessment	Occupant Activity:		
Room:	Lounge		Location:		
Position:	Ceiling		Accessibility:		
Item Description:	Decorative coating		Extent/amount:		
Level of Identification:	SAMPLED		Number of Occupants:		
Action:	None required		Frequency of Use:		
RISK CODE:	No Asbestos		Time in Area:		
			Maintenance activity:		
		Frequency of Maintenance:			
		Priority Score:			
		Total Score:			
Comments:

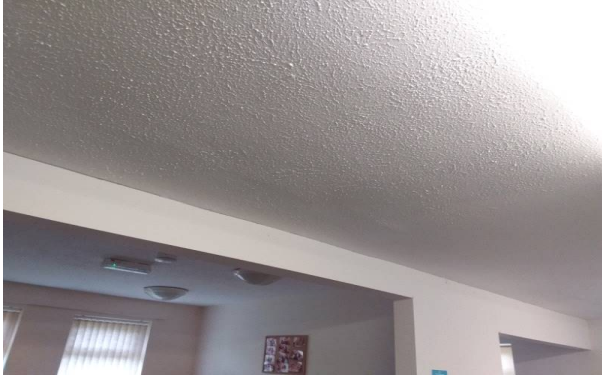
Item / Inspection Ref:	#5	Material Assessment	Product type:	-

Sample Ref:	TB011802		Condition / Damage:		
Survey date:	30/09/22		Surface Treatment:		
Analysis date:	October 07 2022		Asbestos Type:		
Building:	Charlton House, Forest Gate, Wingate. TS28 5LG		Material Score:		
Floor level:	Ground Floor	Priority Assessment	Occupant Activity:		
Room:	Lounge		Location:		
Position:	Ceiling		Accessibility:		
Item Description:	Decorative coating		Extent/amount:		
Level of Identification:	SAMPLED		Number of Occupants:		
Action:	None required		Frequency of Use:		
RISK CODE:	No Asbestos		Time in Area:		
			Maintenance activity:		
		Frequency of Maintenance:			
		Priority Score:			
		Total Score:			
Comments:

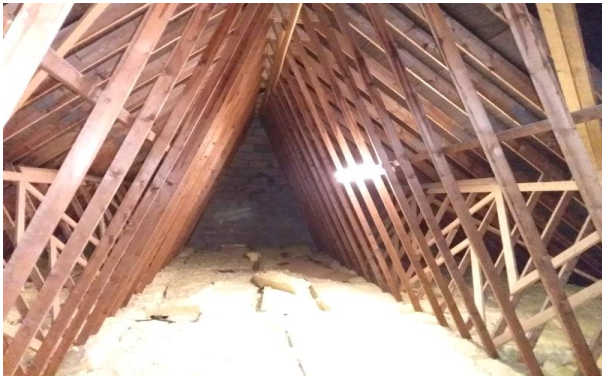
Item / Inspection Ref:	#6	Material Assessment	Product type:	-

Sample Ref:			Condition / Damage:		
Survey date:	30/09/22		Surface Treatment:		
Analysis date:			Asbestos Type:		
Building:	Charlton House, Forest Gate, Wingate. TS28 5LG		Material Score:		
Floor level:	Roof Void	Priority Assessment	Occupant Activity:		
Room:	Loft		Location:		
Position:			Accessibility:		
Item Description:	Loft		Extent/amount:		
Level of Identification:	N/A		Number of Occupants:		
Action:			Frequency of Use:		
RISK CODE:	No Asbestos		Time in Area:		
			Maintenance activity:		
		Frequency of Maintenance:			
		Priority Score:			
		Total Score:			
Comments:	Inspection Photograph
