ASBESTOS REINSPECTION REPORT

Client	Believe Housing
Site	B27 DONNINI HOUSE (1 - 27), EASINGTON COLLIERY, SR8 3ER
Date report issued	29th August 2023
Date of Survey	25 Aug 2023
Recommended Date for Reinspection	
Survey reference	J908617
Lead surveyor	Kevin Russell
Assistant surveyor	N/A
UPRN	3DONN1_Ext_Com

B27 DONNINI HOUSE (1 - 27), EASINGTON COLLIERY, SR8 3ER

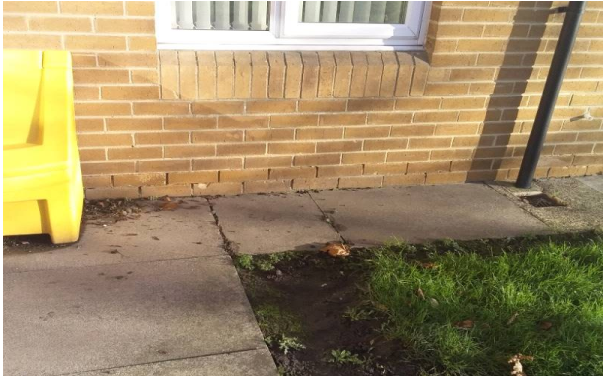
Item / Inspection Ref:	#1	Material Assessment	Product type:	1 - Bitumen Products

Sample Ref:	5 (TB003938)		Condition / Damage:	(1) Low Damage	
Survey date:	25/08/2023		Surface Treatment:	(0) Reinforced plastics, resins, vinyl tiles, well bound materials, bitumen adhesives, damp proof co	
Date last inspected:			Asbestos Type:	1 - Chrysotile	
Next inspection due:	25th August 2024		Material Score:	3	
Building:	B27 Donnini House (1-27), Easington Colliery, SR8 3ER	Priority Assessment	Occupant Activity:	0	
Floor level:	External		Location:	0	
Room:	External elements		Accessibility:	0	
Position:	Walls		Extent/amount:	3 Throughout

Item Description:	Damp proof course		Number of Occupants:	0	
Level of Identification:	SAMPLED		Frequency of Use:	0	
Action:	Monitor and manage		Time in Area:	0	
RISK CODE:	D		Maintenance activity:	0	
		Frequency of Maintenance:	0		
		Priority Score:	1		
		Total Score:	4		
Comments:				Material Status Change: No Change

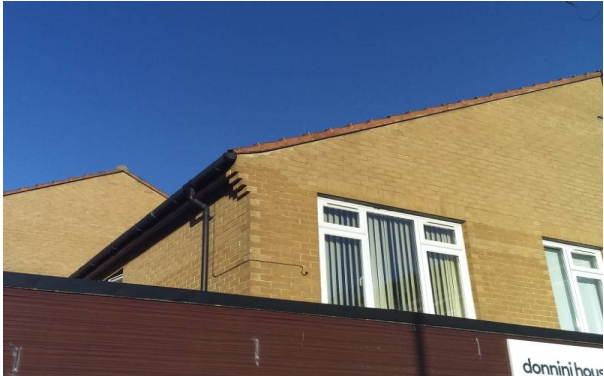
Item / Inspection Ref:	#2	Material Assessment	Product type:	1 - Asbestos Cement

Sample Ref:	6 (TB003939)		Condition / Damage:	(1) Low Damage	
Survey date:	25/08/2023		Surface Treatment:	(1) Enclosed sprays and lagging, Sealed AIB, asbestos cement, textured coating, gasket	
Date last inspected:			Asbestos Type:	1 - Chrysotile	
Next inspection due:	25th August 2024		Material Score:	4	
Building:	B27 Donnini House (1-27), Easington Colliery, SR8 3ER	Priority Assessment	Occupant Activity:	0	
Floor level:	External		Location:	0	
Room:	External elements		Accessibility:	0	
Position:	Roof		Extent/amount:	3 200m

Item Description:	Under cloak		Number of Occupants:	0	
Level of Identification:	SAMPLED		Frequency of Use:	0	
Action:	Monitor and manage		Time in Area:	0	
RISK CODE:	D		Maintenance activity:	1	
		Frequency of Maintenance:	0		
		Priority Score:	2		
		Total Score:	6		
Comments:				Material Status Change: No Change

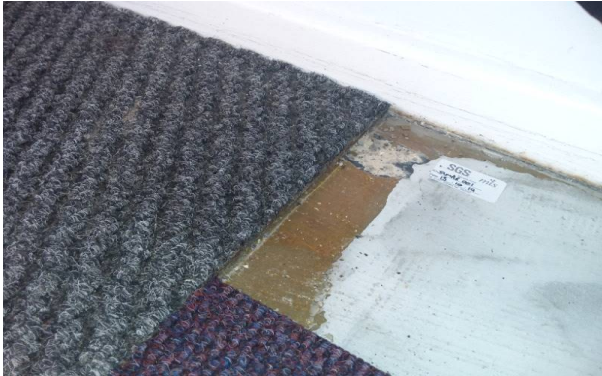
Item / Inspection Ref:	#3	Material Assessment	Product type:	1 - Bitumen Products

Sample Ref:	1 (TB003940)		Condition / Damage:	(1) Low Damage	
Survey date:	25/08/2023		Surface Treatment:	(0) Reinforced plastics, resins, vinyl tiles, well bound materials, bitumen adhesives, damp proof co	
Date last inspected:			Asbestos Type:	1 - Chrysotile	
Next inspection due:	25th August 2024		Material Score:	3	
Building:	B27 Donnini House (1-27), Easington Colliery, SR8 3ER		Occupant Activity:	1	
Floor level:	Ground Floor		Location:	2	
Room:	Entrance front		Accessibility:	0	
Position:	Floor		Extent/amount:	2 25m ²

Item Description:	Adhesive		Number of Occupants:	3	
Level of Identification:	SAMPLED	Frequency of Use:	3		
Action:	Monitor and manage	Time in Area:	1		
		Maintenance activity:	0		
RISK CODE:	C	Frequency of Maintenance:	0		
		Priority Score:	6		
Comments:	Beneath Screed	Total Score:	9		
		Material Status Change:		No Change

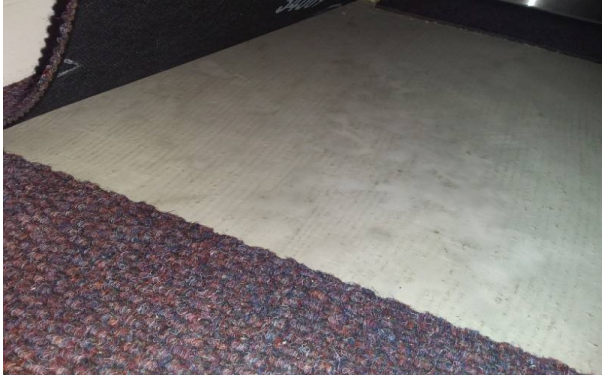
Item / Inspection Ref:	#4	Material Assessment	Product type:	1 - Bitumen Products

Sample Ref:	As Sample 1 (TB003940)		Condition / Damage:	(1) Low Damage	
Survey date:	25/08/2023		Surface Treatment:	(0) Reinforced plastics, resins, vinyl tiles, well bound materials, bitumen adhesives, damp proof co	
Date last inspected:			Asbestos Type:	1 - Chrysotile*	
Next inspection due:	25th August 2024		Material Score:	3	
Building:	B27 Donnini House (1-27), Easington Colliery, SR8 3ER		Occupant Activity:	1	
Floor level:	Ground Floor		Location:	2	
Room:	Corridor		Accessibility:	0	
Position:	Floor		Extent/amount:	2 12m ²

Item Description:	Adhesive		Number of Occupants:	3	
Level of Identification:	STRONGLY PRESUMED	Frequency of Use:	3		
Action:	Monitor and manage	Time in Area:	1		
		Maintenance activity:	0		
RISK CODE:	C	Frequency of Maintenance:	0		
		Priority Score:	6		
Comments:	Beneath Screed	Total Score:	9		
		Material Status Change:		No Change

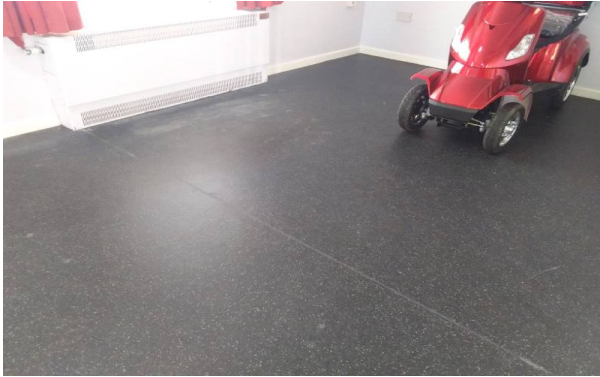
Item / Inspection Ref:	#5	Material Assessment	Product type:	1 - Bitumen Products

Sample Ref:	As Sample 1 (TB003940)		Condition / Damage:	(1) Low Damage	
Survey date:	25/08/2023		Surface Treatment:	(0) Reinforced plastics, resins, vinyl tiles, well bound materials, bitumen adhesives, damp proof co	
Date last inspected:			Asbestos Type:	1 - Chrysotile*	
Next inspection due:	25th August 2024	Material Score:	3		
Building:	B27 Donnini House (1-27), Easington Colliery, SR8 3ER	Priority Assessment	Occupant Activity:	1	
Floor level:	Ground Floor		Location:	2	
Room:	Scooter room / store		Accessibility:	0	
Position:	Floor		Extent/amount:	2 18m ²

Item Description:	Adhesive		Number of Occupants:	0	
Level of Identification:	STRONGLY PRESUMED		Frequency of Use:	0	
Action:	Monitor and manage		Time in Area:	0	
			Maintenance activity:	0	
RISK CODE:	D	Frequency of Maintenance:	0		
		Priority Score:	3		
Comments:	Beneath Modern Lino & Screed	Total Score:	6	Material Status Change:	
				No Change

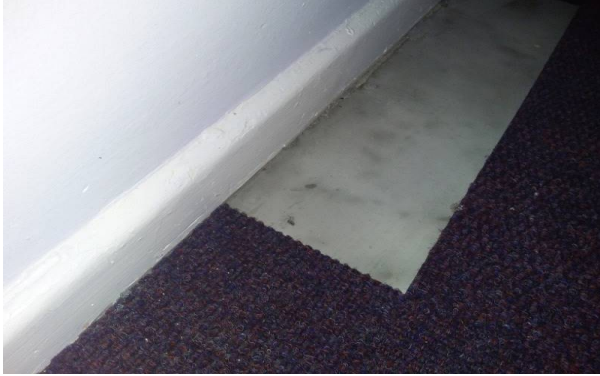
Item / Inspection Ref:	#6	Material Assessment	Product type:	1 - Bitumen Products

Sample Ref:	As Sample 1 (TB003940)		Condition / Damage:	(1) Low Damage	
Survey date:	25/08/2023		Surface Treatment:	(0) Reinforced plastics, resins, vinyl tiles, well bound materials, bitumen adhesives, damp proof co	
Date last inspected:			Asbestos Type:	1 - Chrysotile*	
Next inspection due:	25th August 2024	Material Score:	3		
Building:	B27 Donnini House (1-27), Easington Colliery, SR8 3ER	Priority Assessment	Occupant Activity:	1	
Floor level:	Ground Floor		Location:	2	
Room:	Lounge		Accessibility:	0	
Position:	Floor		Extent/amount:	3 64m ²

Item Description:	Adhesive		Number of Occupants:	3	
Level of Identification:	STRONGLY PRESUMED		Frequency of Use:	3	
Action:	Monitor and manage		Time in Area:	2	
			Maintenance activity:	0	
RISK CODE:	C	Frequency of Maintenance:	0		
		Priority Score:	6		
Comments:	Beneath Screed	Total Score:	9	Material Status Change:	
				No Change

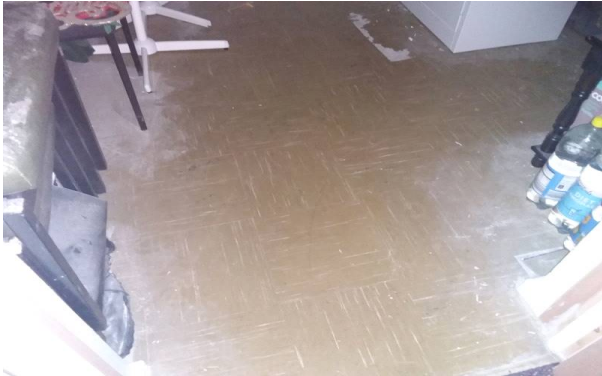
Item / Inspection Ref:	#7	Material Assessment	Product type:	1 - Bitumen Products

Sample Ref:	2 (TB003941)		Condition / Damage:	(1) Low Damage		
Survey date:	25/08/2023		Surface Treatment:	(0) Reinforced plastics, resins, vinyl tiles, well bound materials, bitumen adhesives, damp proof co		
Date last inspected:			Asbestos Type:	1 - Chrysotile		
Next inspection due:	25th August 2024		Material Score:	3		
Building:	B27 Donnini House (1-27), Easington Colliery, SR8 3ER		Priority Assessment	Occupant Activity:		0
Floor level:	Ground Floor			Location:		2
Room:	Cupboard			Accessibility:		1
Position:	Floor			Extent/amount:		1 6m ²

Item Description:	Floor tiles			Number of Occupants:		0
Level of Identification:	SAMPLED	Frequency of Use:		0		
Action:	Monitor and manage	Time in Area:		0		
		Maintenance activity:		1		
RISK CODE:	D	Frequency of Maintenance:	0			
		Priority Score:	3			
Comments:		Total Score:	6	Material Status Change:		
				No Change

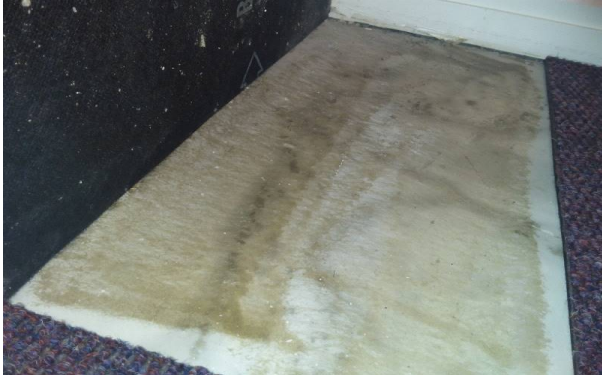
Item / Inspection Ref:	#8	Material Assessment	Product type:	1 - Bitumen Products

Sample Ref:	As Sample 1 (TB003940)		Condition / Damage:	(1) Low Damage		
Survey date:	25/08/2023		Surface Treatment:	(0) Reinforced plastics, resins, vinyl tiles, well bound materials, bitumen adhesives, damp proof co		
Date last inspected:			Asbestos Type:	1 - Chrysotile*		
Next inspection due:	25th August 2024		Material Score:	3		
Building:	B27 Donnini House (1-27), Easington Colliery, SR8 3ER		Priority Assessment	Occupant Activity:		1
Floor level:	Ground Floor			Location:		2
Room:	Corridor - Flats 2-3			Accessibility:		0
Position:	Floor			Extent/amount:		1 8m ²

Item Description:	Adhesive			Number of Occupants:		3
Level of Identification:	STRONGLY PRESUMED	Frequency of Use:		3		
Action:	Monitor and manage	Time in Area:		1		
		Maintenance activity:		0		
RISK CODE:	D	Frequency of Maintenance:	0			
		Priority Score:	5			
Comments:	Beneath Screed	Total Score:	8	Material Status Change:		
				No Change

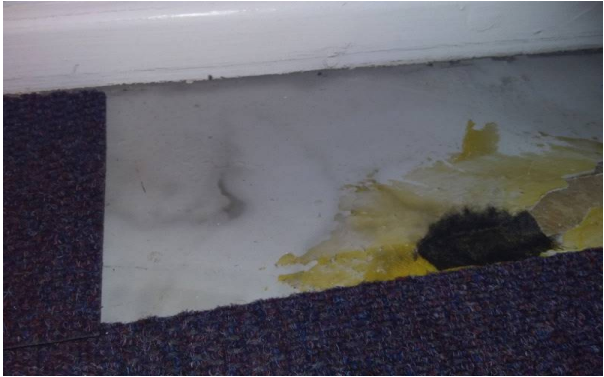
Item / Inspection Ref:	#9	Material Assessment	Product type:	1 - Bitumen Products

Sample Ref:	As Sample 1 (TB003940)		Condition / Damage:	(1) Low Damage	
Survey date:	25/08/2023		Surface Treatment:	(0) Reinforced plastics, resins, vinyl tiles, well bound materials, bitumen adhesives, damp proof co	
Date last inspected:			Asbestos Type:	1 - Chrysotile*	
Next inspection due:	25th August 2024	Material Score:	3		
Building:	B27 Donnini House (1-27), Easington Colliery, SR8 3ER	Priority Assessment	Occupant Activity:	1	
Floor level:	Ground Floor		Location:	2	
Room:	Corridor - Flats 4-7		Accessibility:	0	
Position:	Floor		Extent/amount:	1 16m ²

Item Description:	Adhesive		Number of Occupants:	2	
Level of Identification:	STRONGLY PRESUMED		Frequency of Use:	3	
Action:	Monitor and manage		Time in Area:	1	
RISK CODE:	D		Maintenance activity:	0	
		Frequency of Maintenance:	0		
		Priority Score:	4		
		Total Score:	7		
Comments:	Beneath Screed	Material Status Change:			
		No Change

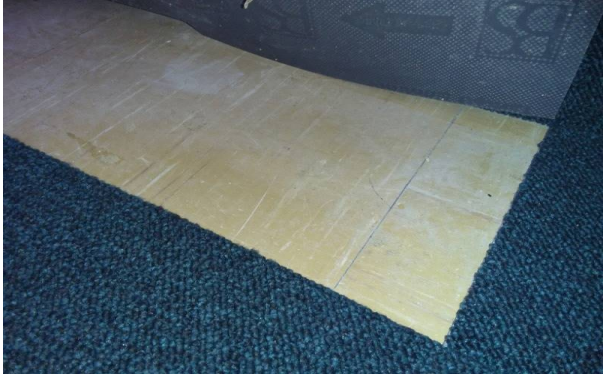
Item / Inspection Ref:	#10	Material Assessment	Product type:	1 - Bitumen Products

Sample Ref:	As Sample 2 (TB003941)		Condition / Damage:	(1) Low Damage	
Survey date:	25/08/2023		Surface Treatment:	(0) Reinforced plastics, resins, vinyl tiles, well bound materials, bitumen adhesives, damp proof co	
Date last inspected:			Asbestos Type:	1 - Chrysotile*	
Next inspection due:	25th August 2024	Material Score:	3		
Building:	B27 Donnini House (1-27), Easington Colliery, SR8 3ER	Priority Assessment	Occupant Activity:	1	
Floor level:	Ground Floor		Location:	2	
Room:	Stairwell		Accessibility:	0	
Position:	Floor		Extent/amount:	1 6m ²

Item Description:	Floor tiles		Number of Occupants:	3	
Level of Identification:	STRONGLY PRESUMED		Frequency of Use:	3	
Action:	Monitor and manage		Time in Area:	0	
RISK CODE:	D		Maintenance activity:	1	
		Frequency of Maintenance:	0		
		Priority Score:	5		
		Total Score:	8		
Comments:	Beige - Beneath Carpet	Material Status Change:			
		No Change

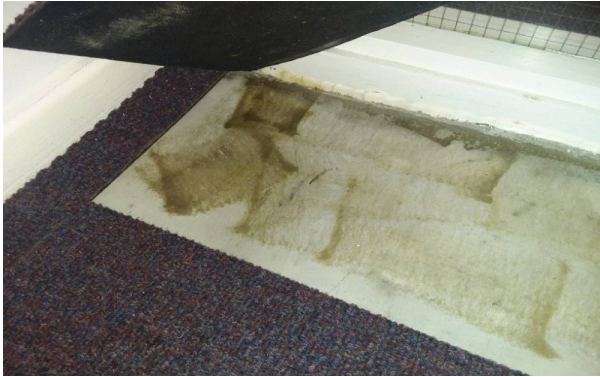
Item / Inspection Ref:	#11	Material Assessment	Product type:	1 - Bitumen Products

Sample Ref:	As Sample 1 (TB003940)		Condition / Damage:	(1) Low Damage		
Survey date:	25/08/2023		Surface Treatment:	(0) Reinforced plastics, resins, vinyl tiles, well bound materials, bitumen adhesives, damp proof co		
Date last inspected:			Asbestos Type:	1 - Chrysotile*		
Next inspection due:	25th August 2024	Material Score:	3			
Building:	B27 Donnini House (1-27), Easington Colliery, SR8 3ER	Priority Assessment	Occupant Activity:	1		
Floor level:	Ground Floor		Location:	2		
Room:	Corridor		Accessibility:	0		
Position:	Floor		Extent/amount:	2		22m ²

Item Description:	Adhesive		Number of Occupants:	3		
Level of Identification:	STRONGLY PRESUMED		Frequency of Use:	3		
Action:	Monitor and manage		Time in Area:	1		
			Maintenance activity:	0		
RISK CODE:	C	Frequency of Maintenance:	0			
		Priority Score:	6			
Comments:	Beneath Screed	Total Score:	9	Material Status Change:		
				No Change

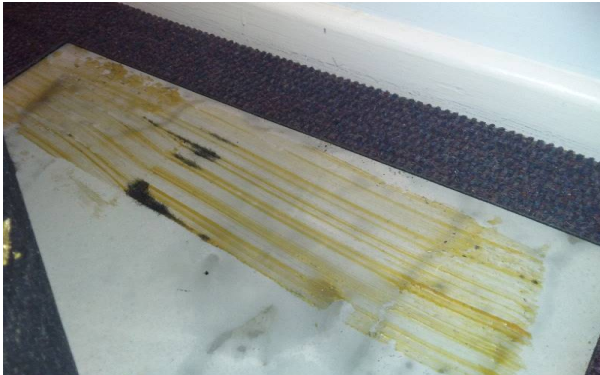
Item / Inspection Ref:	#12	Material Assessment	Product type:	1 - Bitumen Products

Sample Ref:	As Sample 1 (TB003940)		Condition / Damage:	(1) Low Damage		
Survey date:	25/08/2023		Surface Treatment:	(0) Reinforced plastics, resins, vinyl tiles, well bound materials, bitumen adhesives, damp proof co		
Date last inspected:			Asbestos Type:	1 - Chrysotile*		
Next inspection due:	25th August 2024	Material Score:	3			
Building:	B27 Donnini House (1-27), Easington Colliery, SR8 3ER	Priority Assessment	Occupant Activity:	1		
Floor level:	Ground Floor		Location:	2		
Room:	Corridor - Flats 26-27		Accessibility:	0		
Position:	Floor		Extent/amount:	2		22m ²

Item Description:	Adhesive		Number of Occupants:	3		
Level of Identification:	STRONGLY PRESUMED		Frequency of Use:	3		
Action:	Monitor and manage		Time in Area:	1		
			Maintenance activity:	0		
RISK CODE:	C	Frequency of Maintenance:	0			
		Priority Score:	6			
Comments:	Beneath Screed	Total Score:	9	Material Status Change:		
				No Change

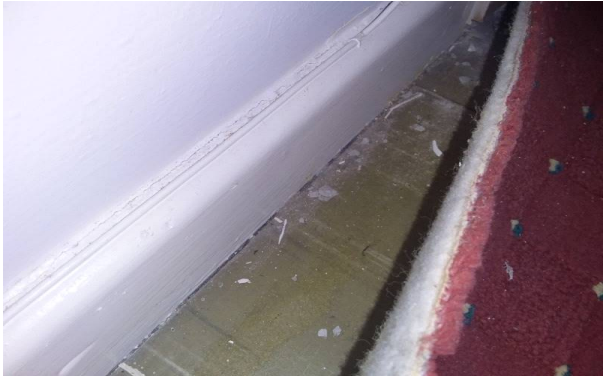
Item / Inspection Ref:	#13	Material Assessment	Product type:	1 - Bitumen Products

Sample Ref:	As Sample 2 (TB003941)		Condition / Damage:	(1) Low Damage	
Survey date:	25/08/2023		Surface Treatment:	(0) Reinforced plastics, resins, vinyl tiles, well bound materials, bitumen adhesives, damp proof co	
Date last inspected:			Asbestos Type:	1 - Chrysotile*	
Next inspection due:	25th August 2024	Material Score:	3		
Building:	B27 Donnini House (1-27), Easington Colliery, SR8 3ER	Priority Assessment	Occupant Activity:	1	
Floor level:	Ground Floor		Location:	2	
Room:	Office		Accessibility:	0	
Position:	Floor		Extent/amount:	2 12m ²

Item Description:	Floor tiles		Number of Occupants:	1	
Level of Identification:	STRONGLY PRESUMED		Frequency of Use:	3	
Action:	Monitor and manage		Time in Area:	2	
			Maintenance activity:	1	
RISK CODE:	C	Frequency of Maintenance:	0		
		Priority Score:	6		
Comments:		Total Score:	9		
					Material Status Change:
				No Change

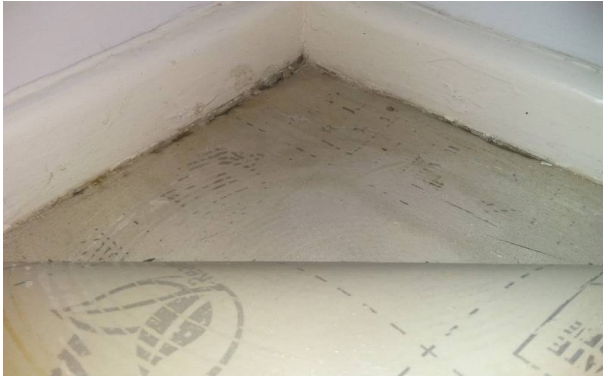
Item / Inspection Ref:	#14	Material Assessment	Product type:	1 - Bitumen Products

Sample Ref:	3 (TB003942)		Condition / Damage:	(1) Low Damage	
Survey date:	25/08/2023		Surface Treatment:	(0) Reinforced plastics, resins, vinyl tiles, well bound materials, bitumen adhesives, damp proof co	
Date last inspected:			Asbestos Type:	1 - Chrysotile	
Next inspection due:	25th August 2024	Material Score:	3		
Building:	B27 Donnini House (1-27), Easington Colliery, SR8 3ER	Priority Assessment	Occupant Activity:	1	
Floor level:	Ground Floor		Location:	2	
Room:	Entrance side		Accessibility:	0	
Position:	Floor		Extent/amount:	1 3.5m ²

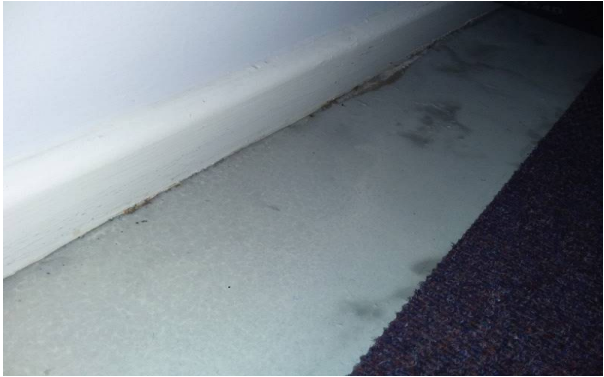
Item / Inspection Ref:	#15	Material Assessment	Product type:	1 - Bitumen Products

Sample Ref:	As Sample 1 (TB003940)		Condition / Damage:	(1) Low Damage	
Survey date:	25/08/2023		Surface Treatment:	(0) Reinforced plastics, resins, vinyl tiles, well bound materials, bitumen adhesives, damp proof co	
Date last inspected:			Asbestos Type:	1 - Chrysotile*	
Next inspection due:	25th August 2024	Material Score:	3		
Building:	B27 Donnini House (1-27), Easington Colliery, SR8 3ER	Priority Assessment	Occupant Activity:	1	
Floor level:	Ground Floor		Location:	2	
Room:	Corridor - Flats 22-25		Accessibility:	0	
Position:	Floor		Extent/amount:	2 16m ²

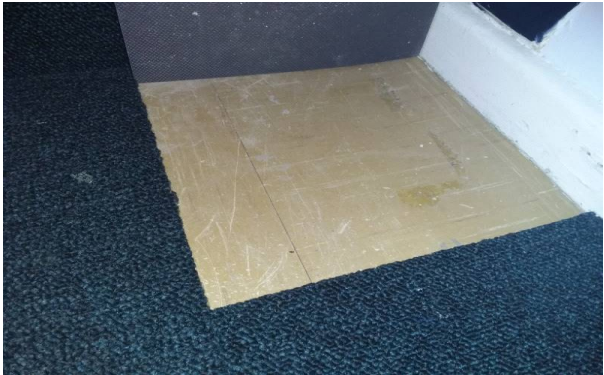
Item / Inspection Ref:	#16	Material Assessment	Product type:	1 - Bitumen Products

Sample Ref:	As Sample 2 (TB003941)		Condition / Damage:	(1) Low Damage	
Survey date:	25/08/2023		Surface Treatment:	(0) Reinforced plastics, resins, vinyl tiles, well bound materials, bitumen adhesives, damp proof co	
Date last inspected:			Asbestos Type:	1 - Chrysotile*	
Next inspection due:	25th August 2024	Material Score:	3		
Building:	B27 Donnini House (1-27), Easington Colliery, SR8 3ER	Priority Assessment	Occupant Activity:	1	
Floor level:	Ground Floor		Location:	2	
Room:	Stairwell (opposite flat 25)		Accessibility:	0	
Position:	Floor		Extent/amount:	1 6m ²

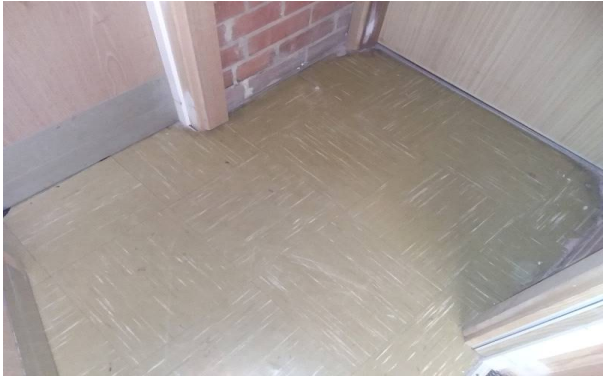
Item / Inspection Ref:	#17	Material Assessment	Product type:	1 - Bitumen Products

Sample Ref:	As Sample 3 (TB003942)		Condition / Damage:	(1) Low Damage	
Survey date:	25/08/2023		Surface Treatment:	(0) Reinforced plastics, resins, vinyl tiles, well bound materials, bitumen adhesives, damp proof co	
Date last inspected:			Asbestos Type:	1 - Chrysotile*	
Next inspection due:	25th August 2024	Material Score:	3		
Building:	B27 Donnini House (1-27), Easington Colliery, SR8 3ER	Priority Assessment	Occupant Activity:	1	
Floor level:	Ground Floor		Location:	2	
Room:	Lobby to Refuse Store		Accessibility:	1	
Position:	Floor		Extent/amount:	1 1.5m ²

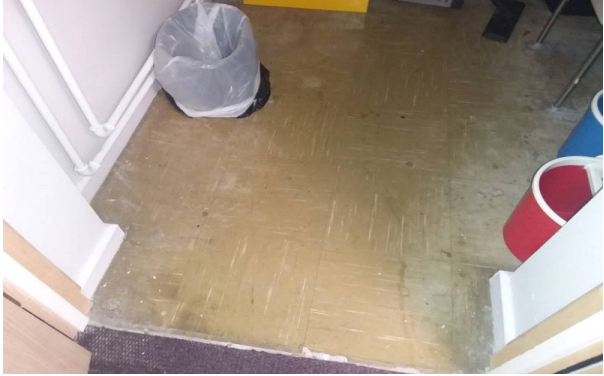
Item / Inspection Ref:	#18	Material Assessment	Product type:	1 - Bitumen Products

Sample Ref:	As Sample 3 (TB003942)		Condition / Damage:	(1) Low Damage	
Survey date:	25/08/2023		Surface Treatment:	(0) Reinforced plastics, resins, vinyl tiles, well bound materials, bitumen adhesives, damp proof co	
Date last inspected:			Asbestos Type:	1 - Chrysotile*	
Next inspection due:	25th August 2024	Material Score:	3		
Building:	B27 Donnini House (1-27), Easington Colliery, SR8 3ER	Priority Assessment	Occupant Activity:	1	
Floor level:	Ground Floor		Location:	2	
Room:	Cleaners Cupboard		Accessibility:	1	
Position:	Floor		Extent/amount:	1 3m ²

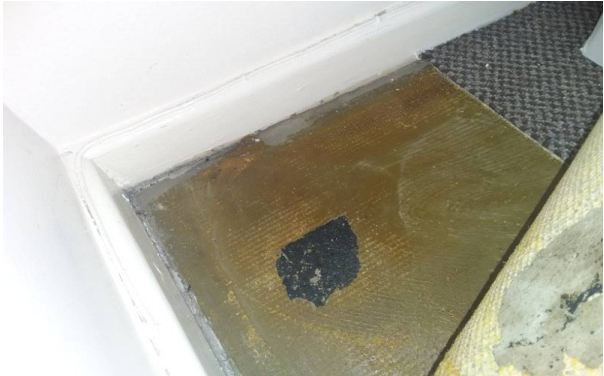
Item / Inspection Ref:	#19	Material Assessment	Product type:	1 - Bitumen Products

Sample Ref:	1 (TB003944)		Condition / Damage:	(1) Low Damage		
Survey date:	25/08/2023		Surface Treatment:	(0) Reinforced plastics, resins, vinyl tiles, well bound materials, bitumen adhesives, damp proof co		
Date last inspected:			Asbestos Type:	1 - Chrysotile		
Next inspection due:	25th August 2024		Material Score:	3		
Building:	B27 Donnini House (1-27), Easington Colliery, SR8 3ER		Priority Assessment	Occupant Activity:		0
Floor level:	Ground Floor			Location:		2
Room:	Store			Accessibility:		0
Position:	Floor			Extent/amount:		1 2m ²

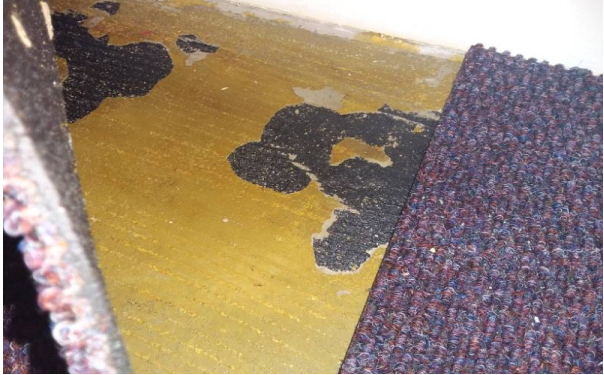
Item / Inspection Ref:	#20	Material Assessment	Product type:	1 - Bitumen Products

Sample Ref:	As Sample 1 (TB003944)		Condition / Damage:	(1) Low Damage		
Survey date:	25/08/2023		Surface Treatment:	(0) Reinforced plastics, resins, vinyl tiles, well bound materials, bitumen adhesives, damp proof co		
Date last inspected:			Asbestos Type:	1 - Chrysotile*		
Next inspection due:	25th August 2024		Material Score:	3		
Building:	B27 Donnini House (1-27), Easington Colliery, SR8 3ER		Priority Assessment	Occupant Activity:		1
Floor level:	Ground Floor			Location:		2
Room:	Office			Accessibility:		0
Position:	Floor			Extent/amount:		1 4m ²

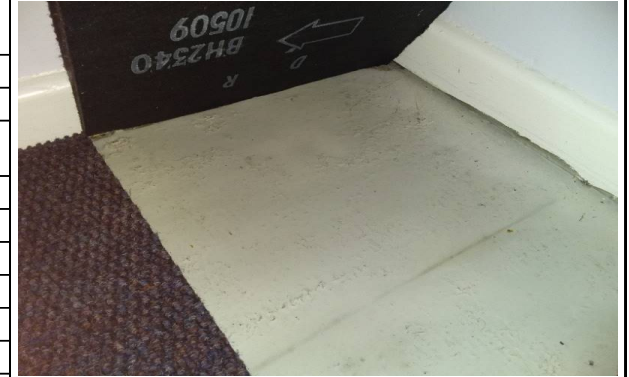
Item / Inspection Ref:	#21	Material Assessment	Product type:	1 - Bitumen Products	
Sample Ref:	As Sample 1 (TB003940)		Condition / Damage:	(1) Low Damage	
Survey date:	25/08/2023		Surface Treatment:	(0) Reinforced plastics, resins, vinyl tiles, well bound materials, bitumen adhesives, damp proof co	
Date last inspected:			Asbestos Type:	1 - Chrysotile*	
Next inspection due:	25th August 2024	Priority Assessment	Material Score:	3	
Building:	B27 Donnini House (1-27), Easington Colliery, SR8 3ER		Occupant Activity:	1	
Floor level:	1st Floor		Location:	2	
Room:	Corridor - Flats 18-21		Accessibility:	0	
Position:	Floor		Extent/amount:	2	16m ²

Item Description:	Adhesive		Number of Occupants:	3	
Level of Identification:	STRONGLY PRESUMED		Frequency of Use:	3	
Action:	Monitor and manage		Time in Area:	1	
			Maintenance activity:	0	
			Frequency of Maintenance:	0	
RISK CODE:	C	Priority Score:	6		
		Total Score:	9		
Comments:	Beneath Screed	Material Status Change:			
		No Change

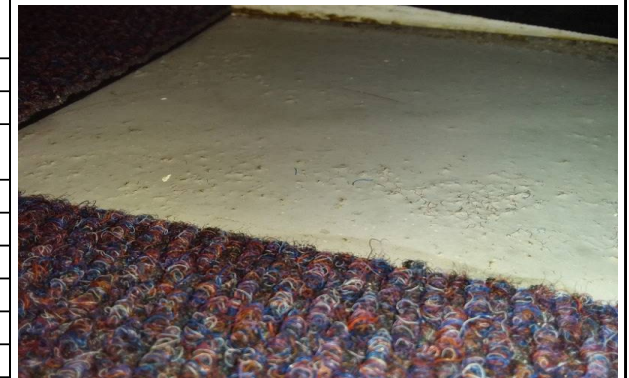
Item / Inspection Ref:	#22	Material Assessment	Product type:	1 - Bitumen Products	
Sample Ref:	As Sample 1 (TB003940)		Condition / Damage:	(1) Low Damage	
Survey date:	25/08/2023		Surface Treatment:	(0) Reinforced plastics, resins, vinyl tiles, well bound materials, bitumen adhesives, damp proof co	
Date last inspected:			Asbestos Type:	1 - Chrysotile*	
Next inspection due:	25th August 2024	Priority Assessment	Material Score:	3	
Building:	B27 Donnini House (1-27), Easington Colliery, SR8 3ER		Occupant Activity:	1	
Floor level:	1st Floor		Location:	2	
Room:	Corridor - Flats 15-17		Accessibility:	0	
Position:	Floor		Extent/amount:	2	24m ²

Item Description:	Adhesive		Number of Occupants:	2	
Level of Identification:	STRONGLY PRESUMED		Frequency of Use:	3	
Action:	Monitor and manage		Time in Area:	1	
			Maintenance activity:	0	
			Frequency of Maintenance:	0	
RISK CODE:	D	Priority Score:	5		
		Total Score:	8		
Comments:	Beneath Screed	Material Status Change:			
		No Change

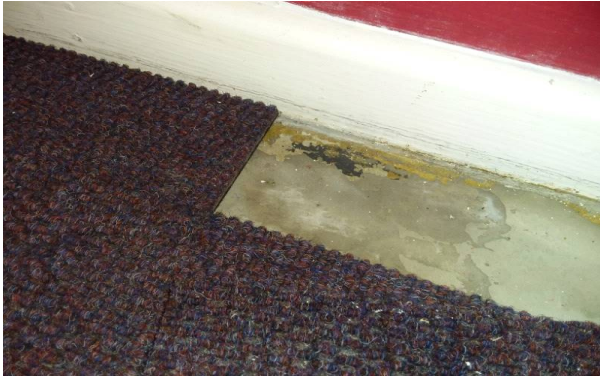
Item / Inspection Ref:	#23	Material Assessment	Product type:	1 - Bitumen Products

Sample Ref:	As Sample 1 (TB003940)		Condition / Damage:	(1) Low Damage	
Survey date:	25/08/2023		Surface Treatment:	(0) Reinforced plastics, resins, vinyl tiles, well bound materials, bitumen adhesives, damp proof co	
Date last inspected:			Asbestos Type:	1 - Chrysotile*	
Next inspection due:	25th August 2024	Material Score:	3		
Building:	B27 Donnini House (1-27), Easington Colliery, SR8 3ER	Priority Assessment	Occupant Activity:	1	
Floor level:	1st Floor		Location:	2	
Room:	Landing		Accessibility:	0	
Position:	Floor		Extent/amount:	2 14m ²

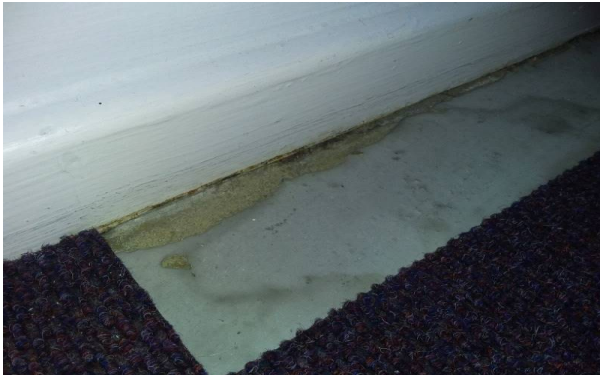
Item / Inspection Ref:	#24	Material Assessment	Product type:	1 - Bitumen Products

Sample Ref:	As Sample 1 (TB003940)		Condition / Damage:	(1) Low Damage	
Survey date:	25/08/2023		Surface Treatment:	(0) Reinforced plastics, resins, vinyl tiles, well bound materials, bitumen adhesives, damp proof co	
Date last inspected:			Asbestos Type:	1 - Chrysotile*	
Next inspection due:	25th August 2024	Material Score:	3		
Building:	B27 Donnini House (1-27), Easington Colliery, SR8 3ER	Priority Assessment	Occupant Activity:	1	
Floor level:	1st Floor		Location:	2	
Room:	Corridor - Flats 12-14		Accessibility:	0	
Position:	Floor		Extent/amount:	2 16m ²

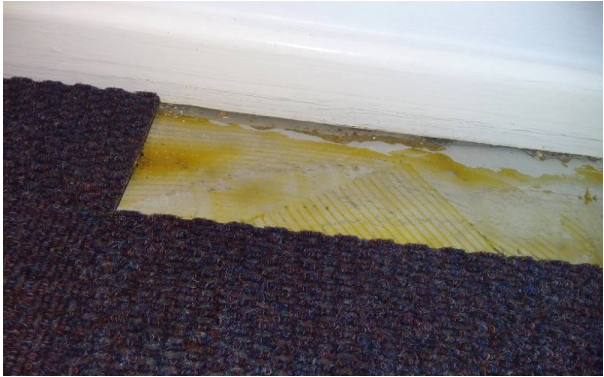
Item / Inspection Ref:	#25	Material Assessment	Product type:	1 - Bitumen Products

Sample Ref:	As Sample 1 (TB003940)		Condition / Damage:	(1) Low Damage	
Survey date:	25/08/2023		Surface Treatment:	(0) Reinforced plastics, resins, vinyl tiles, well bound materials, bitumen adhesives, damp proof co	
Date last inspected:			Asbestos Type:	1 - Chrysotile*	
Next inspection due:	25th August 2024	Material Score:	3		
Building:	B27 Donnini House (1-27), Easington Colliery, SR8 3ER	Priority Assessment	Occupant Activity:	1	
Floor level:	1st Floor		Location:	2	
Room:	Corridor - Flats 8-11		Accessibility:	0	
Position:	Floor		Extent/amount:	2 16m ²

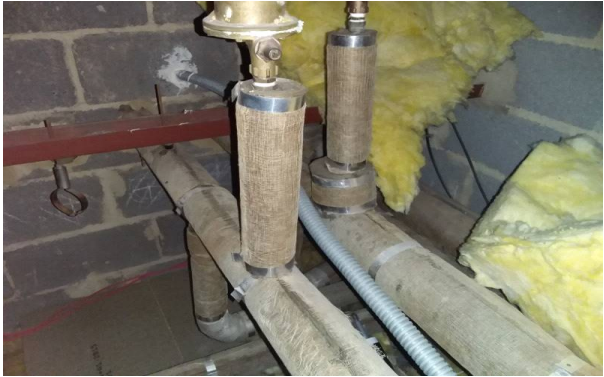
Item / Inspection Ref:	#26	Material Assessment	Product type:	2 - Gaskets

Sample Ref:	P (TB003945)		Condition / Damage:	(1) Low Damage	
Survey date:	25/08/2023		Surface Treatment:	(1) Enclosed sprays and lagging, Sealed AIB, asbestos cement, textured coating, gasket	
Date last inspected:			Asbestos Type:	1 - Chrysotile	
Next inspection due:	25th August 2024	Material Score:	5		
Building:	B27 Donnini House (1-27), Easington Colliery, SR8 3ER	Priority Assessment	Occupant Activity:	0	
Floor level:	Roof Void		Location:	2	
Room:	Loft - Above Flats 18-21		Accessibility:	0	
Position:	Pipework		Extent/amount:	0 NQ
