# Asbestos Reinspection Survey (MA and PA)

| Site Details | Attlee Square Community Hub, Sherburn Village,<br>Durham, County Durham, DH6 1JN<br>UPRN: 1CH00007 |
| Date(s) of Surveys | 14 Feb 2024 |
| Report Reference Number | J084475 |

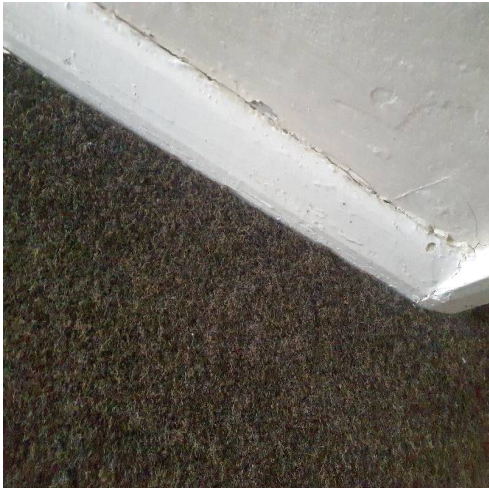
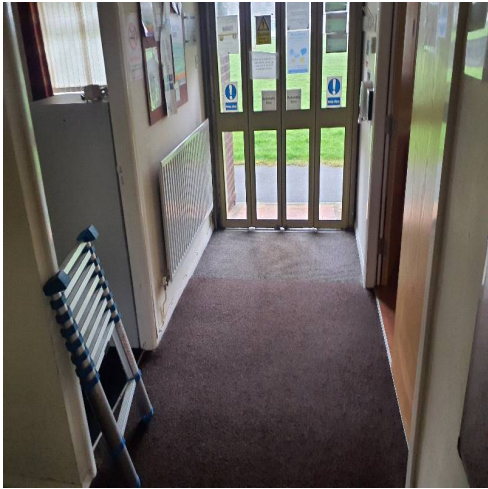
| Item Description: Floor tiles - Floor | | | | | |
| Comments: , | | | Extent:<br>10m² | | |
| Reinspection State / Register Update: No change | | | | | |
| Extent of Damage: | Good Condition | | 0 | | |

| Frequency of maintenance activity | >1 per month | 3 | Total Risk Score (*) | Low Risk (10) |

| <b>Maintenance activity</b> | <b>Average Score</b> | <b>2</b> | <b>Recommendation: Manage &amp; Monitor</b> | |

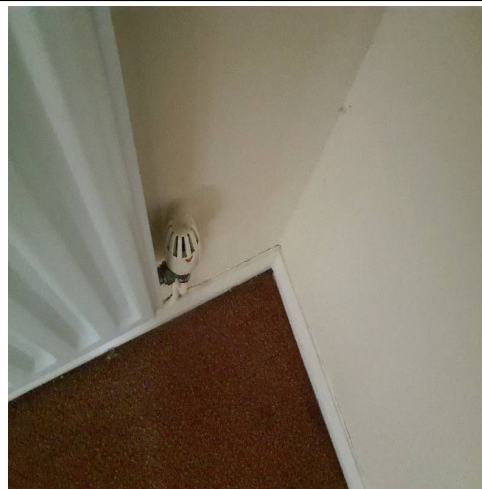
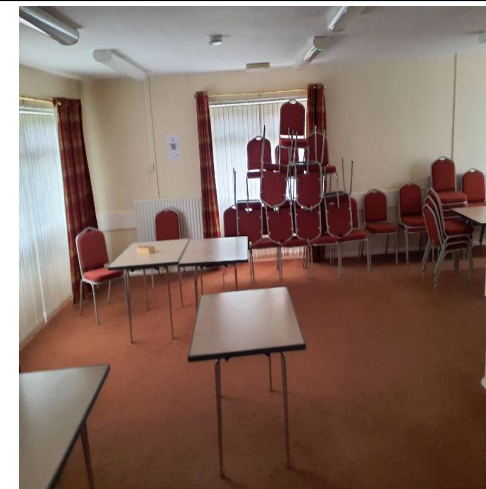
| Item No:<br>6 | Sample No: TB003647 {KO000006}*<br>Level of ID: Identified | Building ID: Attlee Square Community Hub | Location: Lounge, G/02 |

Item Description: Floor tiles - Floor

Extent:  
34m²

Reinspection State / Register Update: No change

| Extent of Damage: | Good Condition | 0 |

| Frequency of maintenance activity | >1 per month | 3 | Total Risk Score (*) | Low Risk (10) |

| <b>Maintenance activity</b> | <b>Average Score</b> | <b>2</b> | <b>Recommendation: Manage &amp; Monitor</b> | |

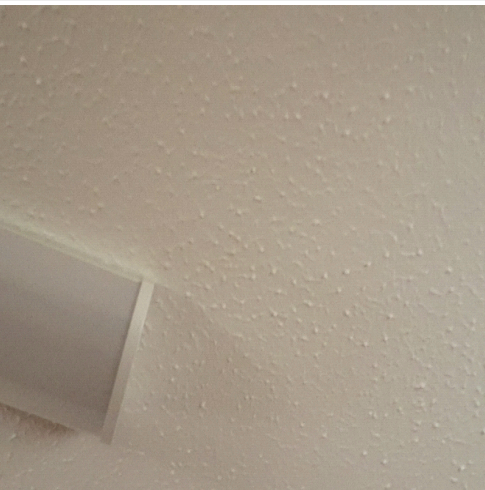
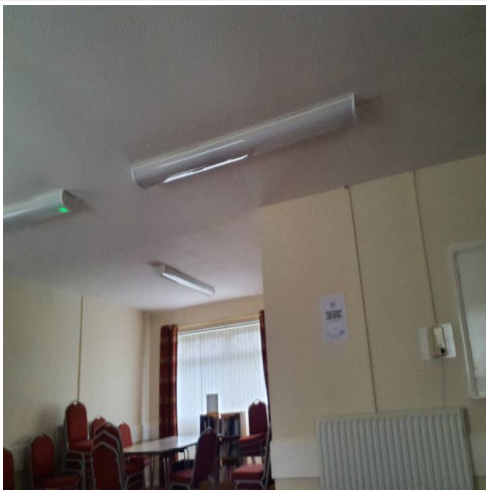
| Item No:<br>7 | Sample No: TB003648 {KO000007}*<br>Level of ID: Identified | Building ID: Attlee Square Community Hub | Location: Lounge, G/02 |

| Item Description: Decorative coating - Ceiling | | |
| Comments: , | | Extent:<br>34m² |
| Reinspection State / Register Update: No change | | |
| Extent of Damage: | Good Condition | 0 |

| Frequency of maintenance activity | >1 per month | 3 | Total Risk Score (*) | <b>Low Risk (11)</b> |

| <b>Maintenance activity</b> | <b>Average Score</b> | <b>2</b> | <b>Recommendation: Manage &amp; Monitor</b> | |

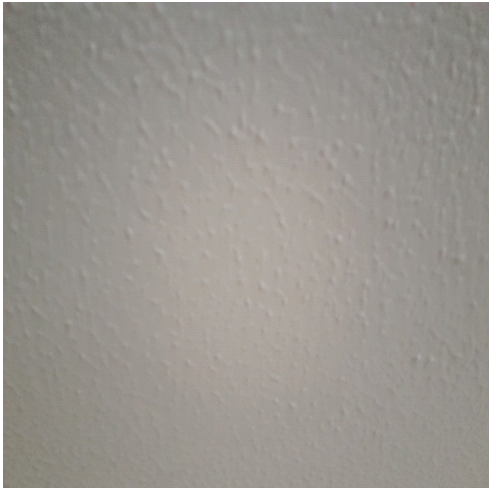
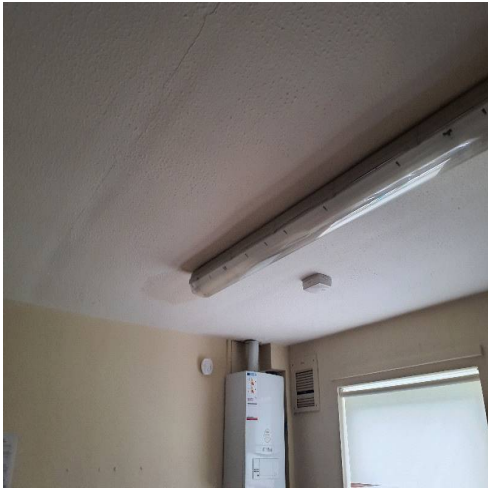
| Item Description: Decorative coating - Ceiling | | | | | |
| Comments: , | | Extent:<br>14m² | | | |
| Reinspection State / Register Update: No change | | | | | |
| Extent of Damage: | Good Condition | 0 | | | |

| Frequency of maintenance activity | >1 per month | 3 | Total Risk Score (*) | <b>Low Risk (11)</b> |

| <b>Maintenance activity</b> | <b>Average Score</b> | <b>2</b> | <b>Recommendation: Manage &amp; Monitor</b> | |

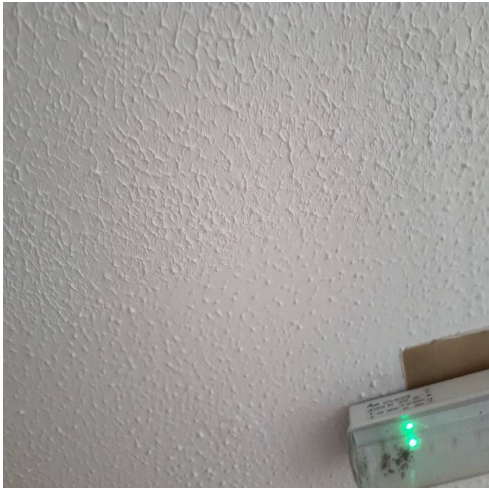
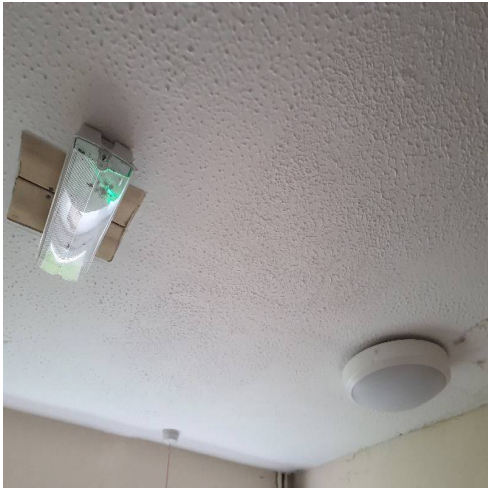
| Item Description: Decorative coating - Ceiling | | | | | |
| Comments: , | | Extent:<br>6m² | | | |
| Reinspection State / Register Update: No change | | | | | |
| Extent of Damage: | Good Condition | 0 | | | |

| Frequency of maintenance activity | >1 per month | 3 | Total Risk Score (*) | <b>Low Risk (11)</b> |

| <b>Maintenance activity</b> | <b>Average Score</b> | <b>2</b> | <b>Recommendation: Manage &amp; Monitor</b> | |

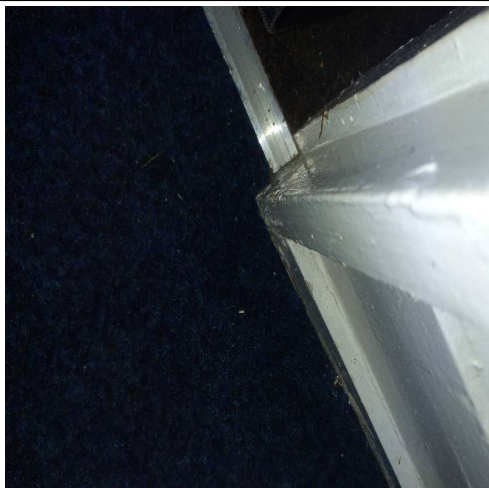
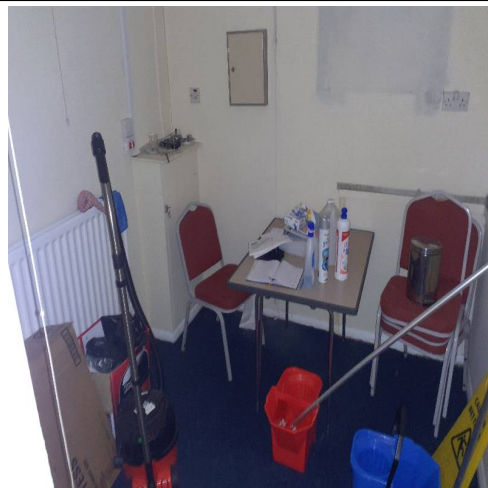
| Item No:<br>10 | Sample No: As TB003646 {KO000005}<br>* | Building ID: Attlee Square Community Hub | Location: Office, G/05 |

| Item Description: Floor tiles - Floor | | |
| Comments: , | | Extent:<br>9m² |
| Reinspection State / Register Update: No change | | |
| Extent of Damage: | Good Condition | 0 |

| Frequency of maintenance activity | >1 per month | 3 | Total Risk Score (*) | Low Risk (10) |

| <b>Maintenance activity</b> | <b>Average Score</b> | <b>2</b> | <b>Recommendation: Manage &amp; Monitor</b> | |

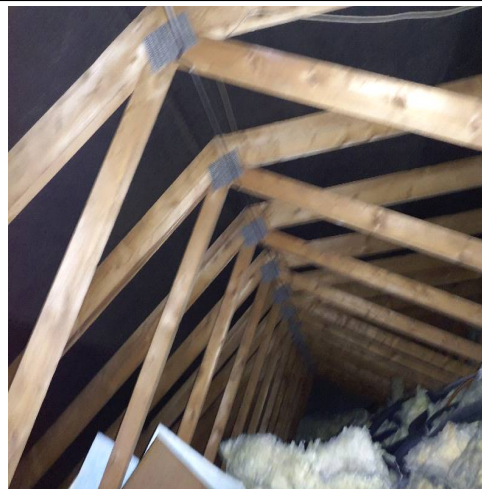
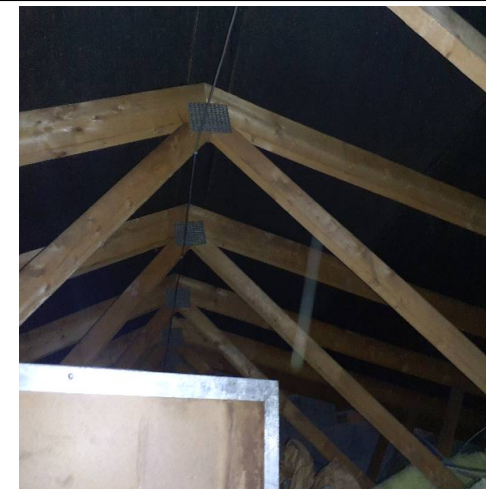
| Item No:<br>11 | Sample No: TB003650 {KO000008}*<br>Level of ID: Identified | Building ID: Attlee Square Community Hub | Location: Loft, R/01 |

Item Description: Sheets - Floor

Comments: Above external store ,

Reinspection State / Register Update: Unable to locate

| Extent of Damage: | Good Condition | 0 |

| Frequency of maintenance activity | >1 per month | 3 | Total Risk Score (*) | Very Low Risk (8) |

| <b>Maintenance activity</b> | <b>Average Score</b> | <b>2</b> | <b>Recommendation: Manage &amp; Monitor</b> | |

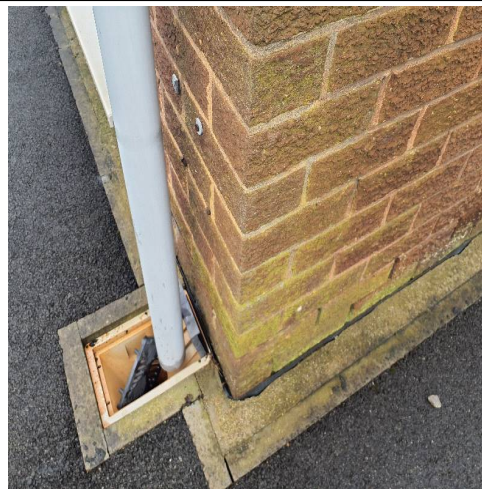
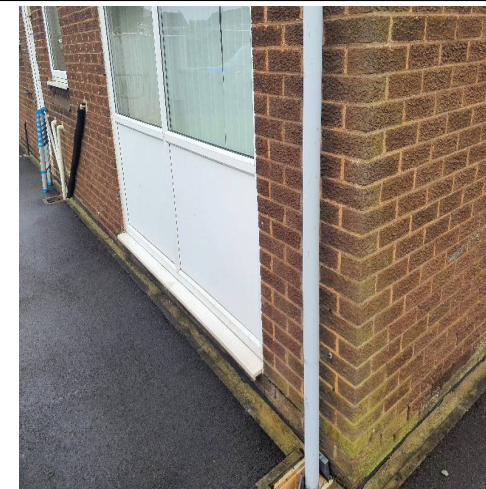
| Item No:<br>1 | Sample No: TB003651 {KO000002}*<br>Level of ID: Identified | Building ID: Attlee Square Community Hub | Location: External elements, E/01 |

Item Description: Damp proof course - Wall

Extent:  
10m²

Reinspection State / Register Update: No change

| Extent of Damage: | Good Condition | 0 |

| Frequency of maintenance activity | >1 per month | 3 | Total Risk Score (*) | Low Risk (10) |

| <b>Maintenance activity</b> | <b>Average Score</b> | <b>2</b> | <b>Recommendation: Manage &amp; Monitor</b> | |

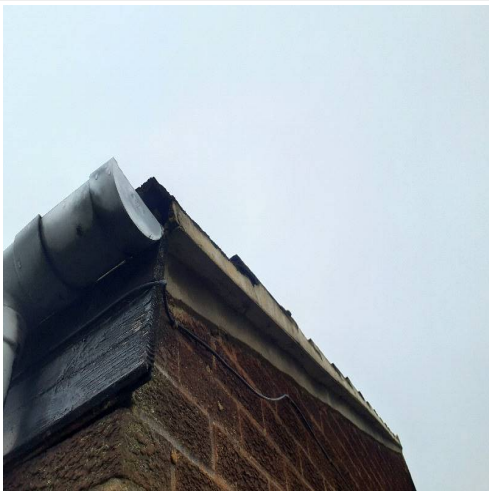
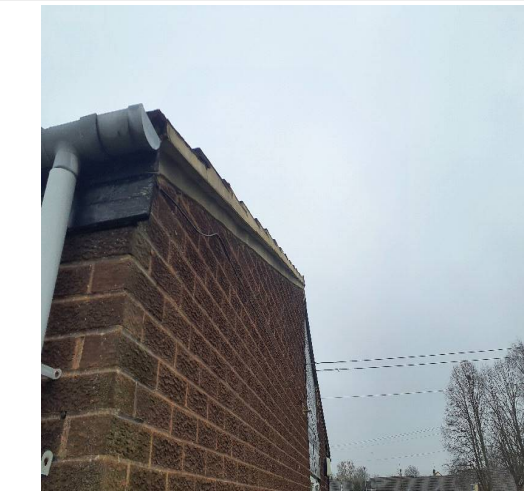
| Item Description: Under cloak - Roof | | | | |
| Comments: , | Extent:<br>12m | | | |
| Reinspection State / Register Update: No change | | | | |
| Extent of Damage: | Good Condition | | | 0 |

| Frequency of maintenance activity | >1 per month | 3 | Total Risk Score (*) | <b>Low Risk (11)</b> |

| <b>Maintenance activity</b> | <b>Average Score</b> | <b>2</b> | <b>Recommendation: Manage &amp; Monitor</b> | |
