**FIRE RISK ASSESSMENT  
COUNTRY HOUSE,  
SOUTH CHURCH ENTERPRISE PARK  
BISHOP AUCKLAND, DL14 6XB**

**AUGUST 2025**

**STORM TEMPEST**  
PROPERTY CONSULTANCY

**Reference:** 4651-04-25-DS

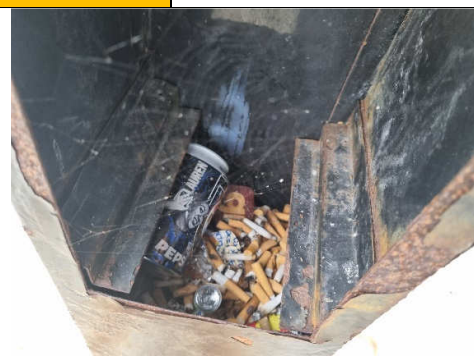
<b>MEDIUM</b>	<b>1</b>

3.17	Smoking:	<p>Smoking is prohibited within the premises. No evidence of illicit smoking noted. A dedicated smoking area is provided to the rear of the premises.</p> <p>We noted combustible materials within the smoking receptacle to the rear elevation externally. The client has also advised there was a recent fire incident due to combustible materials being discarded in the receptacle. We would recommend that the client advises all users of the facility not to discard combustible items in this manner and regular checks should also be undertaken to monitor this situation.</p>

<b>Fire Risk Assessors Observations:</b> We noted combustible materials within the smoking receptacle to the rear elevation externally. The client has also advised there was a recent fire incident due to combustible materials being discarded in the receptacle.
<b>Date First Identified:</b>	30/05/25	<b>Recommended Action:</b> We would recommend that the client advises all users of the facility not to discard combustible items in this manner and regular checks should also be undertaken to monitor this situation.
<b>Date of FRA:</b>	21/08/25	
<b>Rectify Within: (months)</b>	3

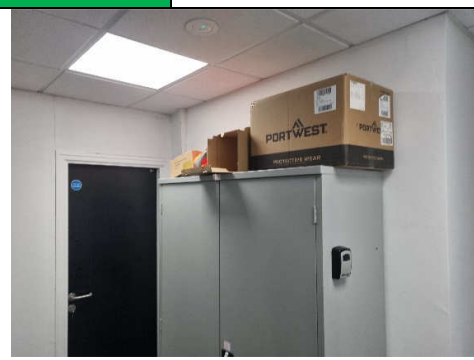
<b>LOW</b>	<b>2</b>

We noted cardboard boxes stored within the ground floor means of escape. We would recommend the client removes these cardboard boxes and ensures they are not stored within the means of escape.

<b>Fire Risk Assessors Observations:</b> We noted cardboard boxes stored within the ground floor means of escape.
<b>Date First Identified:</b>	30/05/25	<b>Recommended Action:</b> We would recommend the client removes these cardboard boxes and ensures they are not stored within the means of escape.
<b>Date of FRA:</b>	21/08/25	
<b>Rectify Within: (months)</b>	6

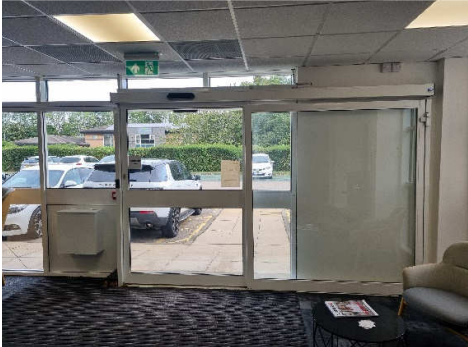
<b>MEDIUM</b>	<b>3</b>

We were unable to determine if the front entrance door would remain in the open position in the event of a power failure during an emergency. The client should ensure that the final exit door can be held open without power to allow safe and unobstructed egress.

<p><b>Fire Risk Assessors Observations:</b></p> <p>We were unable to determine if the front entrance door would remain in the open position in the event of a power failure during an emergency.</p>
<b>Date First Identified:</b>	30/05/25	<p><b>Recommended Action:</b></p> <p>The client should ensure that the final exit door can be held open without power to allow safe and unobstructed egress.</p>
<b>Date of FRA:</b>	21/08/25	
<b>Rectify Within: (months)</b>	3

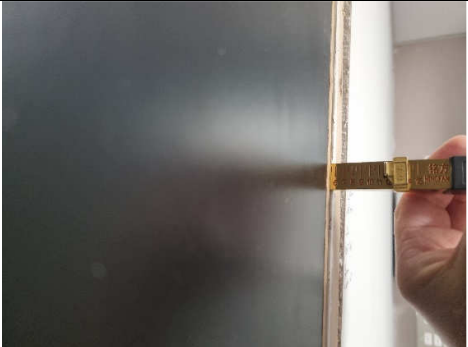
<b>MEDIUM</b>	<b>4</b>

- Excessive gaps over 4mm to lift room door
- Excessive gaps over 4mm electrical cupboard door
- Excessive gaps over 4mm to server room door
- Door closer removed from electrical cupboard door
- Door to server room not fully self-closing

<p><b>Fire Risk Assessors Observations:</b></p> <p>Although the assessment does not constitute a fire door inspection we inspected a sample of fire doors within the premises and noted the following defects:</p> <ul style="list-style-type: none"> <li>➤ Excessive gaps over 4mm to lift room door</li> <li>➤ Excessive gaps over 4mm electrical cupboard door</li> <li>➤ Excessive gaps over 4mm to server room door</li> <li>➤ Door closer removed from electrical cupboard door</li> <li>➤ Door to server room not fully self-closing</li> </ul>
<b>Date First Identified:</b>	30/05/25	<p><b>Recommended Action:</b></p> <p>We would recommend that the client arranges for the above highlighted defects to be remediated to ensure all doors meet the requirements of BS8214. All works should be undertaken by a third party accredited contractor.</p>
<b>Date of FRA:</b>	21/08/25	
<b>Rectify Within: (months)</b>	3

We would recommend that the client arranges for the above highlighted defects to be remediated to ensure all doors meet the requirements of BS8214. All works should be undertaken by a third party accredited contractor.

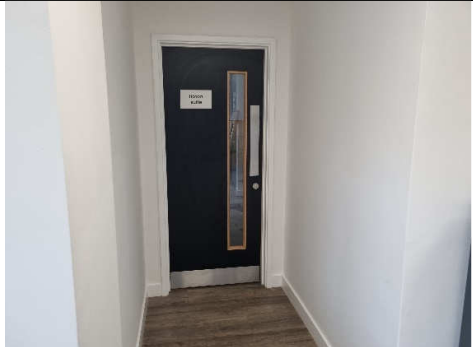
<b>MEDIUM</b>	<b>6</b>

We noted the door located within the first floor office space was not a standard FD30 doorset. We would recommend the door is replaced with a fire door conforming to BS8214. All works should be undertaken by a third party accredited contractor. The client has confirmed that this is in the process of being replaced.

<b>Fire Risk Assessors Observations:</b>
		We noted the door located within the first floor office space was not a standard FD30 doorset.
<b>Date First Identified:</b>	30/05/25	<b>Recommended Action:</b> We would recommend the door is replaced with a fire door conforming to BS8214. All works should be undertaken by a third party accredited contractor. The client has confirmed that this is in the process of being replaced.
<b>Date of FRA:</b>	21/08/25	
<b>Rectify Within: (months)</b>	3

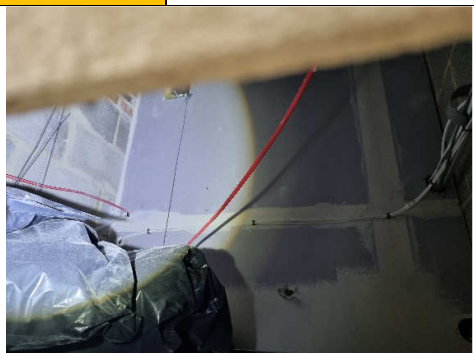
<b>MEDIUM</b>	<b>7</b>

- 5.4 Ceilings: No obvious breaches noted
- 5.5 Walls: We inspected a sample of the compartmentation including above the suspended ceilings throughout the premises and noted breaches in multiple locations. We would recommend that the client arranges for a full compartmentation survey to be undertaken and all highlighted defects be remediated. All works should be undertaken by a third party accredited contractor to ensure all compartmentation meets the requirements of BS9999 to prevent the uncontrolled spread of smoke and fire.
- 5.6 Floors: No obvious breaches noted
- 5.7 Any Other Comments: We could not confirm at the time of inspection if fire dampers are installed within the ductwork due to access limitations. We would recommend that the client reviews the mechanical installation records of the ductwork to check if dampers have been installed in accordance with BS 9999.

<p><b>Fire Risk Assessors Observations:</b></p> <p>We inspected a sample of the compartmentation including above the suspended ceilings throughout the premises and noted breaches in multiple locations.</p>
<b>Date First Identified:</b>	30/05/25	<p><b>Recommended Action:</b></p> <p>We would recommend that the client arranges for a full compartmentation survey to be undertaken and all highlighted defects be remediated. All works should be undertaken by a third party accredited contractor to ensure all compartmentation meets the requirements of BS9999 to prevent the uncontrolled spread of smoke and fire.</p>
<b>Date of FRA:</b>	21/08/25	
<b>Rectify Within: (months)</b>	3

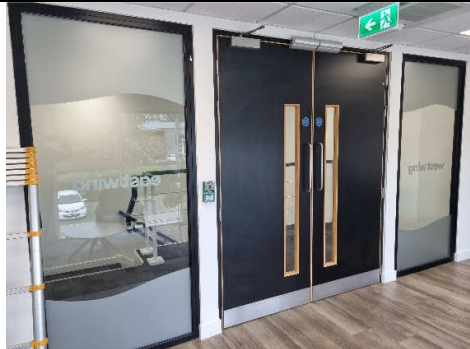
<b>LOW</b>	<b>9</b>

Glazed partitions are used within the means of escape although we were unable to confirm if these are fire rated. We would recommend that the client ensures all glazed partitions are fire rated to REI60.

<p><b>Fire Risk Assessors Observations:</b></p> <p>Glazed partitions are used within the means of escape although we were unable to confirm if these are fire rated.</p>
<b>Date First Identified:</b>	30/05/25	<p><b>Recommended Action:</b></p> <p>We would recommend that the client ensures all glazed partitions are fire rated to REI60.</p>
<b>Date of FRA:</b>	21/08/25	
<b>Rectify Within: (months)</b>	6

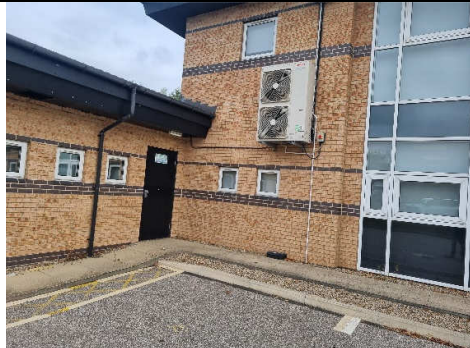
<b>LOW</b>	<b>10</b>

<p><b>Fire Risk Assessors Observations:</b></p> <p>We noted the fire exit signs to the external side of the rear elevation final exit doors are faded and becoming illegible.</p>
<b>Date First Identified:</b>	21/08/25	<p><b>Recommended Action:</b></p> <p>We would recommend that these are replaced with 'Keep Clear Fire Exit' signs in accordance with BS5499.</p>
<b>Date of FRA:</b>	21/08/25	
<b>Rectify Within: (months)</b>	6

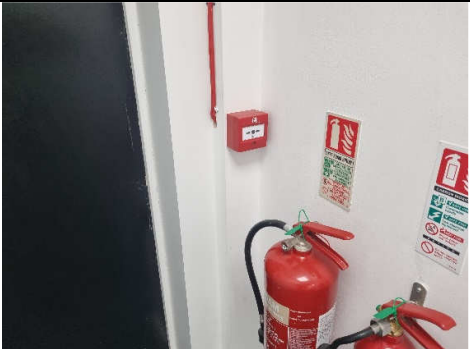
<b>LOW</b>	<b>11</b>

- 8.8 Assembly Point: Identified on fire action notices.
- 8.9 Any Other Comments: We noted there was no manual call point signage throughout the premises in the means of escape area. We would recommend that the appropriate signage is fitted adjacent to the manual call points.

<p><b>Fire Risk Assessors Observations:</b></p> <p>We noted there was no manual call point signage throughout the premises in the means of escape area.</p>
<b>Date First Identified:</b>	30/05/25	<p><b>Recommended Action:</b></p> <p>We would recommend that the appropriate signage is fitted adjacent to the manual call points.</p>
<b>Date of FRA:</b>	21/08/25	
<b>Rectify Within: (months)</b>	6

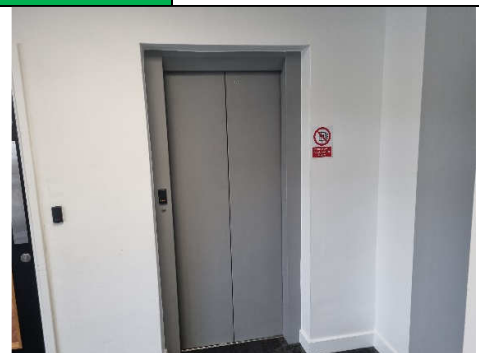
<b>LOW</b>	<b>14</b>

- 9.17 Passenger Lifts: We noted a passenger lift located in the main entrance lobby area. We were unable to confirm if the lift undergoes servicing every 2 months as part of routine maintenance and 6 monthly inspections as required under the Lifting Operations and Lifting Equipment (LOLER) regulations, 1998. The client should confirm that the passenger lift is inspected and maintained in accordance with the regulatory requirements.

<b>Fire Risk Assessors Observations:</b> We noted a passenger lift located in the main entrance lobby area. We were unable to confirm if the lift undergoes servicing every 2 months as part of routine maintenance and 6 monthly inspections as required under the Lifting Operations and Lifting Equipment (LOLER) regulations, 1998.
<b>Date First Identified:</b>	30/05/25	<b>Recommended Action:</b> The client should confirm that the passenger lift is inspected and maintained in accordance with the regulatory requirements.
<b>Date of FRA:</b>	21/08/25	
<b>Rectify Within: (months)</b>	6
