**FIRE RISK ASSESSMENT  
COAST HOUSE,  
SPECTRUM BUSINESS PARK,  
SEAHAM, SR7 7TT**

**MAY 2025**

**Reference:** 4651-04-25-DS

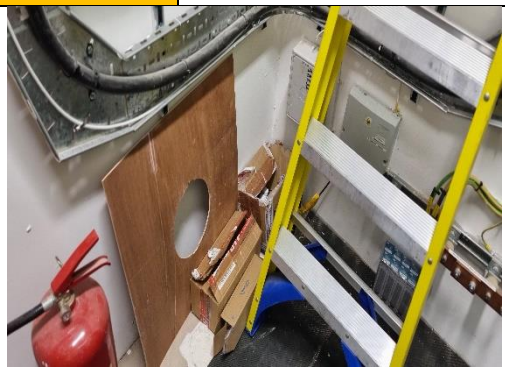
<b>MEDIUM</b>	<b>2</b>

| 3.9 | Any Other Comments: | We noted combustible items / sources of fuel stored within the ground floor electrical cupboard. We would recommend the items are removed and the client ensures such items are not stored within this area. |

<p><b>Fire Risk Assessors Observations:</b></p> <p>We noted combustible items / source of fuel stored within the ground floor electrical cupboard.</p>
<b>Date First Identified:</b>	23/05/25	<p><b>Recommended Action:</b></p> <p>We would recommend the items are removed and the client ensures such items are not stored within this area.</p>
<b>Date of FRA:</b>	23/05/25	
<b>Rectify Within: (months)</b>	3

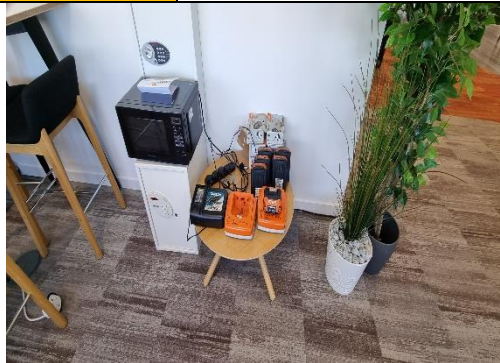
<b>MEDIUM</b>		<b>3</b>

We noted rechargeable batteries located within the north wing office. We would recommend that the batteries are charged and stored in a designated location that is well ventilated and away from combustible materials. The client should also consider a management procedure for the batteries including regular inspections for damage and safe disposal of defective units.

<b>Fire Risk Assessors Observations:</b> We noted rechargeable batteries located within the north wing office.	
<b>Date First Identified:</b>	23/05/25	<b>Recommended Action:</b> We would recommend that the batteries are charged and stored in a designated location that is well ventilated and away from combustible materials. The client should also consider a management procedure for the batteries including regular inspections for damage and safe disposal of defective units.	
<b>Date of FRA:</b>	23/05/25		
<b>Rectify Within: (months)</b>	3

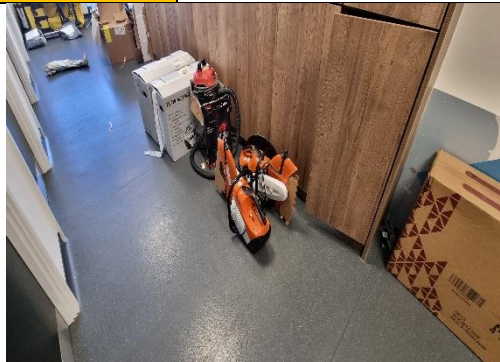
<b>MEDIUM</b>		<b>4</b>

We noted petrol powered tools being stored within the shower room area on the South Wing first floor. The client should ensure all petrol-powered tools are stored appropriately within a secure designated, well-ventilated area designed for flammable materials, to ensure they are kept away from ignition sources, escape routes, and occupied spaces.

<b>Fire Risk Assessors Observations:</b> We noted petrol powered tools being stored within the shower room area on the South Wing first floor.	
<b>Date First Identified:</b>	23/05/25	<b>Recommended Action:</b> The client should ensure all petrol-powered tools are stored appropriately within a secure designated, well-ventilated area designed for flammable materials, to ensure they are kept away from ignition sources, escape routes, and occupied spaces.	
<b>Date of FRA:</b>	23/05/25		
<b>Rectify Within: (months)</b>	3

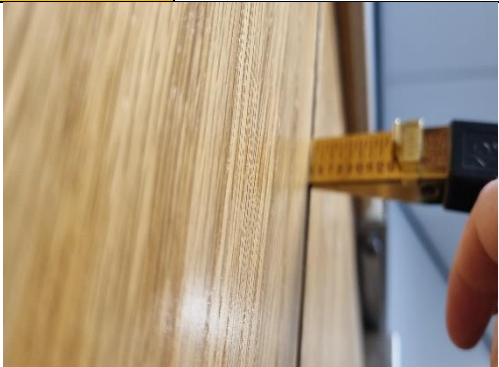
<b>MEDIUM</b>	<b>5</b>

- Excessive gaps over 4mm and loose intumescent strip to door set leading from the lobby to north wing office area
- Excessive gaps over 4mm to doors leading into the shower room area
- Excessive gaps over 4mm to locked cupboard door in south wing office area

<p><b>Fire Risk Assessors Observations:</b></p> <p>Although the assessment does not constitute a fire door inspection we inspected a sample of fire doors within the premises and noted the following defects:</p> <ul style="list-style-type: none"> <li>➤ Excessive gaps over 4mm and loose intumescent strip to door set leading from the lobby to north wing office area</li> <li>➤ Excessive gaps over 4mm to doors leading into the shower room area</li> <li>➤ Excessive gaps over 4mm to locked cupboard door in south wing office area</li> </ul>
<b>Date First Identified:</b>	23/05/25	<p><b>Recommended Action:</b></p> <p>We would recommend that the client arranges for the above highlighted defects to be remediated to ensure all doors meet the requirements of BS8214. All works should be undertaken by a third party accredited contractor.</p>
<b>Date of FRA:</b>	23/05/25	
<b>Rectify Within: (months)</b>	3

We would recommend that the client arranges for the above highlighted defects to be remediated to ensure all doors meet the requirements of BS8214. All works should be undertaken by a third party accredited contractor.

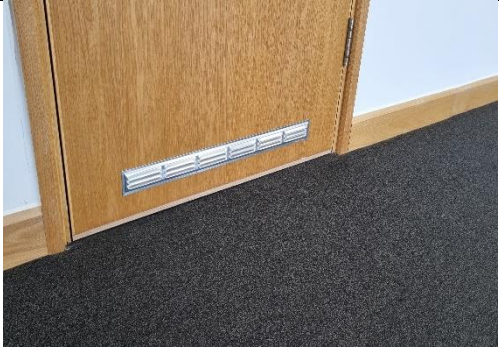
<b>MEDIUM</b>	<b>6</b>

We noted the fire doors to the server room on the first and second floor have a ventilation grilles installed to the bottom of the door and timber added to the base of the door leaf. The client should confirm that both the ventilation grilles and the timber material used at the base of the doors comply with the manufacturer's specifications and meet the requirements of BS 8214.

<p><b>Fire Risk Assessors Observations:</b></p> <p>We noted the fire doors to the server room on the first and second floor have a ventilation grilles installed to the bottom of the door and timber added to the base of the door leaf.</p>
<b>Date First Identified:</b>	23/05/25	<p><b>Recommended Action:</b></p> <p>The client should confirm that both the ventilation grilles and the timber material used at the base of the doors comply with the manufacturer's specifications and meet the requirements of BS 8214.</p>
<b>Date of FRA:</b>	23/05/25	
<b>Rectify Within: (months)</b>	3

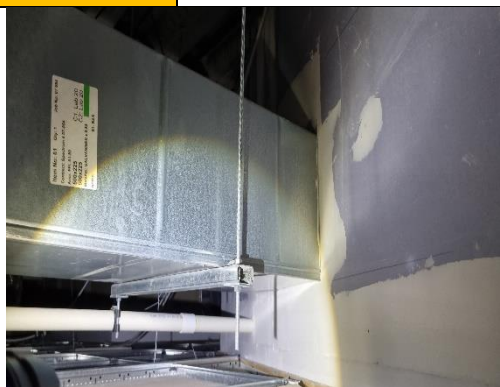
<b>MEDIUM</b>		<b>8</b>

We could not confirm at the time of inspection if fire dampers are installed within the ductwork due to access limitations. We would recommend that the client reviews the mechanical installation records of the ductwork to check if dampers have been installed in accordance with BS 9999.

<b>Fire Risk Assessors Observations:</b> We could not confirm at the time of inspection if fire dampers are installed within the ductwork due to access limitations.	
<b>Date First Identified:</b>	23/05/25	<b>Recommended Action:</b> We would recommend that the client reviews the mechanical installation records of the ductwork to check if dampers have been installed in accordance with BS 9999.	
<b>Date of FRA:</b>	23/05/25		
<b>Rectify Within: (months)</b>	3

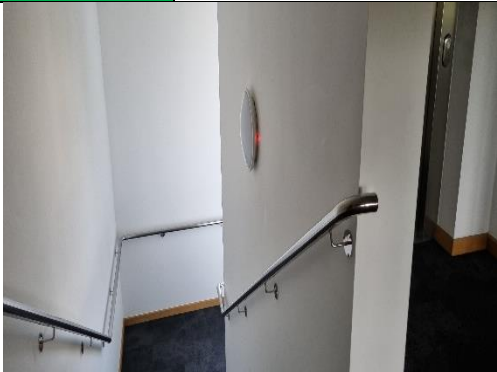
<b>LOW</b>	<b>10</b>

- 7.1 System Type: 3 hour, self-contained, non-maintained.
- 7.2 Internal Areas: Throughout means of escape
- 7.3 External Areas: Above final exit doors
- 7.4 Faults: We noted the following issues to the emergency lighting throughout the premises:
- Emergency light to the side of the building was not working at the time of assessment
  - Red LED to emergency lighting within the central stairwell on the first and second floor
  - No green light indicator to several emergency lights in the second floor office space
- The client should remediate the above highlighted defects. All works should be undertaken by a third party accredited contractor.
- 7.5 Any Other Comments: None

<p><b>Fire Risk Assessors Observations:</b></p> <p>We noted the following issues to the emergency lighting throughout the premises:</p> <ul style="list-style-type: none"> <li>➤ Emergency light to the side of the building was not working at the time of assessment</li> <li>➤ Red LED to emergency lighting within the central stairwell on the first and second floor</li> <li>➤ No green light indicator to several emergency lights in the second floor office space</li> </ul>
<b>Date First Identified:</b>	23/05/25	<p><b>Recommended Action:</b></p> <p>The client should remediate the above highlighted defects. All works should be undertaken by a third party accredited contractor.</p>
<b>Date of FRA:</b>	23/05/25	
<b>Rectify Within: (months)</b>	6

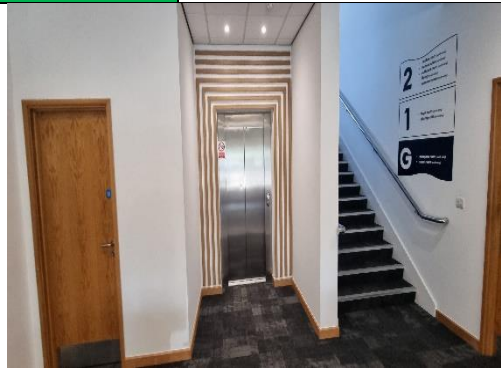
<b>LOW</b>	<b>13</b>

- 9.17 Passenger Lifts: We noted a passenger lift located in the central staircase means of escape area. We were unable to confirm if the lift undergoes servicing every 2 months as part of routine maintenance and 6 monthly

<p><b>Fire Risk Assessors Observations:</b></p> <p>We noted a passenger lift located in the central staircase means of escape area. We were unable to confirm if the lift undergoes servicing every 2 months as part of routine maintenance and 6 monthly inspections as required under the Lifting Operations and Lifting Equipment (LOLER) regulations, 1998.</p>
<b>Date First Identified:</b>	23/05/25	<p><b>Recommended Action:</b></p> <p>The client should confirm that the passenger lift is inspected and maintained in accordance with the regulatory requirements.</p>
<b>Date of FRA:</b>	23/05/25	
<b>Rectify Within: (months)</b>	6

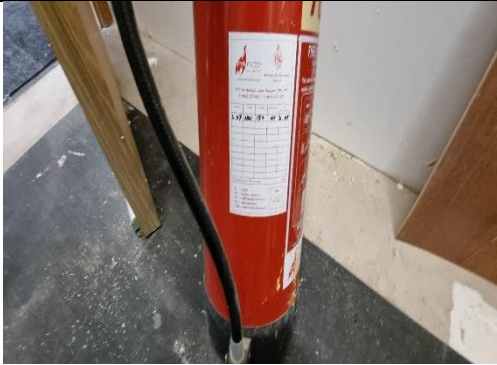
<b>LOW</b>	<b>15</b>

- 9.18 Fire Extinguishers: Serviced December 2024. However, we noted redundant fire extinguishers located within the ground floor electrical cupboard. We would recommend that the redundant fire extinguishers be removed from the electrical cupboard to avoid obstruction and ensure good fire safety housekeeping practices.

<p><b>Fire Risk Assessors Observations:</b></p> <p>We noted redundant fire extinguishers located within the ground floor electrical cupboard.</p>
<b>Date First Identified:</b>	23/05/25	<p><b>Recommended Action:</b></p> <p>We would recommend that the redundant fire extinguishers be removed from the electrical cupboard to avoid obstruction and ensure good fire safety housekeeping practices.</p>
<b>Date of FRA:</b>	23/05/25	
<b>Rectify Within: (months)</b>	6

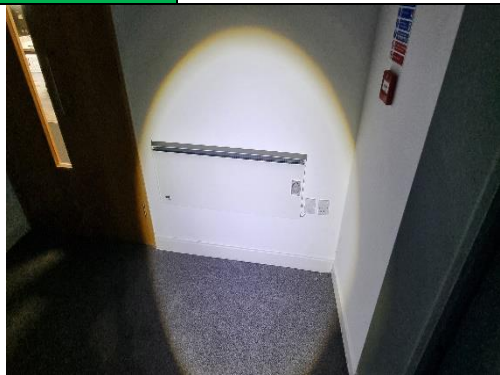
<b>LOW</b>		<b>16</b>

- 9.19 Fire Blankets: NA
- 9.20 Hose Reels: None provided
- 9.21 Fire Fighting Lifts: None provided
- 9.22 Heating System: We noted electric heater panels within the means of escape area. We could not confirm if the electric heating system is included within a maintenance regime. We would recommend that the client ensures all electrical heating appliances are maintained in accordance with manufacturers recommendations.

<b>Fire Risk Assessors Observations:</b> We noted electric heater panels within the means of escape area. We could not confirm if the electric heating system is included within a maintenance regime.	
		<b>Recommended Action:</b> We would recommend that the client ensures all electrical heating appliances are maintained in accordance with manufacturers recommendations.	
<b>Date First Identified:</b>		23/05/25	
<b>Date of FRA:</b>		23/05/25	
<b>Rectify Within: (months)</b>		6

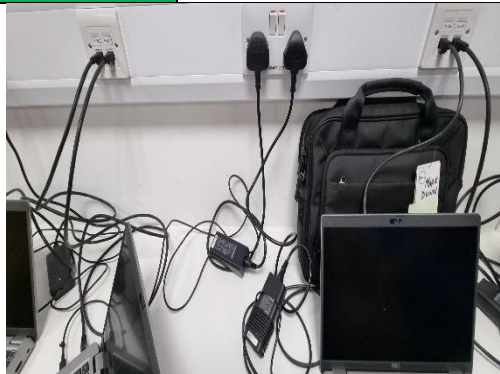
<b>LOW</b>		<b>17</b>

9.28 Portable Appliances: Regular testing of electrical appliances should be undertaken in accordance with the Electricity at Work Regulations 1989. A sample of labelling identified the electrical apparatus has been subject to PAT testing by a competent person across various dates including October 2020 / October 2024 / February 2025, in addition there was no evidence of PAT testing within the server room therefore not meeting the regulation requirements. We would recommend that the client ensures all electrical appliances are PAT tested in accordance with the Electricity at Work Regulations 1989.

<b>Fire Risk Assessors Observations:</b> Regular testing of electrical appliances should be undertaken in accordance with the Electricity at Work Regulations 1989. A sample of labelling identified the electrical apparatus has been subject to PAT testing by a competent person across various dates including October 2020 / October 2024 / February 2025, in addition there was no evidence of PAT testing within the server room therefore not meeting the regulation requirements.	
		<b>Recommended Action:</b> We would recommend that the client ensures all electrical appliances are PAT tested in accordance with the Electricity at Work Regulations 1989.	
<b>Date First Identified:</b>		23/05/25	
<b>Date of FRA:</b>		23/05/25	
<b>Rectify Within: (months)</b>		6

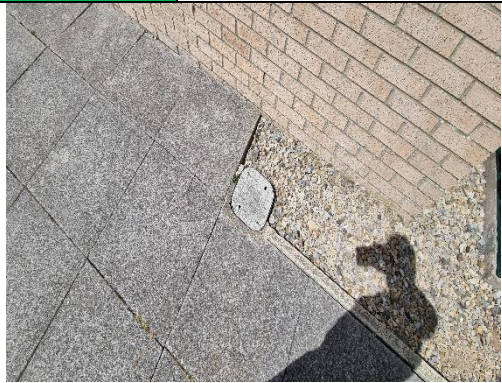
<b>LOW</b>	<b>18</b>

<p><b>Fire Risk Assessors Observations:</b></p> <p>We were unable to confirm if the lightning protection system is inspected and maintained as required.</p>
<b>Date First Identified:</b>	23/05/25	<p><b>Recommended Action:</b></p> <p>The client should ensure that the lightning protection system undergoes regular inspection, testing, and maintenance by a competent contractor in accordance with BS EN 62305.</p>
<b>Date of FRA:</b>	23/05/25	
<b>Rectify Within: (months)</b>	6

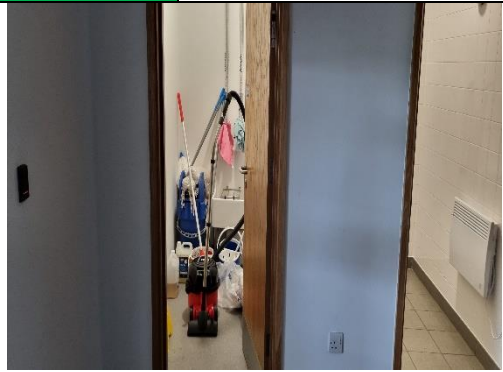
<b>LOW</b>	<b>20</b>

9.36 Any Other Comments: We noted several cleaners cupboards throughout the premises were unlocked at the time of assessment. We would recommend the client

<b>Fire Risk Assessors Observations:</b> We noted several cleaners cupboards throughout the premises were unlocked at the time of assessment.
<b>Date First Identified:</b>	23/05/25	<b>Recommended Action:</b> We would recommend the client ensures all cupboards with 'Fire Door Keep Locked' signage are kept locked at all times.
<b>Date of FRA:</b>	23/05/25	
<b>Rectify Within: (months)</b>	6
