**FIRE RISK ASSESSMENT  
BYRON LODGE COMMUNITY CENTRE,  
SEAHAM, CO DURHAM  
SR7 0JY**

**MARCH 2026**

**Reference:** 4651-04-25-MC

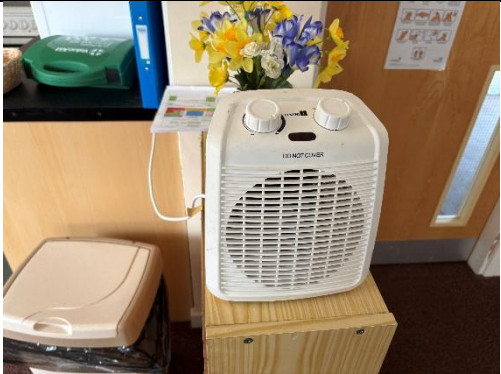
| | | <p><b>Fire Risk Assessors Observations:</b></p> <p>We noted a portable heater within the communal lounge. We do not recommend the use of convector including (fan heaters) heaters as they require:</p> <ul style="list-style-type: none"><li>• A clear space around them to work effectively, that must be kept clear of combustible material to ensure they do not overheat,</li><li>• Anything draped over the heater may cause a fire,</li><li>• Obstructed air grilles may cause the heater to overheat and lead to a fire,</li><li>• One common location for small electric (fan) heaters is under desks particularly in cramped or untidy workspaces – these may be a potential risk and source of fire, as it is difficult to maintain proper clearances for adequate air flow and other combustible materials which can accidentally fall or be kicked into the area around the heater.</li></ul> |

| <b>Date of FRA:</b> | 20/03/26 | Whilst it is recognised that additional heating may be required by persons during inclement weather, it is recommended that oil filled radiant type heaters are used as they are less likely to be affected by conditions that may cause them to overheat. We recommend the existing heaters are replaced with oil filled type heaters. Failure to do so increases the risk of a fire as described. |

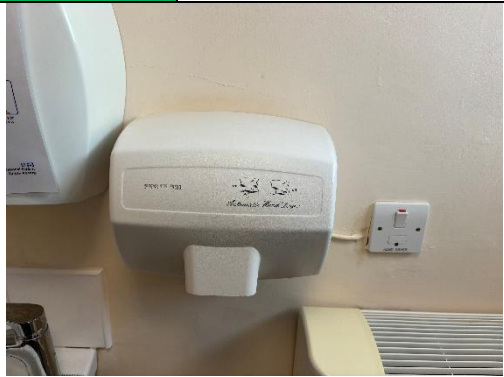
| | | | <b>Fire Risk Assessors Observations:</b><br><p>We noted electric hand dryers within the toilets, a single point water heater within the kitchen area and electric heaters. We could not confirm if the electric hand dryers, electric heaters and electric water heater are included within a maintenance regime.</p> |

| <b>Date First Identified:</b> | | 20/03/26 | <b>Recommended Action:</b><br><p>We would recommend that the client ensures all electrical heating appliances are maintained in accordance with manufacturers recommendations.</p> |

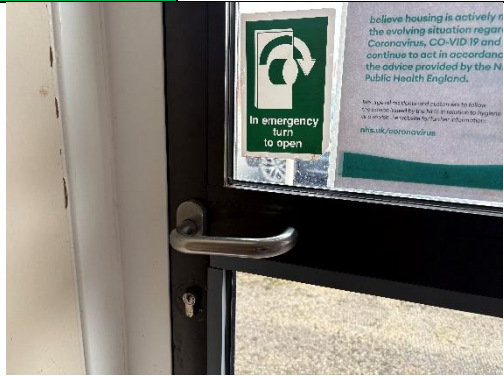
| | | | <b>Fire Risk Assessors Observations:</b><br><p>We noted the final exit door from the main entrance lobby area is fitted with a euro style key locking mechanism and egress may be delayed if this door is locked.</p> |

| <b>Date First Identified:</b> | | 20/03/26 | <b>Recommended Action:</b><br><p>We recommend a thumb turn unlocking mechanism is fitted to the door to mitigate against the risk of egress being prevented or delayed due to missing or misplaced keys.</p> |

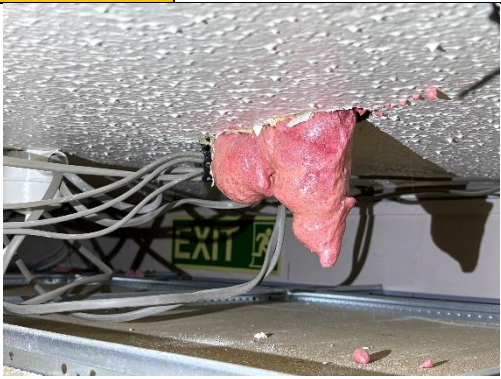
| | | <b>Fire Risk Assessors Observations:</b><br><br>We noted a breach to the ceiling above the ceiling tiles that did not appear to be adequately sealed using pink foam, this breaches the compartmentation between the community centre and the flat above. |

| <b>Date First Identified:</b> | 20/03/26 | <b>Recommended Action:</b><br><br>We recommend the breach is remediated with a fire resistant material. All works should be undertaken by a third party accredited contractor. |

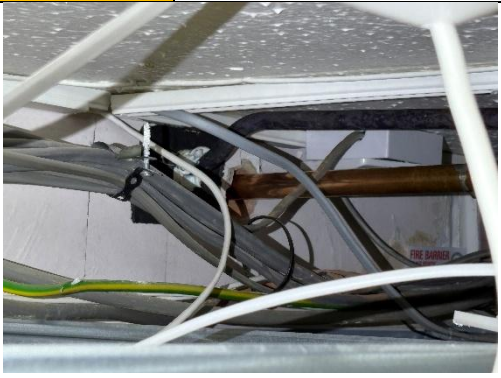
| <b>MEDIUM</b> | <b>6</b> | |

| | | <b>Fire Risk Assessors Observations:</b><br><br>We noted a gas pipe penetrating the wall compartmentation between the lobby area and the cleaner's cupboard. |

| <b>Date First Identified:</b> | 20/03/26 | <b>Recommended Action:</b><br><br>We recommend the breach is remediated with a fire resistant material. All works should be undertaken by a third party accredited contractor. |

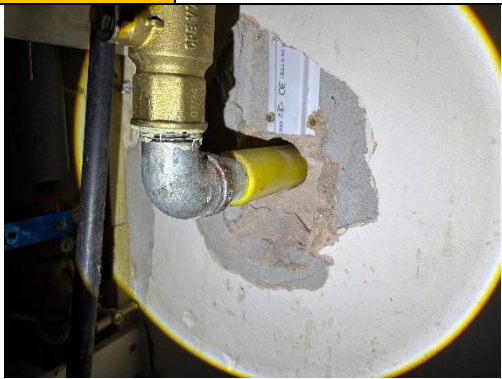
| | | | <b>Fire Risk Assessors Observations:</b><br>We noted a gas pipe penetrating the cavity wall within the cleaners cupboard. |

| <b>Date First Identified:</b> | | 20/03/26 | <b>Recommended Action:</b><br>We recommend the breach is remediated with a fire resistant material to prevent any potential fire spreading through the cavity. All works should be undertaken by a third party accredited contractor. |

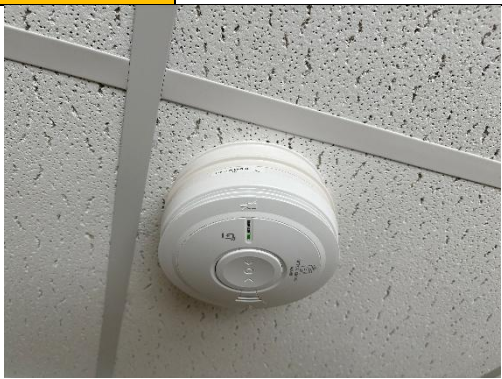
| | | | <b>Fire Risk Assessors Observations:</b><br>There is no fire alarm panel or manual call points installed. Automatic fire detection is provided within the communal lounge, main entrance lobby, and the office, which appears to be of Grade A standard. |

| <b>Date First Identified:</b> | | 20/03/26 | <b>Recommended Action:</b><br>We recommend that the client install an L3 Category system in accordance with BS 5839 part 1 to include Automatic Fire Detection, manual call points and control and indicating equipment, which interlinks to the flat above. |

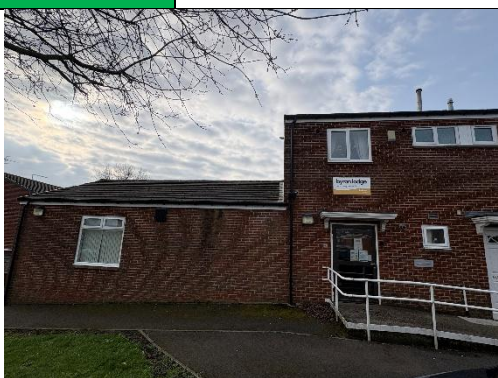
| | | | <b>Fire Risk Assessors Observations:</b><br>There is no emergency lighting installed externally at the front or rear final exit. |

| <b>Date First Identified:</b> | 20/03/26 | <b>Recommended Action:</b><br>We would recommend that the client installs emergency lighting externally at the front and rear final exit door to ensure there is adequate light provided. | |

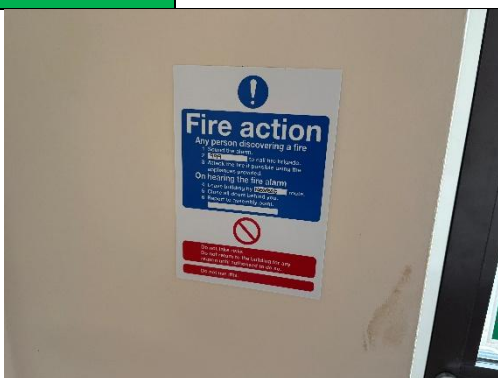
| | | | <b>Fire Risk Assessors Observations:</b><br>Fire action notices are installed within the premises. However, these appear to be incorrect as they instruct occupants to "sound the alarm" upon discovering a fire, which may cause confusion because there are no manual call points within the premises. |

| <b>Date First Identified:</b> | 20/03/26 | <b>Recommended Action:</b><br>We would recommend that the fire action notices are replaced or amended so that the instructions accurately reflect the fire alarm arrangements and fire strategy on site in accordance with BS5499. | |

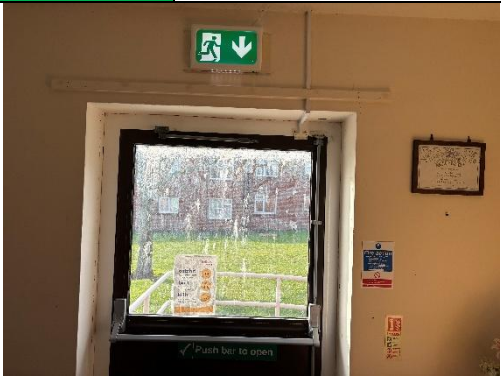
| <b>LOW</b> | | <b>17</b> | |

| | | | The rear final exit door does not fully self-close into the rebate unaided presenting a risk of unauthorised access. |

| <b>Date First Identified:</b> | | 20/03/26 | <b>Recommended Action:</b><br>We would recommend that the door is fitted with a door closer to ensure it fully self-closes reducing the risk of unauthorised access. |
