**FIRE RISK ASSESSMENT
PARK AVENUE CLOSE, CROOK
COUNTY DURHAM,
DL15 9JR**

DECEMBER 2024

Reference: 4560-09-24-PA

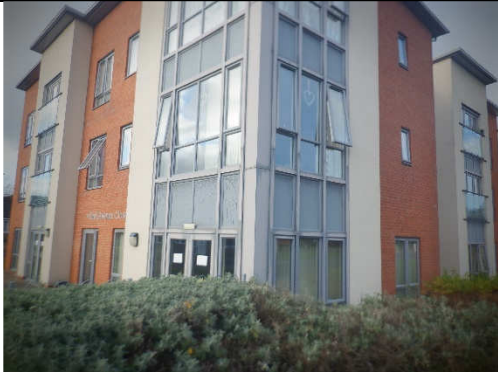
LOW	2

<p>Fire Risk Assessors Observations:</p> <p>Some sections of the building façade are fitted with spandrel panels/infill panels. Such panels can be provided for both functional and aesthetic purposes. Schedule 1 Section B4(1) of the Building Regulations 2010 requires that: "The external walls of the building shall adequately resist the spread of fire over the walls and from one building to another, having regard to the height, use and position of the building". It is not readily apparent what materials are present.</p>
		<p>Recommended Action:</p> <p>The client should check the materials used in the spandrel panels to ensure they do not present a risk of fire spread over the wall.</p>
Date First Identified:	17/12/2024	
Date of FRA:	17/12/2024	
Rectify Within: (months)	6

2.30	Are There any Existing Spandrel Panels:	<p>Some sections of the building façade are fitted with spandrel panels/infill panels. Such panels can be provided for both functional and aesthetic purposes. Schedule 1 Section B4(1) of the Building Regulations 2010 requires that: "The external walls of the building shall adequately resist the spread of fire over the walls and from one building to another, having regard to the height, use and position of the building". It is not readily apparent what materials are present.</p> <p>The client should check the materials used in the spandrel panels to ensure they do not present a risk of fire spread over the wall.</p>

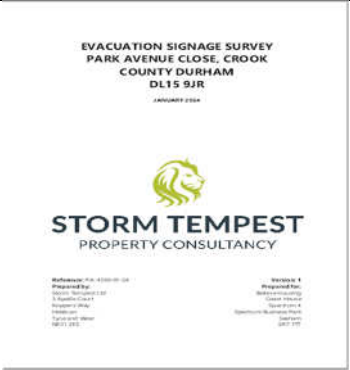
MEDIUM	4

Fire Risk Assessors Observations: We noted several issues with the fire safety signage throughout the building. We are aware that a fire safety signage survey was carried out on 3 rd January 2024.
Date First Identified:	17/12/2024	Recommended Action: The client should take account of the report and undertake all recommendations.
Date of FRA:	17/12/2024	
Rectify Within: (months)	3

8.9 Any Other Comments: We noted several issues with the fire safety signage throughout the building. We are aware that a fire safety signage survey was carried out on 3rd January 2024. The client should take account of the report and undertake all recommendations.

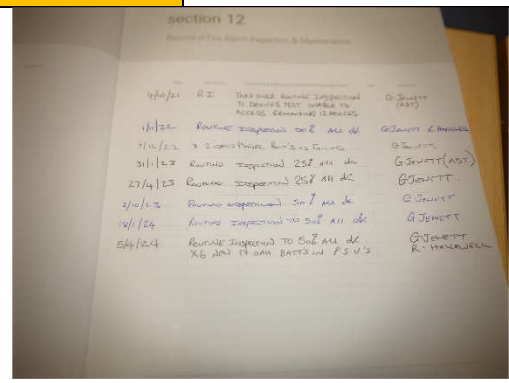
MEDIUM	8

Fire Risk Assessors Observations:
		The last recorded service of the fire alarm system was on the 05/04/2024.
Date First Identified:	17/12/2024	Recommended Action: The client should ensure that the fire alarm system is serviced at 6 monthly intervals in accordance with BS 5839.
Date of FRA:	17/12/2024	
Rectify Within: (months)	3

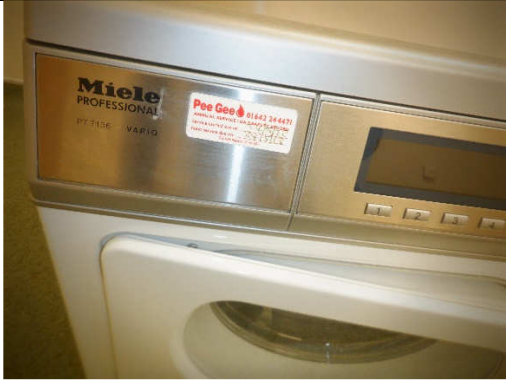
MEDIUM	12

Fire Risk Assessors Observations:
		A label attached to the dryers show that they were last serviced on the 24/05/2022 and were due a service on the 24/5/2023.
Date First Identified:	17/12/2024	Recommended Action: Whilst the laundry equipment is not of the commercial type it is expected that it will be used more frequently than if it were in a domestic environment so, in addition to the user checks, we recommend the laundry equipment is subject regular servicing by a competent person. Failure to do so could result in the increased risk from a fire in the dryer.
Date of FRA:	17/12/2024	
Rectify Within: (months)	3

- 9.23 Laundry Equipment: A label attached to the dryers show that they were last serviced on the 24/05/2022 and were due a service on the 24/5/2023.
- Whilst the laundry equipment is not of the commercial type it is expected that it will be used more frequently than if it were in a domestic environment so, in addition to the user checks, we recommend the laundry equipment is subject regular servicing by a competent person. Failure to do so could result in the increased risk from a fire in the dryer.

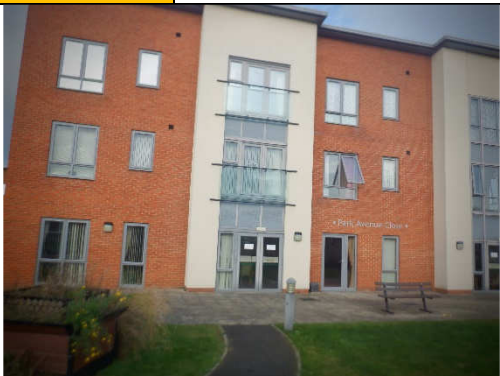
MEDIUM	13

Fire Risk Assessors Observations: We are unable to confirm when the lightning protection system was last subject to servicing.
Date First Identified:	17/12/2024	Recommended Action: We recommend the lightning protection system is subject to regular testing in accordance with "BS EN 62305-1:2006 Protection against Lightning: General Principles". And records are retained on site for inspection by relevant persons.
Date of FRA:	17/12/2024	
Rectify Within: (months)	3

- We recommend the lightning protection system is subject to regular testing in accordance with "BS EN 62305-1:2006 Protection against Lightning: General Principles". And records are retained on site for inspection by relevant persons.

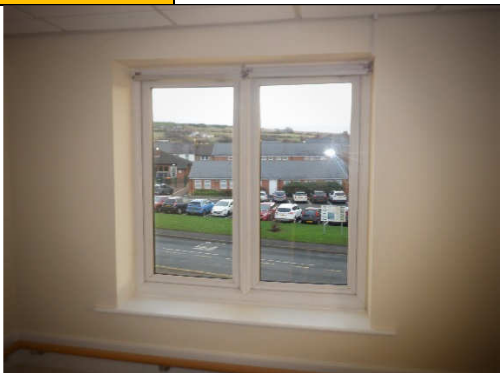
MEDIUM	14

Fire Risk Assessors Observations: There were no records available confirming the testing and servicing of the dry riser and automatically opening vents.
Date First Identified:	17/12/2024	Recommended Action: The client should ensure that the dry riser and automatically opening vents are tested and serviced in accordance with BS 9990 and BS 7346 respectively.
Date of FRA:	17/12/2024	
Rectify Within: (months)	3

- 9.30 Any Other Comments: We noted a dry riser with outlets on all upper floors and automatically opening smoke vents to the ends of corridors and within top floor of each protected stair.
