Asbestos Reinspection Survey (MA and PA)

Client Details	believe housing, Coast House, Spectrum 4, Spectrum Business Park, Seaham,SR7 7TT
Site Details	Alcote House, Shotton Colliery, Durham, County Durham, DH6 2RB UPRN: 3CH00808
Date(s) of Surveys	8 Dec 2025
Report Reference Number	J142002
Brief Survey Scope of Works	Re-inspection Survey

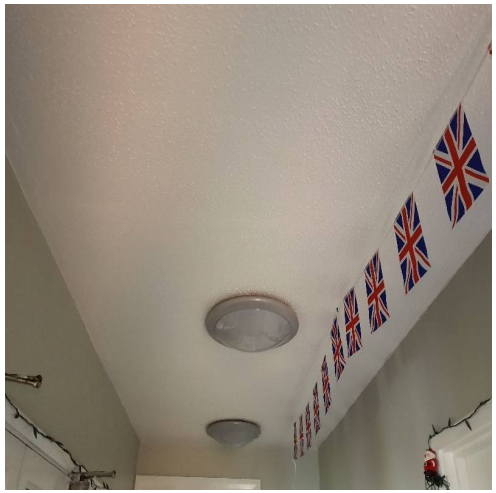
Item No: 5	Sample No: TB003728 {KO000017}*	Building ID: Alcote House	Location: Entrance front, G/01
	Level of ID: Identified

Item Description: Decorative coating - Ceiling		
Comments: , Small crack in ceiling		Extent: 9m²
Reinspection State / Register Update: No change		
Product Type:	Textured Coating	1
Extent of Damage:	Low Damage	1
Surface Treatment:		1
Asbestos Type:	Chrysotile	1

Location	Rooms up to 100m^2	2	Number of occupants	4 to 10	2
Accessibility	Usually inaccessible or unlikely to be disturbed	0	Frequency of use of area	Daily	3
Extent / Amount	10m^2 - 50m^2 or 10m - 50m pipe run	2	Average time area is in use	>6 hours	3
Likelihood of disturbance	*Average Score*	2	***Human exposure potential***	Average Score	3

Normal occupant activity:	***Low disturbance***	1	Material Assessment Score	4
Type of maintenance activity	Minor disturbance	0	Priority Assessment Score (*)	8
Frequency of maintenance activity	>1 per month	3	Total Risk Score (*)	Low Risk (12)
Maintenance activity	*Average Score*	2	Recommendation: Manage & Monitor

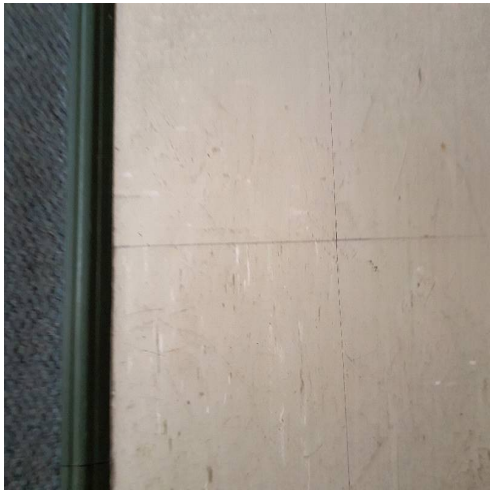
Item Description: Floor tiles - Floor

Comments: ,	Extent: 50m²

Product Type:	Vinyl Tile	1
Extent of Damage:	Good Condition	0
Surface Treatment:		0
Asbestos Type:	SP: Chrysotile	1

Location	Rooms up to 100m^2	2	Number of occupants	4 to 10	2
Accessibility	Occasionally likely to be disturbed	1	Frequency of use of area	Daily	3
Extent / Amount	10m^2 - 50m^2 or 10m - 50m pipe run	2	Average time area is in use	<1 hour	0
Likelihood of disturbance	*Average Score*	2	***Human exposure potential***	Average Score	2

Normal occupant activity:	***Low disturbance***	1	Material Assessment Score	2
Type of maintenance activity	Minor disturbance	0	Priority Assessment Score (*)	7
Frequency of maintenance activity	>1 per month	3	Total Risk Score (*)	Low Risk (9)
Maintenance activity	*Average Score*	2	Recommendation: Manage & Monitor

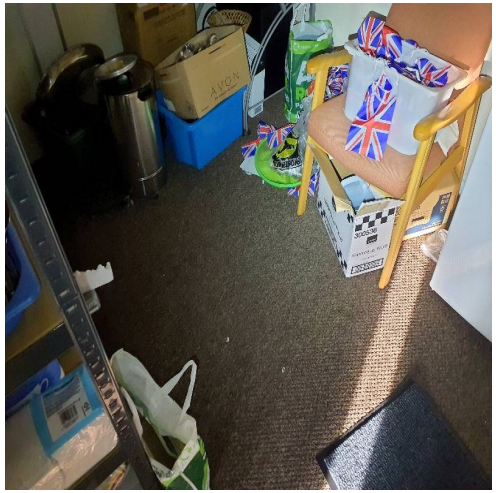
Item No: 11	Sample No: As TB003729 {KO000018} *	Building ID: Alcote House	Location: Cupboard, G/04
	Level of ID: Strongly Presumed

Item Description: Floor tiles - Floor		
Comments: ,		Extent: 8m²
Reinspection State / Register Update: No change		
Product Type:	Vinyl Tile	1
Extent of Damage:	Low Damage	1
Surface Treatment:		0
Asbestos Type:	SP: Chrysotile	1

Location	Confined spaces	3	Number of occupants	4 to 10	2
Accessibility	Usually inaccessible or unlikely to be disturbed	0	Frequency of use of area	Daily	3
Extent / Amount	<10m^2 or <10m pipe run	1	Average time area is in use	1 to 3 hours	1
Likelihood of disturbance	*Average Score*	2	***Human exposure potential***	Average Score	2

Normal occupant activity:	***Low disturbance***	1	Material Assessment Score	3
Type of maintenance activity	Minor disturbance	0	Priority Assessment Score (*)	7
Frequency of maintenance activity	>1 per month	3	Total Risk Score (*)	Low Risk (10)
Maintenance activity	*Average Score*	2	Recommendation: Manage & Monitor

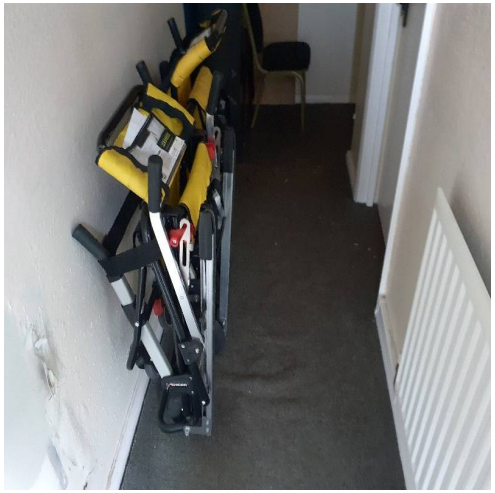
Item Description: Floor tiles - Floor

Comments: ,		Extent: 8m²
Reinspection State / Register Update: No change		
Product Type:	Vinyl Tile	1
Extent of Damage:	Low Damage	1
Surface Treatment:		0
Asbestos Type:	SP: Chrysotile	1

Location	Rooms up to 100m^2	2	Number of occupants	>10	3
Accessibility	Usually inaccessible or unlikely to be disturbed	0	Frequency of use of area	Daily	3
Extent / Amount	10m^2 - 50m^2 or 10m - 50m pipe run	2	Average time area is in use	>6 hours	3
Likelihood of disturbance	*Average Score*	2	***Human exposure potential***	Average Score	3

Normal occupant activity:	***Low disturbance***	1	Material Assessment Score	3
Type of maintenance activity	Minor disturbance	0	Priority Assessment Score (*)	8
Frequency of maintenance activity	>1 per month	3	Total Risk Score (*)	Low Risk (11)
Maintenance activity	*Average Score*	2	Recommendation: Manage & Monitor

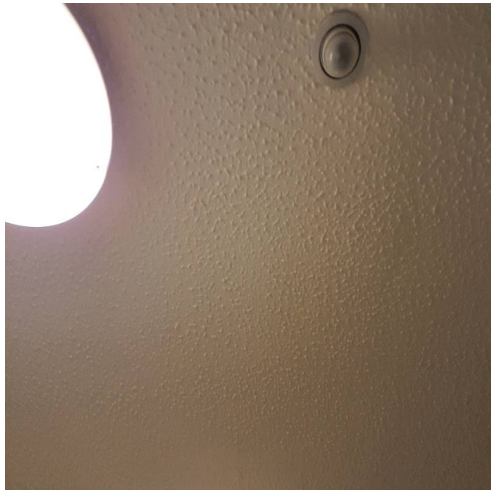
Reinspection State / Register Update: No change

Product Type:	Textured Coating	1
Extent of Damage:	Low Damage	1
Surface Treatment:		1
Asbestos Type:	SP: Chrysotile	1

Location	Rooms up to 100m^2	2	Number of occupants	>10	3
Accessibility	Occasionally likely to be disturbed	1	Frequency of use of area	Daily	3
Extent / Amount	10m^2 - 50m^2 or 10m - 50m pipe run	2	Average time area is in use	>6 hours	3
Likelihood of disturbance	*Average Score*	2	***Human exposure potential***	Average Score	3

Normal occupant activity:	***Low disturbance***	1	Material Assessment Score	4
Type of maintenance activity	Minor disturbance	0	Priority Assessment Score (*)	8
Frequency of maintenance activity	>1 per month	3	Total Risk Score (*)	Low Risk (12)
Maintenance activity	*Average Score*	2	Recommendation: Manage & Monitor

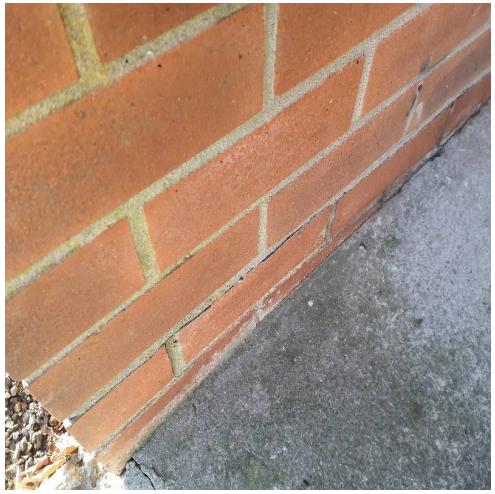
Item No: 1	Sample No: TB003731 {KO000013}*	Building ID: Alcote House	Location: External elements, E/01
	Level of ID: Identified

Item Description: Damp proof course - Wall		
Comments: ,		Extent: 10m²
Reinspection State / Register Update: No change		
Product Type:	Bituminous	1
Extent of Damage:	Good Condition	0
Surface Treatment:		0
Asbestos Type:	Chrysotile	1

Location	External	0	Number of occupants	4 to 10	2
Accessibility	Usually inaccessible or unlikely to be disturbed	0	Frequency of use of area	Daily	3
Extent / Amount	10m^2 - 50m^2 or 10m - 50m pipe run	2	Average time area is in use	>6 hours	3
Likelihood of disturbance	*Average Score*	1	***Human exposure potential***	Average Score	3

Normal occupant activity:	***Periodic disturbance***	2	Material Assessment Score	2
Type of maintenance activity	Minor disturbance	0	Priority Assessment Score (*)	8
Frequency of maintenance activity	>1 per month	3	Total Risk Score (*)	Low Risk (10)
Maintenance activity	*Average Score*	2	Recommendation: Manage & Monitor

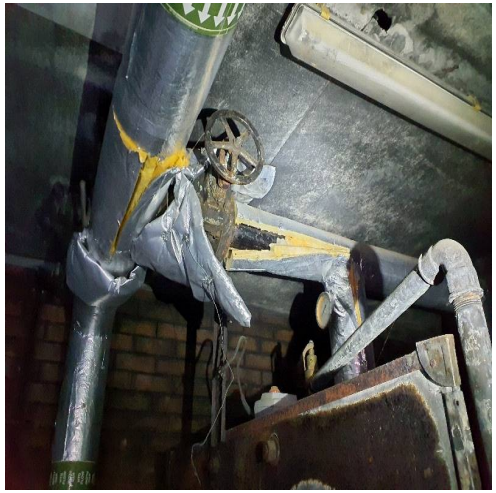
Item No: 3	Sample No: TP003733 {KO000015}*	Building ID: Alcote House	Location: Boiler Room, E/02
	Level of ID: Identified

Item Description: Gasket - Ductwork		
Comments: ,		Extent: 2no.
Reinspection State / Register Update: No change		
Product Type:	Gasket	2
Extent of Damage:	Good Condition	0
Surface Treatment:		1
Asbestos Type:	Chrysotile	1

Location	Rooms up to 100m^2	2	Number of occupants	None	0
Accessibility	Usually inaccessible or unlikely to be disturbed	0	Frequency of use of area	Monthly	1
Extent / Amount	10m^2 - 50m^2 or 10m - 50m pipe run	2	Average time area is in use	<1 hour	0
Likelihood of disturbance	*Average Score*	2	***Human exposure potential***	Average Score	1

Normal occupant activity:	***Rare disturbance***	0	Material Assessment Score	4
Type of maintenance activity	Minor disturbance	0	Priority Assessment Score (*)	5
Frequency of maintenance activity	>1 per month	3	Total Risk Score (*)	Low Risk (9)
Maintenance activity	*Average Score*	2	Recommendation: Manage & Monitor
