Asbestos Reinspection Survey (MA and PA)

Client Details	believe housing, Coast House, Spectrum 4, Spectrum Business Park, Seaham,SR7 7TT
Site Details	Training Facility, 20 Mickle Grove, Leeholme, Bishop Auckland, County Durham, DL14 8XL UPRN: 2CH00625
Date(s) of Surveys	6 Jan 2026
Report Reference Number	J143722
Brief Survey Scope of Works	Re-inspection Survey

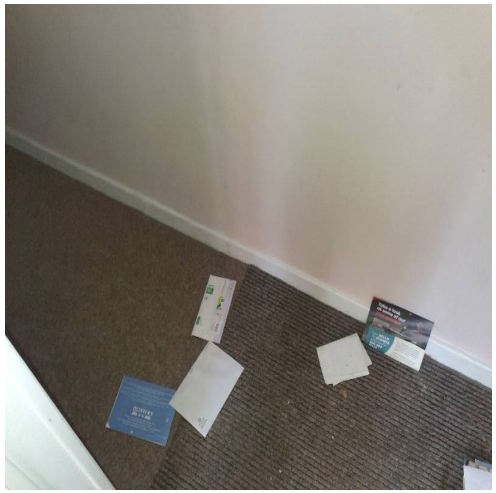
Item No: 1	Sample No: TB004062 {KO000059}*	Building ID: Training Facility 20 Mickle Grove	Location: Entrance front, G/01
	Level of ID: Identified

Item Description: Adhesive - Floor

Extent: 6m²

Reinspection State / Register Update: No change

Product Type:	Adhesive	1
Extent of Damage:	Good Condition	0
Surface Treatment:		0
Asbestos Type:	Chrysotile	1

Normal occupant activity:	***Low disturbance***	1	Material Assessment Score	2
Type of maintenance activity	Minor disturbance	0	Priority Assessment Score (*)	8
Frequency of maintenance activity	>1 per month	3	Total Risk Score (*)	Low Risk (10)
Maintenance activity	*Average Score*	2	Recommendation: Manage & Monitor
