Asbestos Reinspection Survey (MA and PA)

Client Details	believe housing, Coast House, Spectrum 4, Spectrum Business Park, Seaham,SR7 7TT
Site Details	Block 34 - 35 (COMMUNITY CENTRE BELOW) Grey Gardens Coundon Bishop Auckland Co Durham , DL14 8LZ UPRN: 2GREY1_Ext_Com
Date(s) of Surveys	4 Feb 2026
Report Reference Number	J148020
Brief Survey Scope of Works	Re-inspection Survey

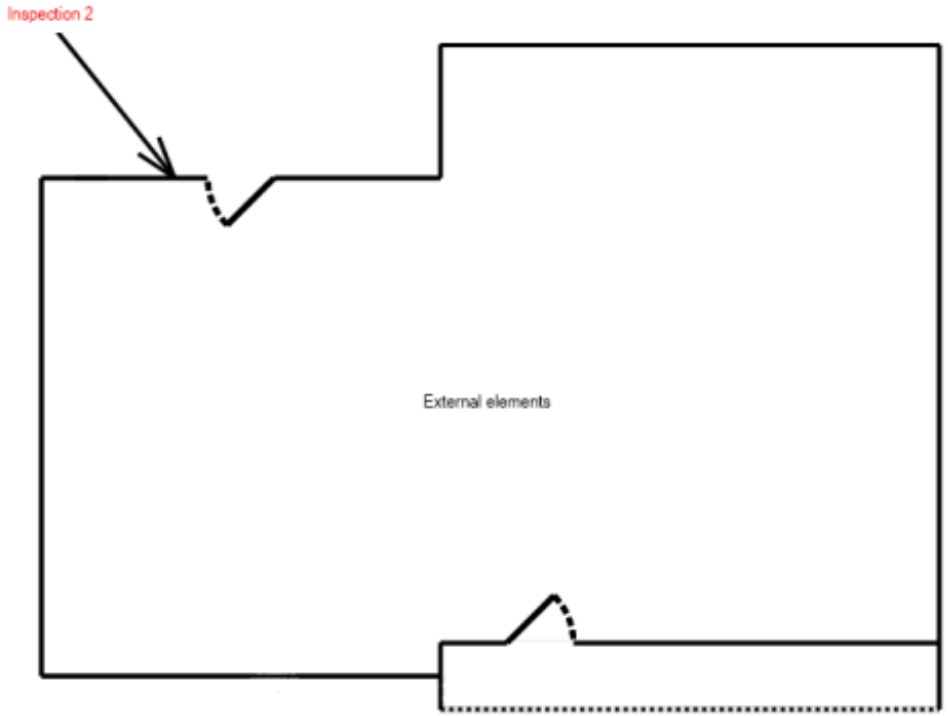
Floor/Level: External

Item No: 2	Sample No: TH002914 {IJ000306}*	Building ID: Block 34 - 35 (COMMUNITY CENTRE BELOW) Grey Gardens	Location: External elements, E/01
	Level of ID: Identified

Item Description: Sealant - Wall

Comments: Residual mastic to window and door reveals,	Extent: 40lm

Reinspection State / Register Update: No change

Normal occupant activity:	***Periodic disturbance***	2	Material Assessment Score	3
Type of maintenance activity	Minor disturbance	0	Priority Assessment Score (*)	8
Frequency of maintenance activity	>1 per month	3	Total Risk Score (*)	Low Risk (11)
Maintenance activity	*Average Score*	2	Recommendation: Manage & Monitor
