Asbestos Reinspection Survey (MA and PA)

Client Details	believe housing, Coast House, Spectrum 4, Spectrum Business Park, Seaham,SR7 7TT
Site Details	B25 Primrose Court (1-25), Blackhall Colliery, Hartlepool, County Durham, TS27 4NX UPRN: 3PRIM1_Ext_Com
Date(s) of Surveys	9 Mar 2026
Report Reference Number	J152242
Brief Survey Scope of Works	Re-inspection survey

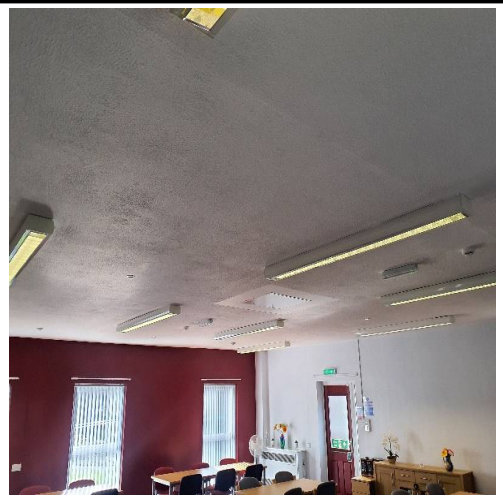
Product Type:	Textured Coating	1
Extent of Damage:	Good Condition	0
Surface Treatment:		0
Asbestos Type:	Chrysotile	1

Location	Rooms up to 100m^2	2	Number of occupants	4 to 10	2
Accessibility	Occasionally likely to be disturbed	1	Frequency of use of area	Daily	3
Extent / Amount	10m^2 - 50m^2 or 10m - 50m pipe run	2	Average time area is in use	<1 hour	0
Likelihood of disturbance	*Average Score*	2	***Human exposure potential***	Average Score	2

Normal occupant activity:	***Low disturbance***	1	Material Assessment Score	2
Type of maintenance activity	Minor disturbance	0	Priority Assessment Score (*)	7
Frequency of maintenance activity	>1 per month	3	Total Risk Score (*)	Low Risk (9)
Maintenance activity	*Average Score*	2	Recommendation: Manage & Monitor

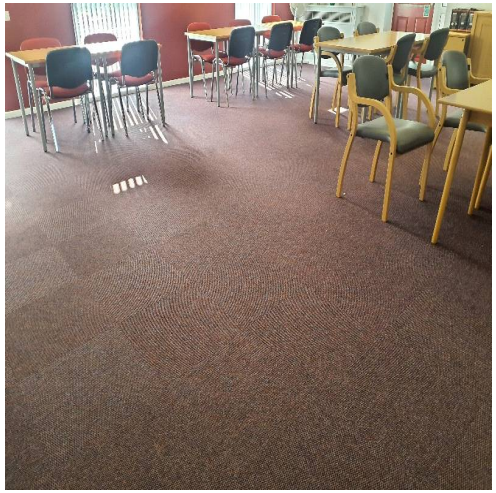
Product Type:	Vinyl Tile & Adhesive	1
Extent of Damage:	Good Condition	0
Surface Treatment:		0
Asbestos Type:	Chrysotile	1

Location	Rooms up to 100m^2	2	Number of occupants	4 to 10	2
Accessibility	Occasionally likely to be disturbed	1	Frequency of use of area	Daily	3
Extent / Amount	10m^2 - 50m^2 or 10m - 50m pipe run	2	Average time area is in use	<1 hour	0
Likelihood of disturbance	*Average Score*	2	***Human exposure potential***	Average Score	2

Normal occupant activity:	***Low disturbance***	1	Material Assessment Score	2
Type of maintenance activity	Minor disturbance	0	Priority Assessment Score (*)	7
Frequency of maintenance activity	>1 per month	3	Total Risk Score (*)	Low Risk (9)
Maintenance activity	*Average Score*	2	Recommendation: Manage & Monitor

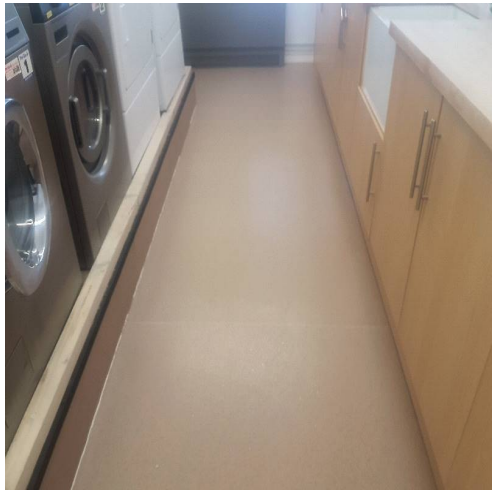
Product Type:	Adhesive	1
Extent of Damage:	Good Condition	0
Surface Treatment:		0
Asbestos Type:	SP: Chrysotile	1

Location	Rooms up to 100m^2	2	Number of occupants	>10	3
Accessibility	Usually inaccessible or unlikely to be disturbed	0	Frequency of use of area	Daily	3
Extent / Amount	10m^2 - 50m^2 or 10m - 50m pipe run	2	Average time area is in use	3 to 6 hours	2
Likelihood of disturbance	*Average Score*	2	***Human exposure potential***	Average Score	3

Normal occupant activity:	***Low disturbance***	1	Material Assessment Score	2
Type of maintenance activity	Minor disturbance	0	Priority Assessment Score (*)	8
Frequency of maintenance activity	>1 per month	3	Total Risk Score (*)	Low Risk (10)
Maintenance activity	*Average Score*	2	Recommendation: Manage & Monitor

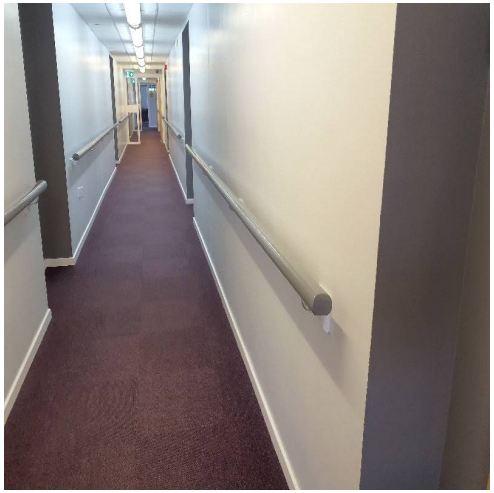
Product Type:	Adhesive	1
Extent of Damage:	Good Condition	0
Surface Treatment:		0
Asbestos Type:	SP: Chrysotile	1

Location	Rooms up to 100m^2	2	Number of occupants	>10	3
Accessibility	Usually inaccessible or unlikely to be disturbed	0	Frequency of use of area	Daily	3
Extent / Amount	10m^2 - 50m^2 or 10m - 50m pipe run	2	Average time area is in use	>6 hours	3
Likelihood of disturbance	*Average Score*	2	***Human exposure potential***	Average Score	3

Normal occupant activity:	***Low disturbance***	1	Material Assessment Score	2
Type of maintenance activity	Minor disturbance	0	Priority Assessment Score (*)	8
Frequency of maintenance activity	>1 per month	3	Total Risk Score (*)	Low Risk (10)
Maintenance activity	*Average Score*	2	Recommendation: Manage & Monitor

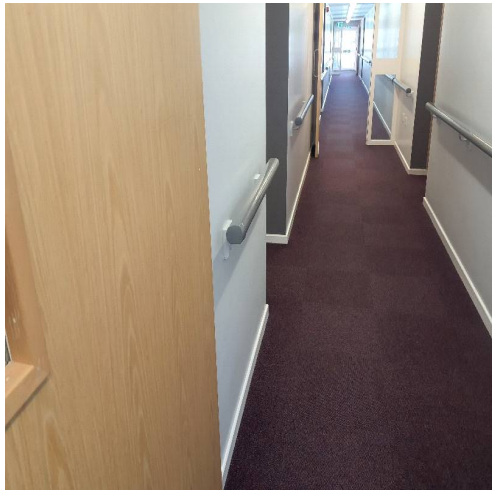
Product Type:	Adhesive	1
Extent of Damage:	Good Condition	0
Surface Treatment:		0
Asbestos Type:	SP: Chrysotile	1

Location	Rooms up to 100m^2	2	Number of occupants	>10	3
Accessibility	Usually inaccessible or unlikely to be disturbed	0	Frequency of use of area	Daily	3
Extent / Amount	10m^2 - 50m^2 or 10m - 50m pipe run	2	Average time area is in use	>6 hours	3
Likelihood of disturbance	*Average Score*	2	***Human exposure potential***	Average Score	3

Normal occupant activity:	***Low disturbance***	1	Material Assessment Score	2
Type of maintenance activity	Minor disturbance	0	Priority Assessment Score (*)	8
Frequency of maintenance activity	>1 per month	3	Total Risk Score (*)	Low Risk (10)
Maintenance activity	*Average Score*	2	Recommendation: Manage & Monitor

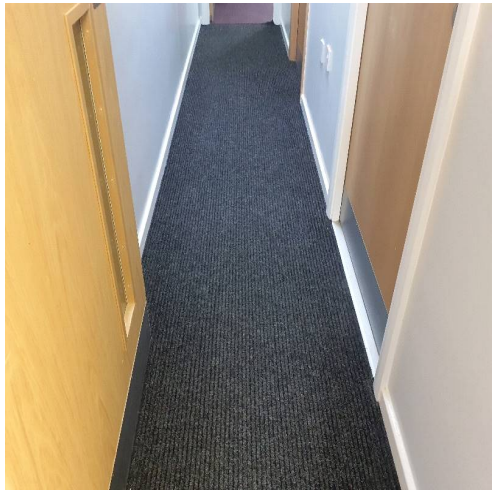
Product Type:	Vinyl Tile & Adhesive	1
Extent of Damage:	Good Condition	0
Surface Treatment:		0
Asbestos Type:	Chrysotile	1

Location	Rooms up to 100m^2	2	Number of occupants	>10	3
Accessibility	Usually inaccessible or unlikely to be disturbed	0	Frequency of use of area	Daily	3
Extent / Amount	10m^2 - 50m^2 or 10m - 50m pipe run	2	Average time area is in use	>6 hours	3
Likelihood of disturbance	*Average Score*	2	***Human exposure potential***	Average Score	3

Normal occupant activity:	***Low disturbance***	1	Material Assessment Score	2
Type of maintenance activity	Minor disturbance	0	Priority Assessment Score (*)	8
Frequency of maintenance activity	>1 per month	3	Total Risk Score (*)	Low Risk (10)
Maintenance activity	*Average Score*	2	Recommendation: Manage & Monitor

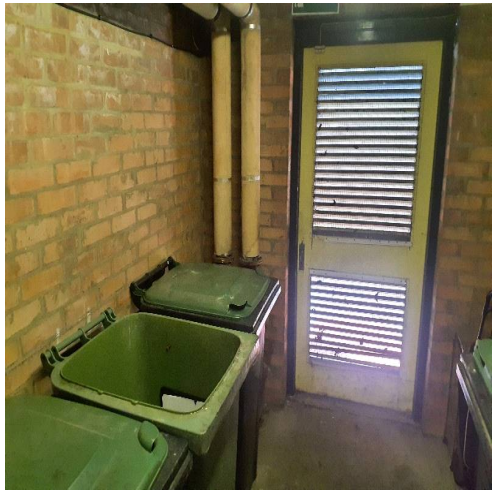
Product Type:	Gasket	2
Extent of Damage:	Good Condition	0
Surface Treatment:		2
Asbestos Type:	Chrysotile	1

Location	Confined spaces	3	Number of occupants	None	0
Accessibility	Usually inaccessible or unlikely to be disturbed	0	Frequency of use of area	Daily	3
Extent / Amount	<10m^2 or <10m pipe run	1	Average time area is in use	<1 hour	0
Likelihood of disturbance	*Average Score*	2	***Human exposure potential***	Average Score	1

Normal occupant activity:	***Periodic disturbance***	2	Material Assessment Score	5
Type of maintenance activity	Minor disturbance	0	Priority Assessment Score (*)	7
Frequency of maintenance activity	>1 per month	3	Total Risk Score (*)	Low Risk (12)
Maintenance activity	*Average Score*	2	Recommendation: Manage & Monitor

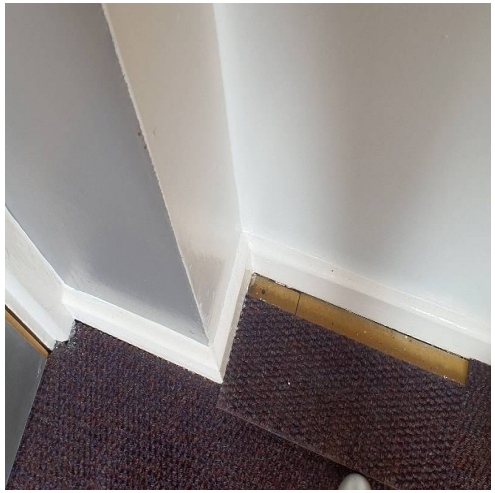
Product Type:	Adhesive	1
Extent of Damage:	Good Condition	0
Surface Treatment:		0
Asbestos Type:	Chrysotile	1

Location	Rooms up to 100m^2	2	Number of occupants	>10	3
Accessibility	Usually inaccessible or unlikely to be disturbed	0	Frequency of use of area	Daily	3
Extent / Amount	10m^2 - 50m^2 or 10m - 50m pipe run	2	Average time area is in use	>6 hours	3
Likelihood of disturbance	*Average Score*	2	***Human exposure potential***	Average Score	3

Normal occupant activity:	***Low disturbance***	1	Material Assessment Score	2
Type of maintenance activity	Minor disturbance	0	Priority Assessment Score (*)	8
Frequency of maintenance activity	>1 per month	3	Total Risk Score (*)	Low Risk (10)
Maintenance activity	*Average Score*	2	Recommendation: Manage & Monitor

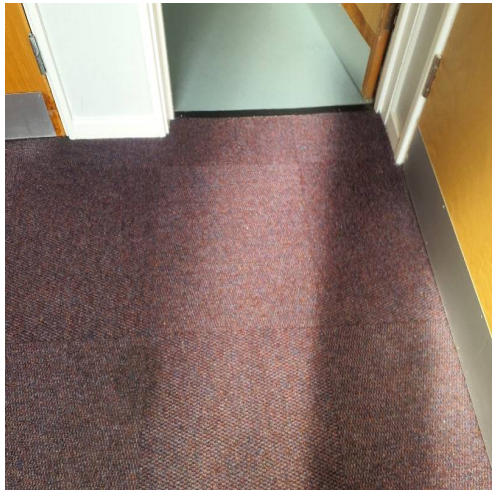
Product Type:	Adhesive	1
Extent of Damage:	Good Condition	0
Surface Treatment:		0
Asbestos Type:	SP: Chrysotile	1

Location	Rooms up to 100m^2	2	Number of occupants	>10	3
Accessibility	Usually inaccessible or unlikely to be disturbed	0	Frequency of use of area	Daily	3
Extent / Amount	10m^2 - 50m^2 or 10m - 50m pipe run	2	Average time area is in use	>6 hours	3
Likelihood of disturbance	*Average Score*	2	***Human exposure potential***	Average Score	3

Normal occupant activity:	***Low disturbance***	1	Material Assessment Score	2
Type of maintenance activity	Minor disturbance	0	Priority Assessment Score (*)	8
Frequency of maintenance activity	>1 per month	3	Total Risk Score (*)	Low Risk (10)
Maintenance activity	*Average Score*	2	Recommendation: Manage & Monitor

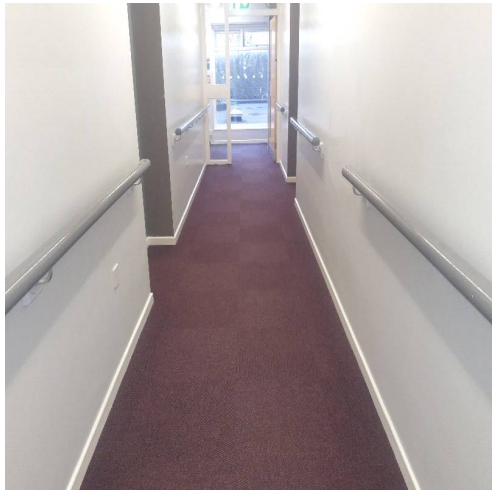
Product Type:	Adhesive	1
Extent of Damage:	Good Condition	0
Surface Treatment:		0
Asbestos Type:	SP: Chrysotile	1

Location	Rooms up to 100m^2	2	Number of occupants	>10	3
Accessibility	Usually inaccessible or unlikely to be disturbed	0	Frequency of use of area	Daily	3
Extent / Amount	10m^2 - 50m^2 or 10m - 50m pipe run	2	Average time area is in use	>6 hours	3
Likelihood of disturbance	*Average Score*	2	***Human exposure potential***	Average Score	3

Normal occupant activity:	***Low disturbance***	1	Material Assessment Score	2
Type of maintenance activity	Minor disturbance	0	Priority Assessment Score (*)	8
Frequency of maintenance activity	>1 per month	3	Total Risk Score (*)	Low Risk (10)
Maintenance activity	*Average Score*	2	Recommendation: Manage & Monitor

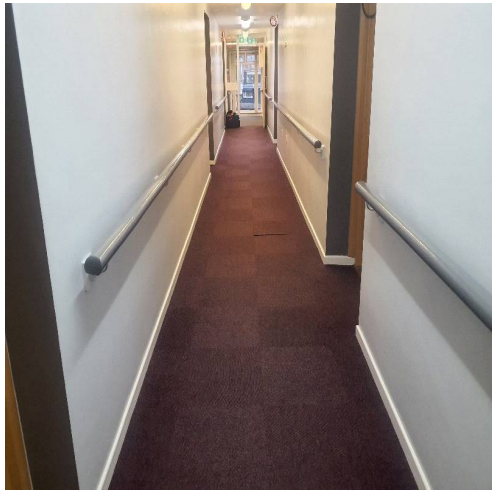
Product Type:	Adhesive	1
Extent of Damage:	Good Condition	0
Surface Treatment:		0
Asbestos Type:	SP: Chrysotile	1

Location	Rooms up to 100m^2	2	Number of occupants	>10	3
Accessibility	Usually inaccessible or unlikely to be disturbed	0	Frequency of use of area	Daily	3
Extent / Amount	10m^2 - 50m^2 or 10m - 50m pipe run	2	Average time area is in use	>6 hours	3
Likelihood of disturbance	*Average Score*	2	***Human exposure potential***	Average Score	3

Normal occupant activity:	***Low disturbance***	1	Material Assessment Score	2
Type of maintenance activity	Minor disturbance	0	Priority Assessment Score (*)	8
Frequency of maintenance activity	>1 per month	3	Total Risk Score (*)	Low Risk (10)
Maintenance activity	*Average Score*	2	Recommendation: Manage & Monitor

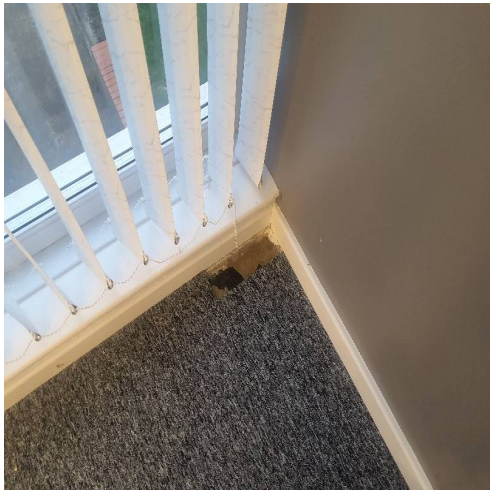
Product Type:	Adhesive	1
Extent of Damage:	Good Condition	0
Surface Treatment:		0
Asbestos Type:	SP: Chrysotile	1

Location	Rooms up to 100m^2	2	Number of occupants	4 to 10	2
Accessibility	Usually inaccessible or unlikely to be disturbed	0	Frequency of use of area	Daily	3
Extent / Amount	10m^2 - 50m^2 or 10m - 50m pipe run	2	Average time area is in use	3 to 6 hours	2
Likelihood of disturbance	*Average Score*	2	***Human exposure potential***	Average Score	3

Normal occupant activity:	***Low disturbance***	1	Material Assessment Score	2
Type of maintenance activity	Minor disturbance	0	Priority Assessment Score (*)	8
Frequency of maintenance activity	>1 per month	3	Total Risk Score (*)	Low Risk (10)
Maintenance activity	*Average Score*	2	Recommendation: Manage & Monitor
