Asbestos Reinspection Survey (MA and PA)

Client Details	believe housing, Coast House, Spectrum 4, Spectrum Business Park, Seaham,SR7 7TT
Site Details	Community Centre, Dovedale Avenue, Sunnybrow, Crook, County Durham, DL15 0XD UPRN: 2CH00620
Date(s) of Surveys	18 Mar 2026
Report Reference Number	J152957
Brief Survey Scope of Works	Re-inspection Survey

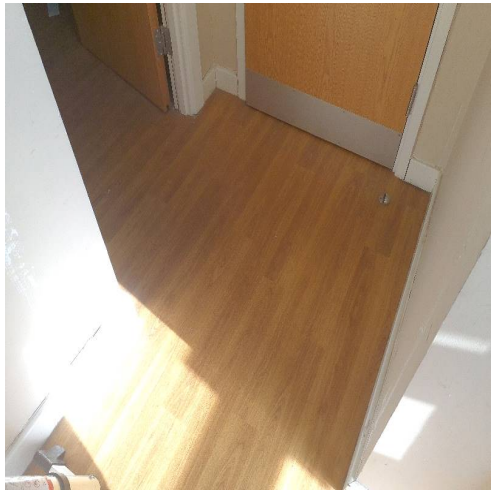
Item No: 11	Sample No: MI001255*	Building ID: Community Centre, Dovedale Avenue	Location: Hall, G/01
	Level of ID: Identified

Item Description: Adhesive - Floor Beneath Screed

Comments: Below modern vinyl covering and screed., Extent: 5m²

Reinspection State / Register Update: No change

Product Type:	Bituminous	1
Extent of Damage:	Low Damage	1
Surface Treatment:		0
Asbestos Type:	Chrysotile	1

Normal occupant activity:	***Low disturbance***	1	Material Assessment Score	3
Type of maintenance activity	Minor disturbance	0	Priority Assessment Score (*)	8
Frequency of maintenance activity	>1 per month	3	Total Risk Score (*)	Low Risk (11)
Maintenance activity	*Average Score*	2	Recommendation: Manage & Monitor

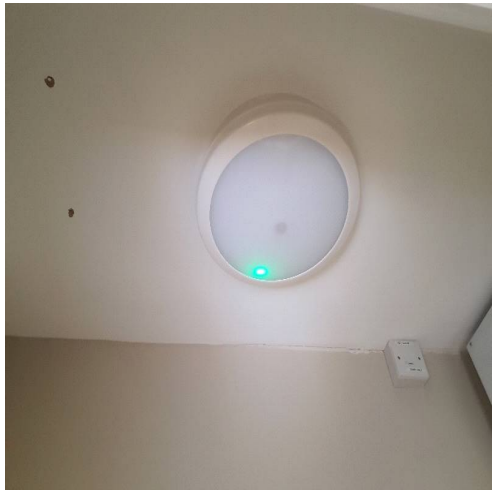
Item No: 5	Sample No: As TB011290 {IJ000875}*	Building ID: Community Centre, Dovedale Avenue	Location: Cupboard, G/02
	Level of ID: Strongly Presumed

Item Description: Decorative coating - Ceiling

Comments: Above plaster skim.,	Extent: 0.75m²

Reinspection State / Register Update: No change

Product Type:	Textured Coating	1
Extent of Damage:	Good Condition	0
Surface Treatment:		1
Asbestos Type:	SP: Chrysotile	1

Normal occupant activity:	***Low disturbance***	1	Material Assessment Score	3
Type of maintenance activity	Minor disturbance	0	Priority Assessment Score (*)	7
Frequency of maintenance activity	>1 per month	3	Total Risk Score (*)	Low Risk (10)
Maintenance activity	*Average Score*	2	Recommendation: Manage & Monitor

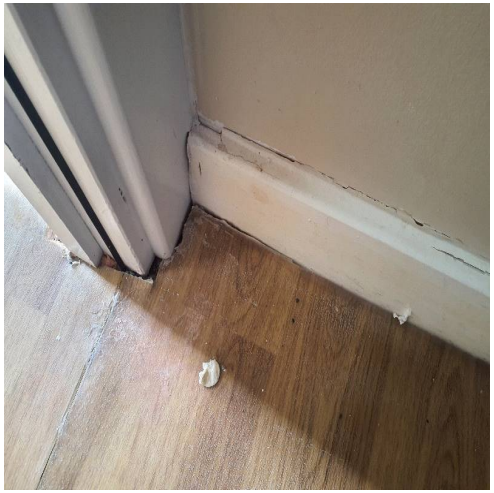
Item No: 16	Sample No: As MI001255*	Building ID: Community Centre, Dovedale Avenue	Location: Cupboard, G/02
	Level of ID: Strongly Presumed

Item Description: Adhesive - Floor Beneath Screed

Comments: Below modern vinyl covering and screed., Extent: 4m²

Reinspection State / Register Update: No change

Product Type:	Bituminous	1
Extent of Damage:	Low Damage	1
Surface Treatment:		0
Asbestos Type:	SP: Chrysotile	1

Normal occupant activity:	***Low disturbance***	1	Material Assessment Score	3
Type of maintenance activity	Minor disturbance	0	Priority Assessment Score (*)	7
Frequency of maintenance activity	>1 per month	3	Total Risk Score (*)	Low Risk (10)
Maintenance activity	*Average Score*	2	Recommendation: Manage & Monitor

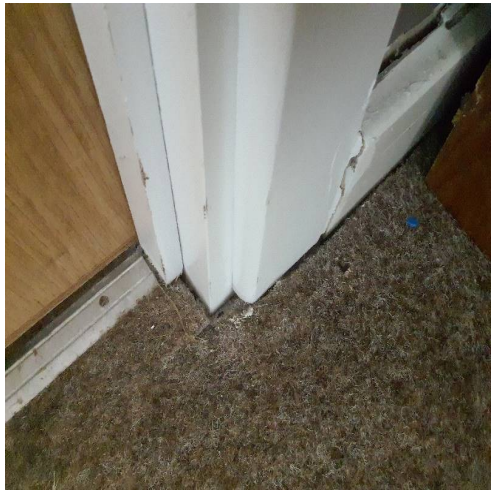
Item No: 13	Sample No: MI001256*	Building ID: Community Centre, Dovedale Avenue	Location: Lounge, G/03
	Level of ID: Identified

Item Description: Adhesive - Floor Beneath Screed

Extent: 16m²

Reinspection State / Register Update: No change

Product Type:	Bituminous	1
Extent of Damage:	Low Damage	1
Surface Treatment:		0
Asbestos Type:	Chrysotile	1

Normal occupant activity:	***Low disturbance***	1	Material Assessment Score	3
Type of maintenance activity	Minor disturbance	0	Priority Assessment Score (*)	8
Frequency of maintenance activity	>1 per month	3	Total Risk Score (*)	Low Risk (11)
Maintenance activity	*Average Score*	2	Recommendation: Manage & Monitor

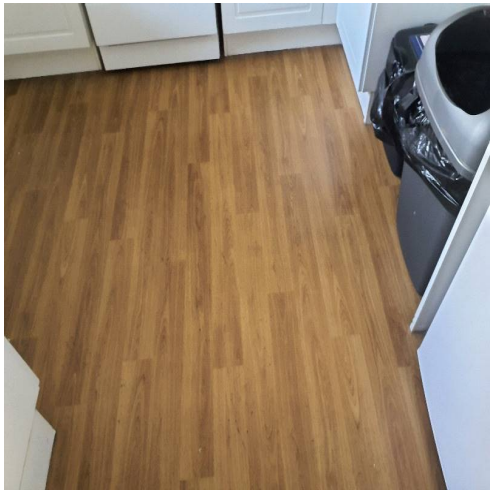
Item No: 12	Sample No: As MI001255*	Building ID: Community Centre, Dovedale Avenue	Location: Kitchen, G/04
	Level of ID: Strongly Presumed

Item Description: Adhesive - Floor Beneath Screed

Comments: Below modern vinyl covering and screed., Extent: 4m²

Reinspection State / Register Update: No change

Product Type:	Bituminous	1
Extent of Damage:	Low Damage	1
Surface Treatment:		0
Asbestos Type:	SP: Chrysotile	1

Normal occupant activity:	***Low disturbance***	1	Material Assessment Score	3
Type of maintenance activity	Minor disturbance	0	Priority Assessment Score (*)	8
Frequency of maintenance activity	>1 per month	3	Total Risk Score (*)	Low Risk (11)
Maintenance activity	*Average Score*	2	Recommendation: Manage & Monitor

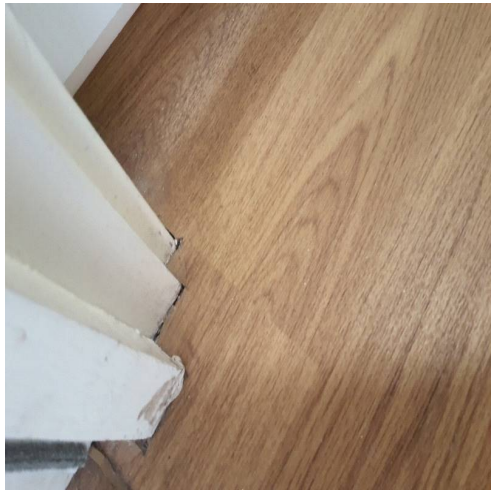
Item No: 15	Sample No: As MI001255*	Building ID: Community Centre, Dovedale Avenue	Location: W/C, G/06
	Level of ID: Strongly Presumed

Item Description: Adhesive - Floor Beneath Screed

Comments: Below modern vinyl covering and screed.,	Extent: 1m²

Reinspection State / Register Update: No change

Product Type:	Bituminous	1
Extent of Damage:	Low Damage	1
Surface Treatment:		0
Asbestos Type:	SP: Chrysotile	1

Normal occupant activity:	***Low disturbance***	1	Material Assessment Score	3
Type of maintenance activity	Minor disturbance	0	Priority Assessment Score (*)	8
Frequency of maintenance activity	>1 per month	3	Total Risk Score (*)	Low Risk (11)
Maintenance activity	*Average Score*	2	Recommendation: Manage & Monitor

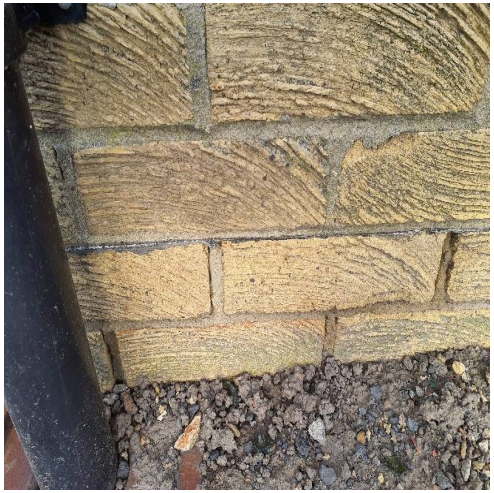
Reinspection State / Register Update: No change

Product Type:	Bituminous	1
Extent of Damage:	Low Damage	1
Surface Treatment:		0
Asbestos Type:	Chrysotile	1

Normal occupant activity:	***Periodic disturbance***	2	Material Assessment Score	3
Type of maintenance activity	Minor disturbance	0	Priority Assessment Score (*)	8
Frequency of maintenance activity	>1 per month	3	Total Risk Score (*)	Low Risk (11)
Maintenance activity	*Average Score*	2	Recommendation: Manage & Monitor

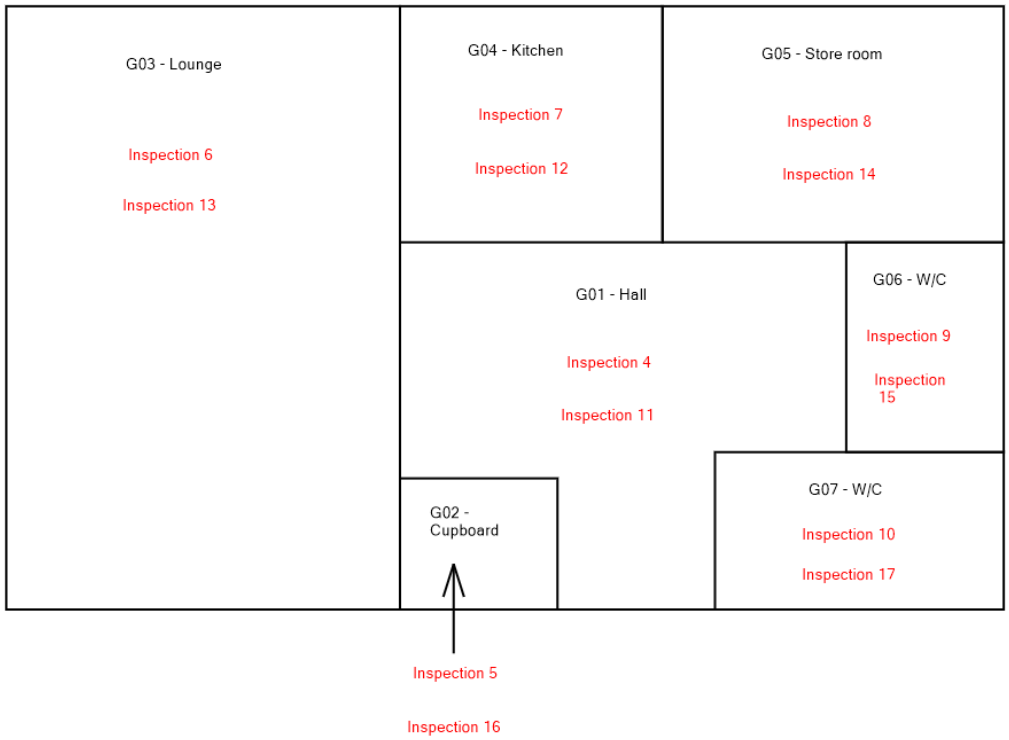
Item no:	Sample Ref:	Item Description:	Extent	Product Type	Condition	Surface Treatment	Asbestos Type	Material Score	Priority Risk Score, (Total score) (*)	Photo
1	TB005868 {IJ000872}*	Damp proof course - Wall	30lm	1	1	0	1	3	8 (11)
