Asbestos Reinspection Survey (MA and PA)

Client Details	believe housing, Coast House, Spectrum 4, Spectrum Business Park, Seaham,SR7 7TT
Site Details	Fairclough Court Community Centre, Peterlee, County Durham, SR8 2NB UPRN: 3CH00810
Date(s) of Surveys	14 Apr 2026
Report Reference Number	J155544
Brief Survey Scope of Works	Re-inspection Survey

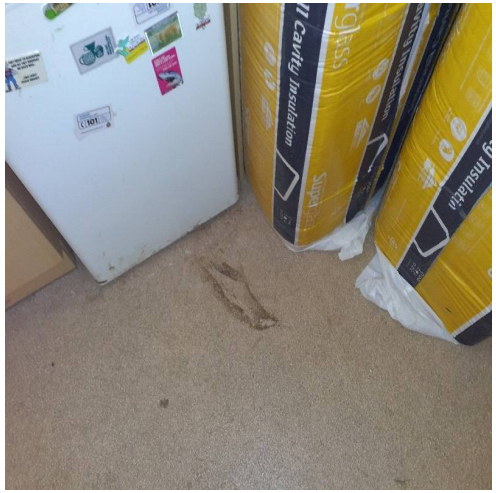
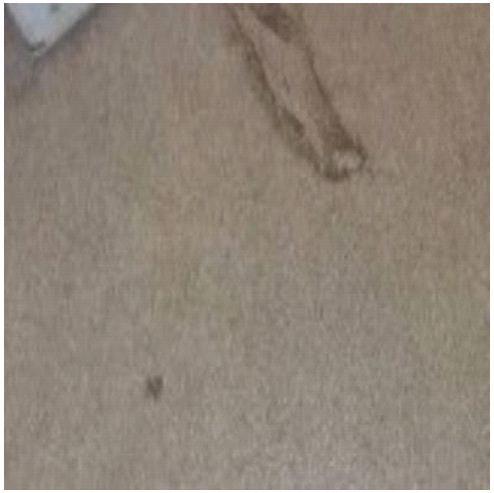
Item No: 5	Sample No: As TH002327 {KO000027} *	Building ID: Fairclough Court Community Centre	Location: Kitchen, G/02
	Level of ID: Strongly Presumed

Item Description: Adhesive - Floor

Comments: Below fixed modern vinyl.,

Extent: 8m²

Reinspection State / Register Update: No change

Product Type:	Bituminous	1
Extent of Damage:	Good Condition	0
Surface Treatment:		0
Asbestos Type:	SP: Chrysotile	1

Normal occupant activity:	***Low disturbance***	1	Material Assessment Score	2
Type of maintenance activity	Minor disturbance	0	Priority Assessment Score (*)	8
Frequency of maintenance activity	>1 per month	3	Total Risk Score (*)	Low Risk (10)
Maintenance activity	*Average Score*	2	Recommendation: Manage & Monitor

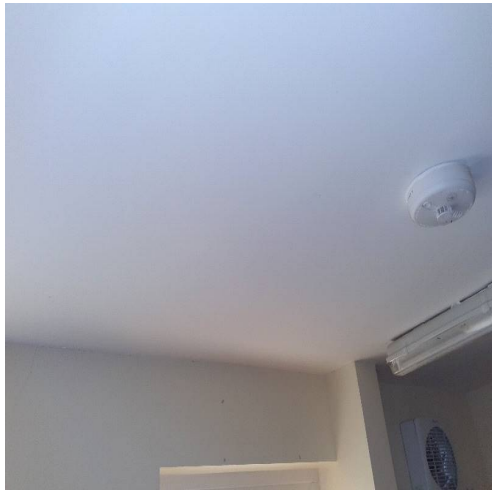
Item No: 6	Sample No: As TH002328 {KO000028} *	Building ID: Fairclough Court Community Centre	Location: Kitchen, G/02
	Level of ID: Strongly Presumed

Item Description: Decorative coating - Ceiling

Comments: Presume to be above plasterboard ceiling.,	Extent: 8m²

Reinspection State / Register Update: No change

Product Type:	Textured Coating	1
Extent of Damage:	Good Condition	0
Surface Treatment:		1
Asbestos Type:	SP: Chrysotile	1

Normal occupant activity:	***Low disturbance***	1	Material Assessment Score	3
Type of maintenance activity	Minor disturbance	0	Priority Assessment Score (*)	8
Frequency of maintenance activity	>1 per month	3	Total Risk Score (*)	Low Risk (11)
Maintenance activity	*Average Score*	2	Recommendation: Manage & Monitor

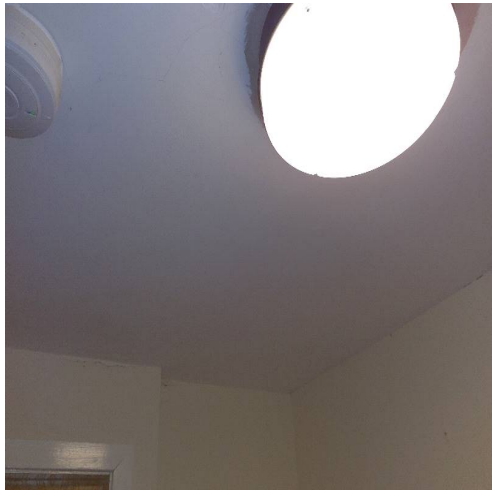
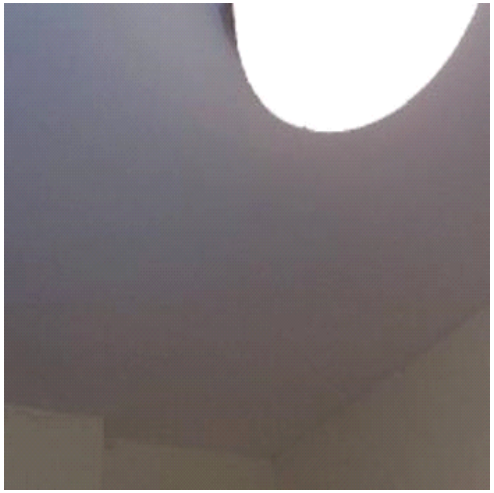
Reinspection State / Register Update: No change

Product Type:	Textured Coating	1
Extent of Damage:	Good Condition	0
Surface Treatment:		1
Asbestos Type:	SP: Chrysotile	1

Normal occupant activity:	***Low disturbance***	1	Material Assessment Score	3
Type of maintenance activity	Minor disturbance	0	Priority Assessment Score (*)	8
Frequency of maintenance activity	>1 per month	3	Total Risk Score (*)	Low Risk (11)
Maintenance activity	*Average Score*	2	Recommendation: Manage & Monitor

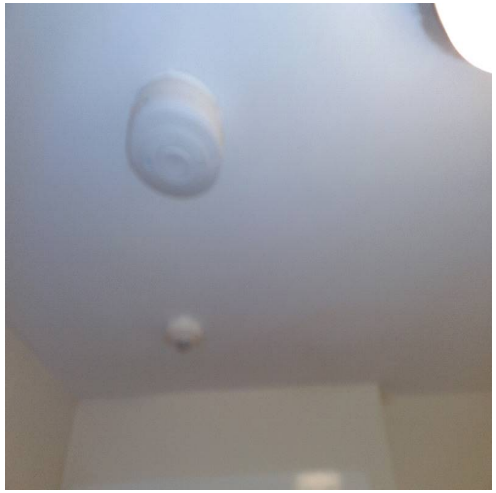
Reinspection State / Register Update: No change

Product Type:	Insulating Board	2
Extent of Damage:	Good Condition	0
Surface Treatment:		1
Asbestos Type:	P: Crocidolite (or unknown)	3

Normal occupant activity:	***Low disturbance***	1	Material Assessment Score	6
Type of maintenance activity	Minor disturbance	0	Priority Assessment Score (*)	8
Frequency of maintenance activity	>1 per month	3	Total Risk Score (*)	Medium Risk (14)
Maintenance activity	*Average Score*	2	Recommendation: Manage & Monitor

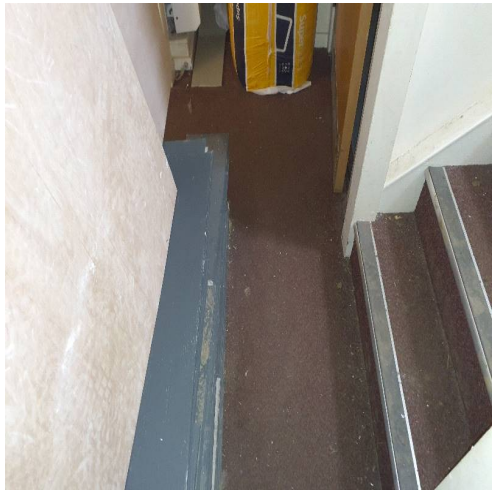
Reinspection State / Register Update: No change

Product Type:	Bituminous	1
Extent of Damage:	Good Condition	0
Surface Treatment:		0
Asbestos Type:	SP: Chrysotile	1

Normal occupant activity:	***Low disturbance***	1	Material Assessment Score	2
Type of maintenance activity	Minor disturbance	0	Priority Assessment Score (*)	8
Frequency of maintenance activity	>1 per month	3	Total Risk Score (*)	Low Risk (10)
Maintenance activity	*Average Score*	2	Recommendation: Manage & Monitor

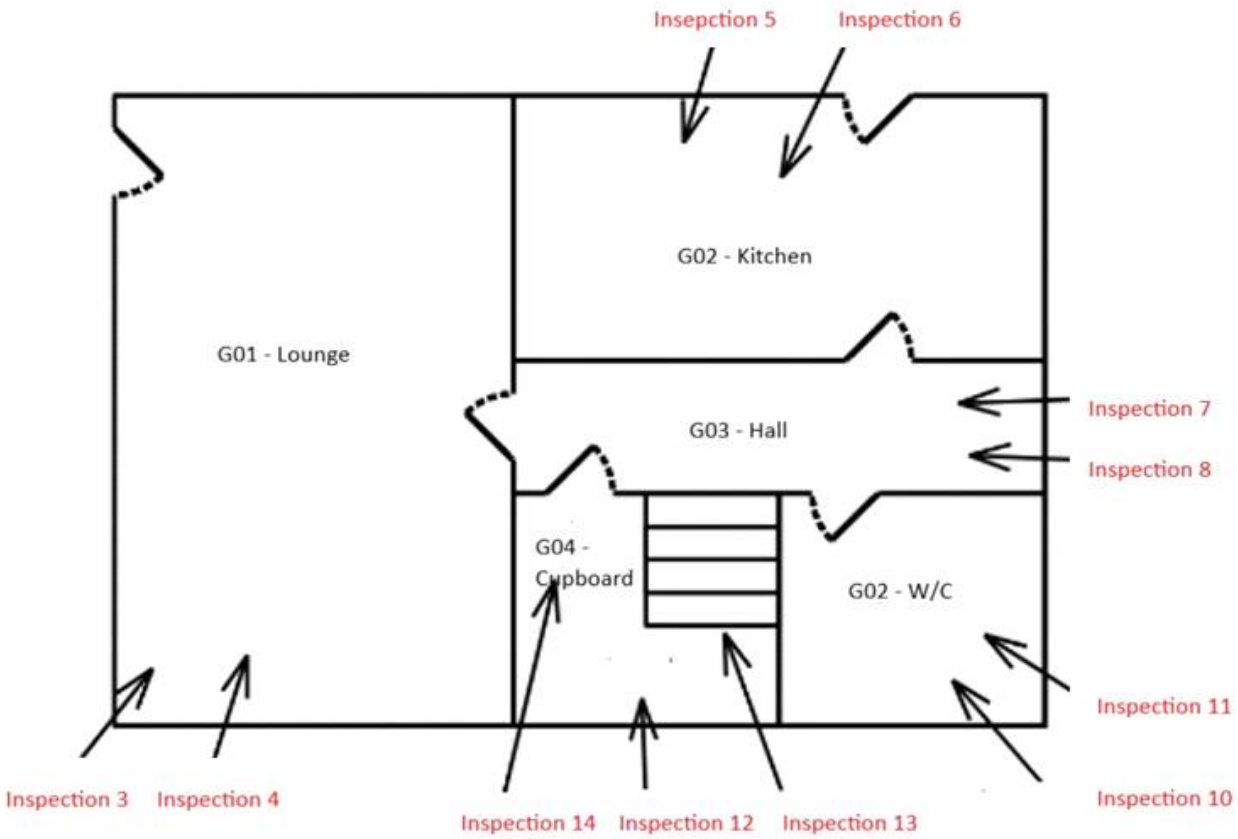
Floor/Level: Ground Floor	Job Ref No: J155544	Client Name: believe housing
Building Designation: Fairclough Court Community Centre / Communal Areas		
Date of Survey: 14 Apr 2026	Surveyed By: Liam White
