# Asbestos Reinspection Survey (MA and PA)

| Site Details | B14 JUBILEE CENTRE (1 - 14) CHARLES STREET SEAHAM, SR7 7SG<br>UPRN: 3CHAR1_Ext_Com |
| Report Reference Number | J161168 |

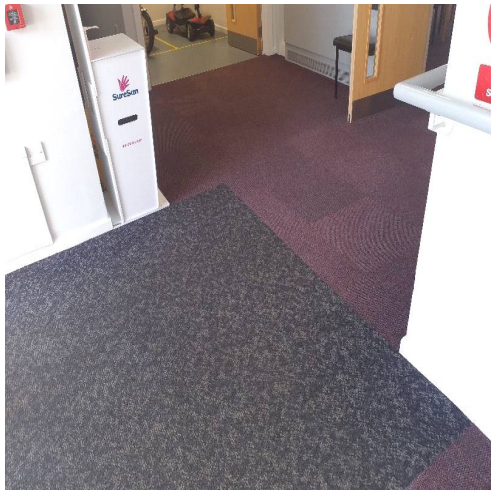
| Item No: 5 | Sample No: 1 TB003989 {IJ001237}* | Building ID: B14 JUBILEE CENTRE (1 - 14) | Location: Entrance front, G/01 |

Item Description: Adhesive - Floor Beneath Screed

Extent: 16m²

Reinspection State / Register Update: No change

| Extent of Damage: | Low Damage | 1 |

| ***Maintenance activity*** | *Average Score* | 2 | Recommendation: Manage & Monitor | |

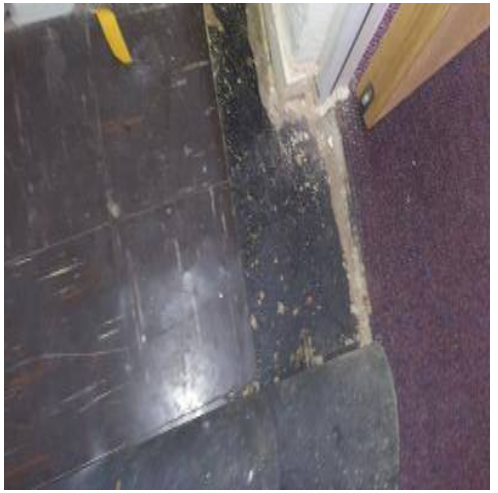
| Item No: | Sample No: As 1 TB003989 {IJ001237} * | Building ID: B14 JUBILEE CENTRE (1 - 14) | Location: Electric meter cupboard, G/11 |

Item Description: Adhesive - Floor

| Comments: , | Extent: 0.5m² |

Reinspection State / Register Update: No change

| Extent of Damage: | Low Damage | 1 |

| ***Normal occupant activity:*** | ***Periodic disturbance*** | 2 | Material Assessment Score | 3 |
|---|---|---|---|---|
| ***Maintenance activity*** | *Average Score* | 2 | Recommendation: Manage & Monitor | |

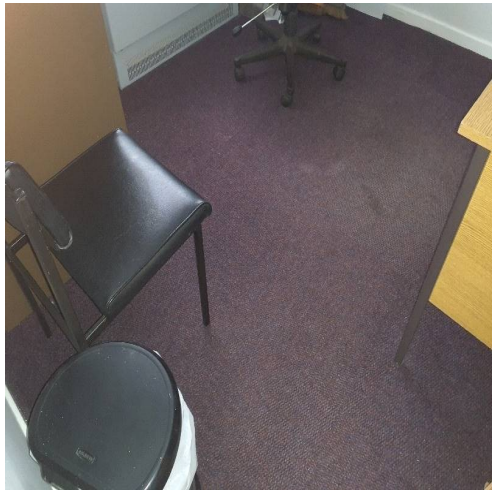
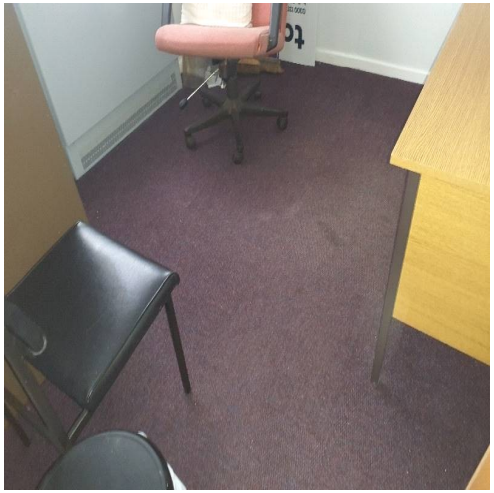
| Item No: 6 | Sample No: As 1 TB003989 {IJ001237} * | Building ID: B14 JUBILEE CENTRE (1 - 14) | Location: Office, G/02 |

Item Description: Adhesive - Floor Beneath Screed

| Comments: , | Extent: 6m² |
| Reinspection State / Register Update: No change | |

| Extent of Damage: | Low Damage | 1 |

| ***Normal occupant activity:*** | ***Low disturbance*** | 1 | Material Assessment Score | 3 |
|---|---|---|---|---|
| ***Maintenance activity*** | *Average Score* | 2 | Recommendation: Manage & Monitor | |

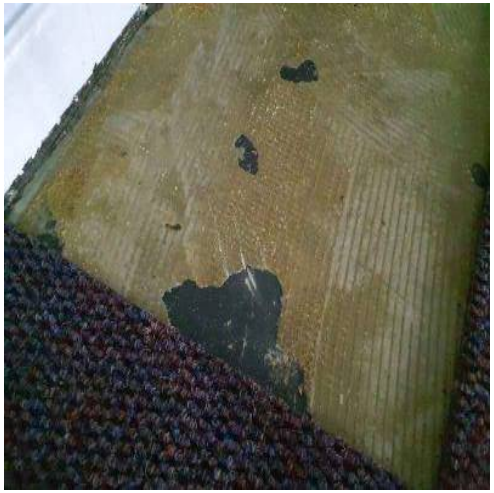
| Asbestos Type: | Chrysotile | 1 |

| Location | Rooms up to 100m^2 | 2 | Number of occupants | 4 to 10 | 2 |
| Accessibility | Usually inaccessible or unlikely to be disturbed | 0 | Frequency of use of area | Daily | 3 |

| ***Normal occupant activity:*** | ***Low disturbance*** | 1 | Material Assessment Score | 3 |
|---|---|---|---|---|
| ***Maintenance activity*** | *Average Score* | 2 | Recommendation: Manage & Monitor | |

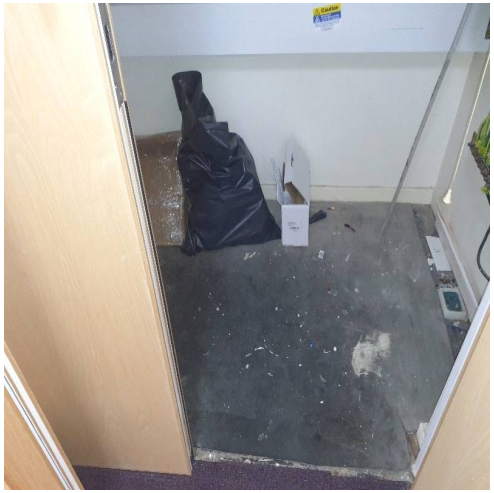
| Extent of Damage: | Low Damage | 1 |
| Asbestos Type: | Chrysotile | 1 |

| Location | Confined spaces | 3 | Number of occupants | None | 0 |
| Accessibility | Occasionally likely to be disturbed | 1 | Frequency of use of area | Infrequent | 0 |

| ***Normal occupant activity:*** | ***Periodic disturbance*** | 2 | Material Assessment Score | 3 |
|---|---|---|---|---|
| ***Maintenance activity*** | *Average Score* | 2 | Recommendation: Manage & Monitor | |

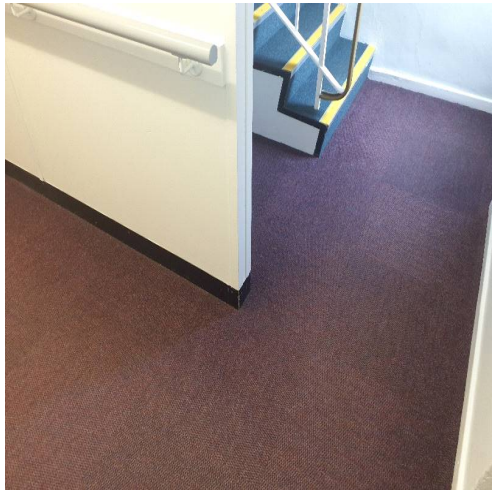
| Extent of Damage: | Low Damage | 1 |
| Asbestos Type: | SP: Chrysotile | 1 |

| Location | Confined spaces | 3 | Number of occupants | >10 | 3 |
| Accessibility | Usually inaccessible or unlikely to be disturbed | 0 | Frequency of use of area | Daily | 3 |

| ***Normal occupant activity:*** | ***Low disturbance*** | 1 | Material Assessment Score | 3 |
|---|---|---|---|---|
| ***Maintenance activity*** | *Average Score* | 2 | Recommendation: Manage & Monitor | |

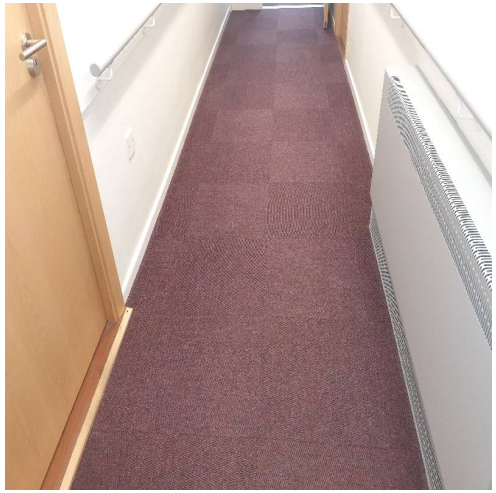
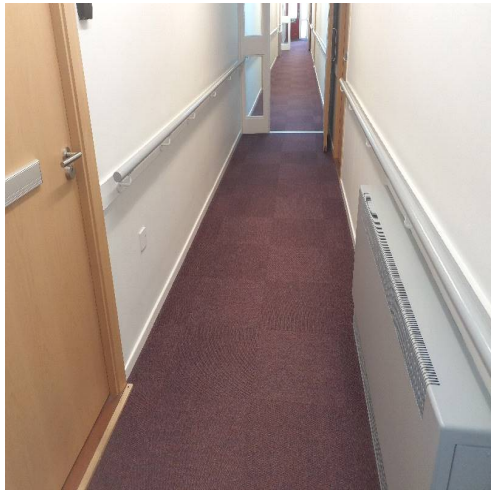
| Extent of Damage: | Low Damage | 1 |
| Asbestos Type: | SP: Chrysotile | 1 |

| Location | Rooms up to 100m^2 | 2 | Number of occupants | >10 | 3 |
| Accessibility | Usually inaccessible or unlikely to be disturbed | 0 | Frequency of use of area | Daily | 3 |

| ***Normal occupant activity:*** | ***Low disturbance*** | 1 | Material Assessment Score | 3 |
|---|---|---|---|---|
| ***Maintenance activity*** | *Average Score* | 2 | Recommendation: Manage & Monitor | |

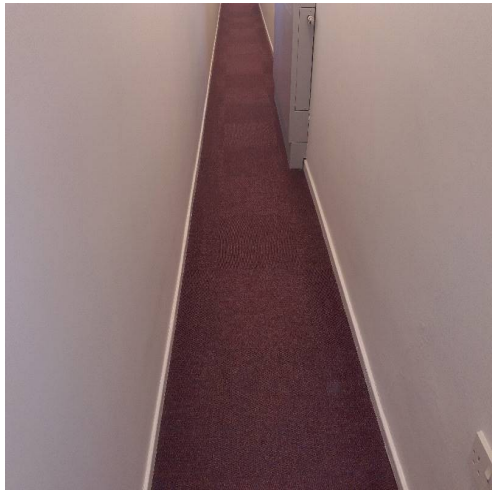
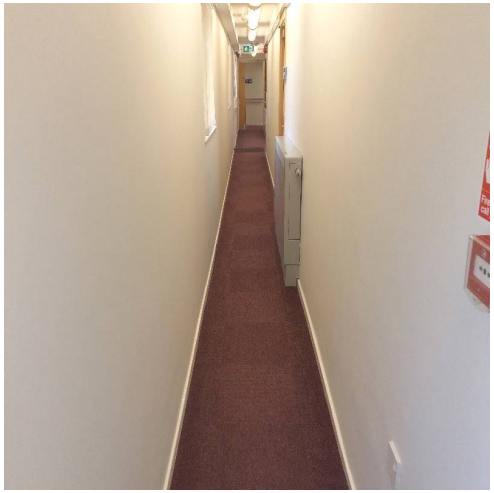
| Extent of Damage: | Low Damage | 1 |
| Asbestos Type: | SP: Chrysotile | 1 |

| Location | Rooms up to 100m^2 | 2 | Number of occupants | >10 | 3 |
| Accessibility | Usually inaccessible or unlikely to be disturbed | 0 | Frequency of use of area | Daily | 3 |

| ***Normal occupant activity:*** | ***Low disturbance*** | 1 | Material Assessment Score | 3 |
|---|---|---|---|---|
| ***Maintenance activity*** | *Average Score* | 2 | Recommendation: Manage & Monitor | |

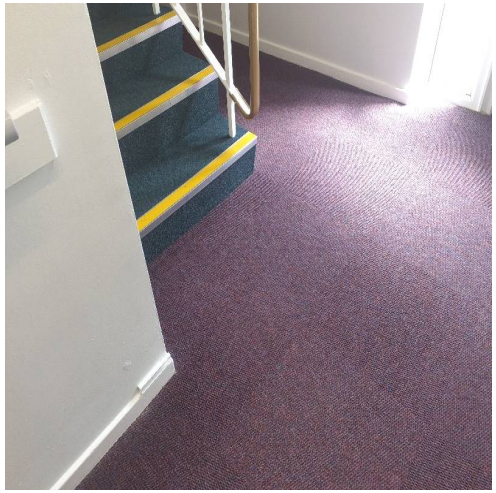
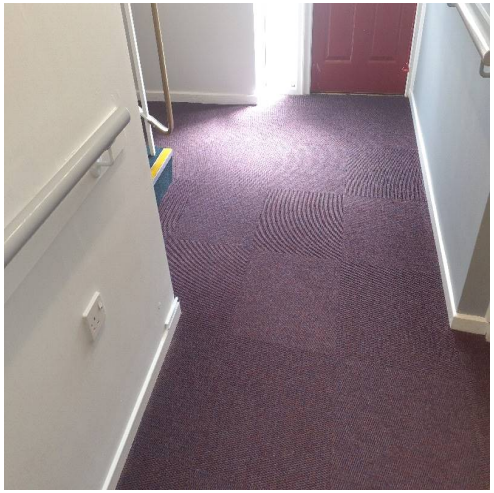
| Extent of Damage: | Low Damage | 1 |
| Asbestos Type: | SP: Chrysotile | 1 |

| Location | Confined spaces | 3 | Number of occupants | >10 | 3 |
| Accessibility | Usually inaccessible or unlikely to be disturbed | 0 | Frequency of use of area | Daily | 3 |

| ***Normal occupant activity:*** | ***Low disturbance*** | 1 | Material Assessment Score | 3 |
|---|---|---|---|---|
| ***Maintenance activity*** | *Average Score* | 2 | Recommendation: Manage & Monitor | |

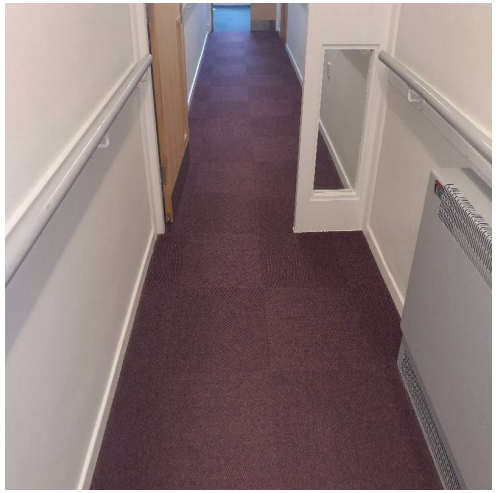
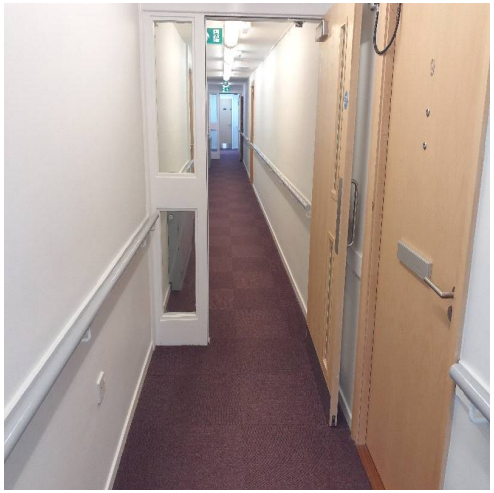
| Extent of Damage: | Low Damage | 1 |
| Asbestos Type: | SP: Chrysotile | 1 |

| Location | Rooms up to 100m^2 | 2 | Number of occupants | >10 | 3 |
| Accessibility | Usually inaccessible or unlikely to be disturbed | 0 | Frequency of use of area | Daily | 3 |

| ***Normal occupant activity:*** | ***Low disturbance*** | 1 | Material Assessment Score | 3 |
|---|---|---|---|---|
| ***Maintenance activity*** | *Average Score* | 2 | Recommendation: Manage & Monitor | |

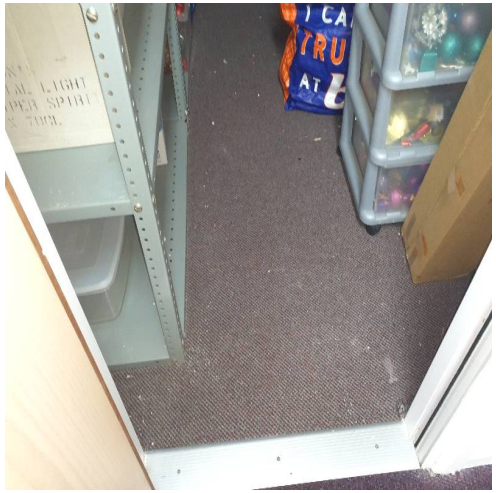
| Item No: | Sample No: As 1 TB003989 {IJ001237} * | Building ID: B14 JUBILEE CENTRE (1 - 14) | Location: Store room, 1/02 |
|---|---|---|---|
| 18 | Level of ID: Strongly Presumed | | |

Item Description: Adhesive - Floor Beneath Screed

| Comments: , | Extent: 3m² |
| Reinspection State / Register Update: No change | |

| Extent of Damage: | Low Damage | 1 |

| ***Maintenance activity*** | *Average Score* | 2 | Recommendation: Manage & Monitor | |

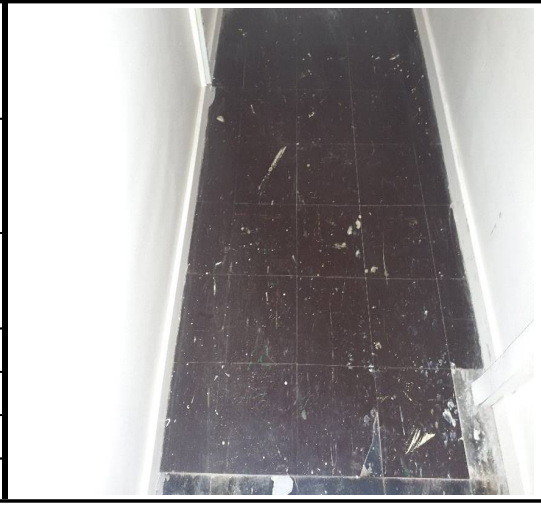
| Item No: | Sample No: As 1 TB003989 {IJ001237} * | Building ID: B14 JUBILEE CENTRE (1 - 14) | Location: Store room, 1/03 |
|---|---|---|---|
| 19 | Level of ID: Strongly Presumed | | |

Item Description: Floor tiles - Floor

| Comments: , | Extent: 2m² |
| Reinspection State / Register Update: No change | |

| Extent of Damage: | Low Damage | 1 |

| ***Maintenance activity*** | *Average Score* | 2 | Recommendation: Manage & Monitor | |

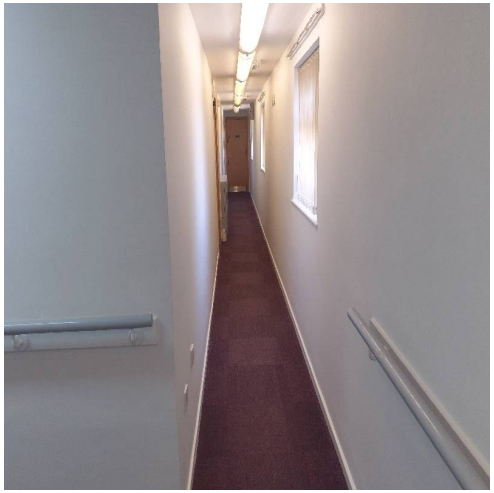
| Item No: | Sample No: As 1 TB003989 {IJ001237} * | Building ID: B14 JUBILEE CENTRE (1 - 14) | Location: Corridor, 1/04 |
|---|---|---|---|
| 20 | Level of ID: Strongly Presumed | | |

Item Description: Adhesive - Floor Beneath Screed

| Comments: Beneath screed Flats 13&14, | Extent: 20m² |
| Reinspection State / Register Update: No change | |

| Extent of Damage: | Low Damage | 1 |

| ***Maintenance activity*** | *Average Score* | 2 | Recommendation: Manage & Monitor | |

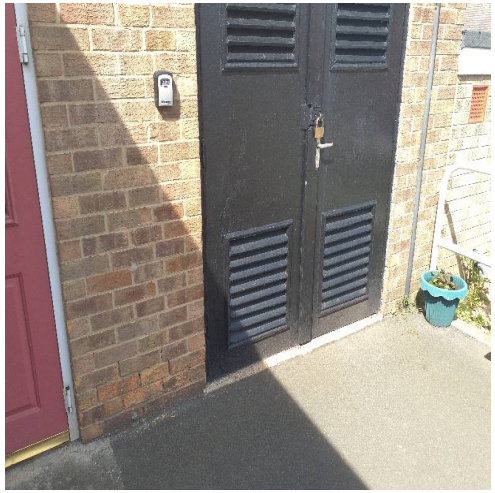
| Extent of Damage: | Low Damage | 1 |
| Asbestos Type: | SP: Chrysotile | 1 |

| Location | Rooms up to 100m^2 | 2 | Number of occupants | None | 0 |
| Accessibility | Usually inaccessible or unlikely to be disturbed | 0 | Frequency of use of area | Monthly | 1 |

| ***Normal occupant activity:*** | ***Rare disturbance*** | 0 | Material Assessment Score | 3 |
|---|---|---|---|---|
| ***Maintenance activity*** | *Average Score* | 2 | Recommendation: Manage & Monitor | |
