# Asbestos Reinspection Survey (MA and PA)

| Site Details | Attlee Square Community Hub, Sherburn Village,<br>Durham, County Durham, DH6 1JN<br>UPRN: 1CH00007 |
| Date(s) of Surveys | 14 Feb 2024 |
| Report Reference Number | J084475 |

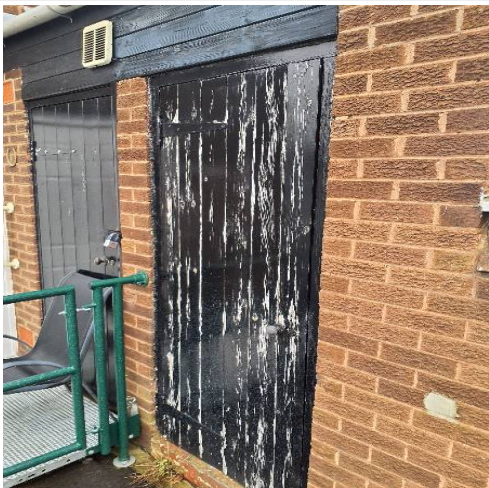
| Item No:<br>3 | Sample No: TB003649 {KO000004}*<br>Level of ID: Identified | Building ID: Attlee Square Community Hub | Location: External store, E/02 | |

| Item Description: Sheets - Ceiling | | | No Photographic Evidence Available | |
| Comments: Unable to Locate Keys, | Extent:<br>2m² | | | |
| Reinspection State / Register Update: Unable to access | | | | |

| <b>Maintenance activity</b> | <b>Average Score</b> | <b>2</b> | <b>Recommendation: Manage &amp; Monitor</b> | |
