LEGIONELLA RISK ASSESSMENT

Geo Tag: ,
Customer: Believe Housing
Site: Coast House Spectrum 4 Spectrum Business Park Seaham , SR7 7TT
Date: 17th February 2022
Risk Assessor: Mark Henderson
Report No: J042647 - 462441

COAST HOUSE SPECTRUM 4

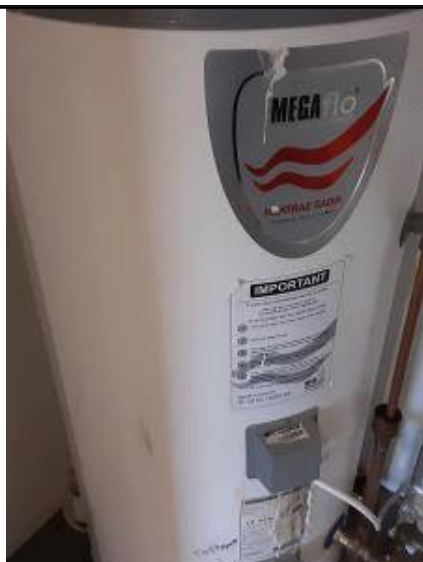
Shunt Pump Fitted	N/A
Other Info	
WRAS Approved Materials	Yes
Suitable Capacity For System	Yes
Inspection Hatch Present	N/A
Suitable Access Present	Yes
Temperatures	NH 57.0°C FH 55.0°C

Risk Rating	
System Risk	Low

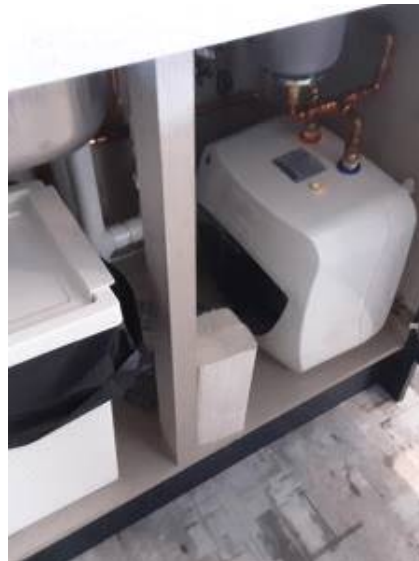
Asset No.	WH1
Location	Pit Stop Kitchen
Water Heater Details	
Fed from	Mains
Heating Source	Electric
Storage	Low Storage Less 15 Ltrs
Power Supply To Units	On
Number Of Outlets	1
Max Temperature	56.0°C
WRAS Approved Materials	Yes
High Turn Over	Yes
Is Aerosol Likely	No
Condition Of Units Satisfactory	Yes
Temperatures	NH 54.0°C

Risk Rating	
System Risk	Low

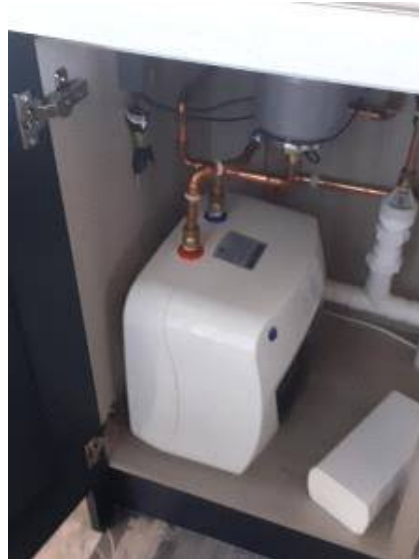
Asset No.	WH2
Location	Staff Area Rhs
Water Heater Details	
Fed from	Mains
Heating Source	Electric
Storage	Low Storage Less 15 Ltrs
Power Supply To Units	On
Number Of Outlets	2
Max Temperature	56.0°C
WRAS Approved Materials	Yes
High Turn Over	Yes
Is Aerosol Likely	No
Condition Of Units Satisfactory	Yes
Temperatures	NH 55.0°C

Risk Rating	
System Risk	Low

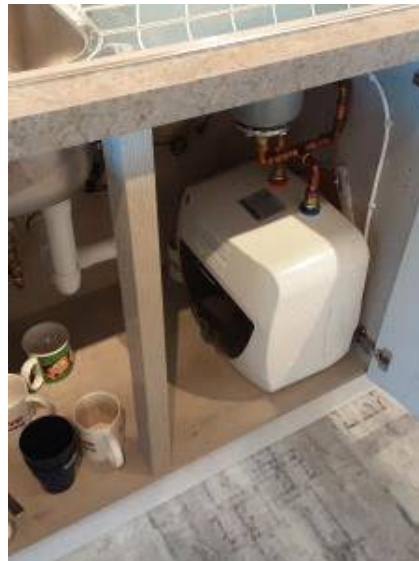
Asset No.	WH3
Location	Staff Area Lhs
Water Heater Details	
Fed from	Mains
Heating Source	Electric
Storage	Low Storage Less 15 Ltrs
Power Supply To Units	On
Number Of Outlets	2
Max Temperature	55.0°C
WRAS Approved Materials	Yes
High Turn Over	Yes
Is Aerosol Likely	No
Condition Of Units Satisfactory	Yes
Temperatures	NH 55.0°C

Risk Rating	
System Risk	Low

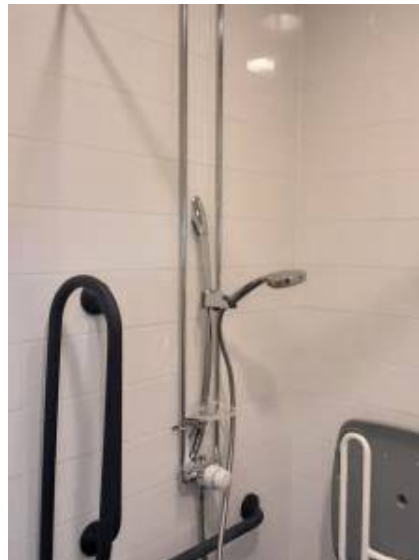
Asset No.		SH1
Location		2nd Floor Shower Room
SH Details	Number of Outlets	1
	Fed From Hot	Calorifier
	Fed From Cold	Mains
	Type Of Shower	Thermostatic
Unit Type	Fixed Head	No
	Hose And Handset Type	Yes
	Connected To Bath	N/A
TMV Arrangement	Accessible	N/A
	At Each Individual Shower	N/A
	Supplying Multiple Showers	N/A
Showerhead Condition	Scale Present	No
	Algae Growth Present	No
	Usage - Frequently	No

Risk Rating	
System Risk	High

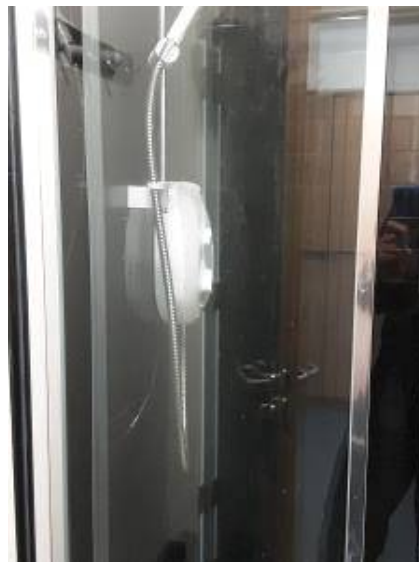
Asset No.	SH2-4
	Location	F/F Floor Changing Room
SH Details	Number of Outlets	3
	Fed From Hot	Calorifier
	Fed From Cold	Mains
	Type Of Shower	Thermostatic
Unit Type	Fixed Head	No
	Hose And Handset Type	Yes
	Connected To Bath	N/A
TMV Arrangement	Accessible	N/A
	At Each Individual Shower	N/A
	Supplying Multiple Showers	N/A
Showerhead Condition	Scale Present	No
	Algae Growth Present	No
	Usage - Frequently	Yes

Risk Rating	
System Risk	Low

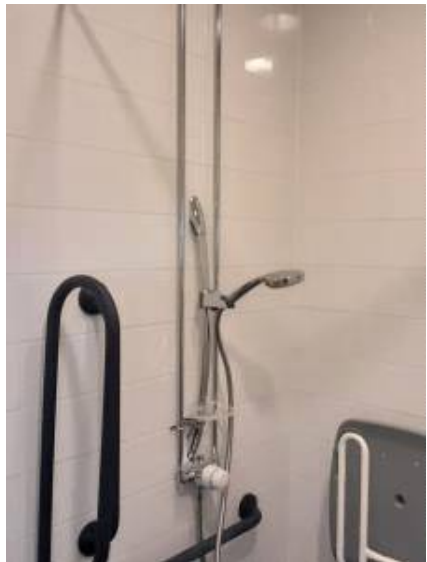
Asset No.		SH5
Location		F/F Shower Room
SH Details	Number of Outlets	1
	Fed From Hot	Calorifier
	Fed From Cold	Mains
	Type Of Shower	Thermostatic
Unit Type	Fixed Head	No
	Hose And Handset Type	Yes
	Connected To Bath	N/A
TMV Arrangement	Accessible	N/A
	At Each Individual Shower	N/A
	Supplying Multiple Showers	N/A
Showerhead Condition	Scale Present	No
	Algae Growth Present	No
	Usage - Frequently	No

Risk Rating	
System Risk	Low

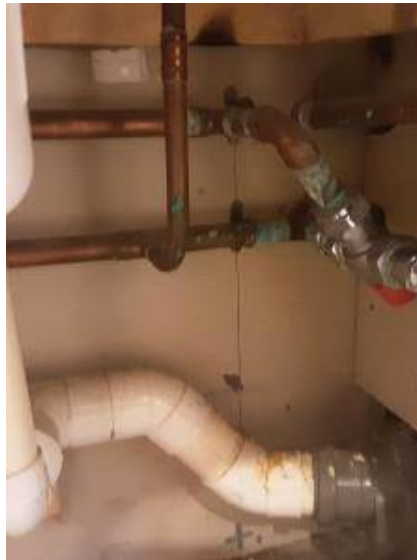
Asset No.	TMV1
Location	G/F Male Toilet
TMV Details	
Approximate Number	1
TMV Type	TMV
Fed from Hot	Calorifier
Fed from Cold	Mains
Accessible	Yes
At Each Individual Outlet	No
Supplying Multiple Outlets	Yes
Number of outlets	4
Temperature	
Hot Supply To TMV Temperature	56.0°C
Cold Supply To TMV Temperature	8.0°C
Nearest Non-TMV Tap- Max Hot Temperature	N/A
Nearest Non-TMV Tap- Max Cold Temperature	N/A
TMV Outlet Temperature	39.0°C
Can TMV be moved closer to the POU	No
Can TMV be removed from system	No

Risk Rating	
System Risk	Low

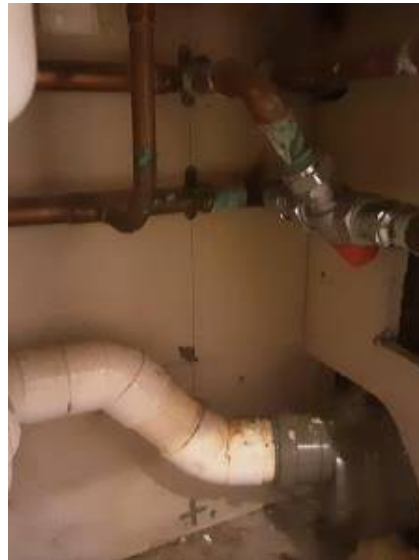
Asset No.	TMV2
Location	G/F Female Toilet
TMV Details	
Approximate Number	1
TMV Type	TMV
Fed from Hot	Calorifier
Fed from Cold	Mains
Accessible	Yes
At Each Individual Outlet	No
Supplying Multiple Outlets	Yes
Number of outlets	4
Temperature	
Hot Supply To TMV Temperature	56.0°C
Cold Supply To TMV Temperature	8.0°C
Nearest Non-TMV Tap- Max Hot Temperature	N/A
Nearest Non-TMV Tap- Max Cold Temperature	N/A
TMV Outlet Temperature	39.0°C
Can TMV be moved closer to the POU	No
Can TMV be removed from system	No

Risk Rating	
System Risk	Low

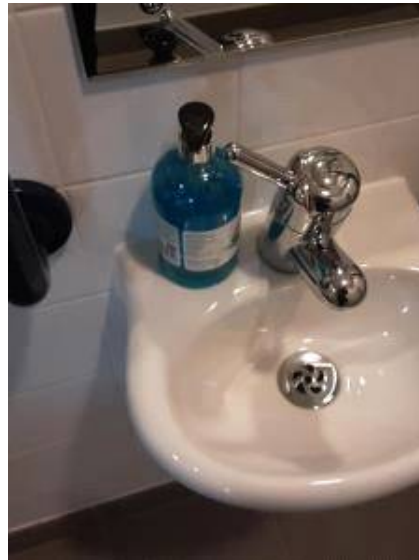
Asset No.	TMV3
Location	G/F Accessible Toilet
TMV Details	
Approximate Number	1
TMV Type	TMV Tap
Fed from Hot	Calorifier
Fed from Cold	Mains
Accessible	Yes
At Each Individual Outlet	Yes
Supplying Multiple Outlets	No
Number of outlets	1
Temperature	
Hot Supply To TMV Temperature	56.0°C
Cold Supply To TMV Temperature	8.0°C
Nearest Non-TMV Tap- Max Hot Temperature	N/A
Nearest Non-TMV Tap- Max Cold Temperature	N/A
TMV Outlet Temperature	40.0°C
Can TMV be moved closer to the POU	No
Can TMV be removed from system	No

Risk Rating	
System Risk	Low

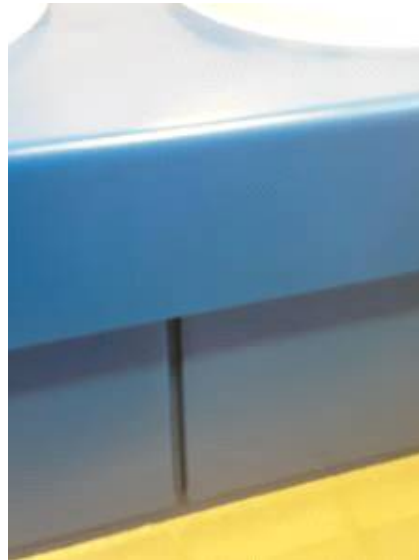
Asset No.	TMV4
Location	F/F Female Toilet
TMV Details	
Approximate Number	1
TMV Type	TMV
Fed from Hot	Calorifier
Fed from Cold	Mains
Accessible	Yes
At Each Individual Outlet	No
Supplying Multiple Outlets	Yes
Number of outlets	4
Temperature	
Hot Supply To TMV Temperature	56.0°C
Cold Supply To TMV Temperature	8.0°C
Nearest Non-TMV Tap- Max Hot Temperature	N/A
Nearest Non-TMV Tap- Max Cold Temperature	N/A
TMV Outlet Temperature	40.0°C
Can TMV be moved closer to the POU	No
Can TMV be removed from system	No

Risk Rating	
System Risk	Low

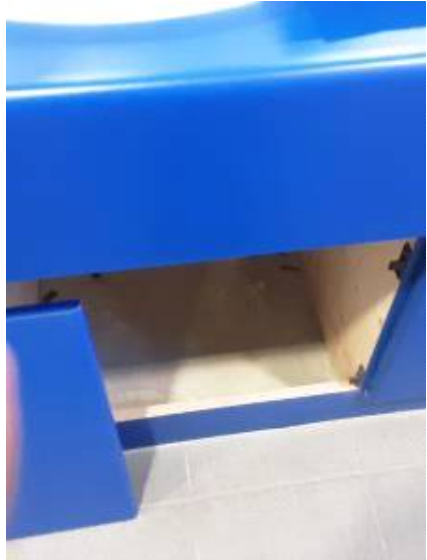
Asset No.	TMV5
	Location	F/F Male Toilet
TMV Details	Approximate Number	1
	TMV Type	TMV
	Fed from Hot	Calorifier
	Fed from Cold	Mains
	Accessible	Yes
	At Each Individual Outlet	No
	Supplying Multiple Outlets	Yes
	Number of outlets	4
Temperature	Hot Supply To TMV Temperature	56.0°C
	Cold Supply To TMV Temperature	8.0°C
	Nearest Non-TMV Tap- Max Hot Temperature	N/A
	Nearest Non-TMV Tap- Max Cold Temperature	N/A
	TMV Outlet Temperature	39.0°C
	Can TMV be moved closer to the POU	No
	Can TMV be removed from system	No

Risk Rating	
System Risk	Low

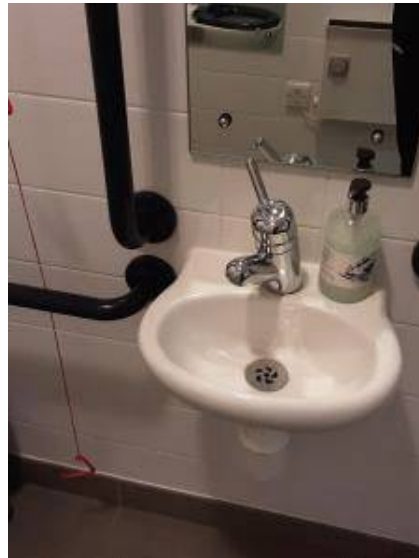
Asset No.	TMV6
Location	F/F Accessible Toilet
TMV Details	
Approximate Number	1
TMV Type	TMV Tap
Fed from Hot	Calorifier
Fed from Cold	Mains
Accessible	Yes
At Each Individual Outlet	Yes
Supplying Multiple Outlets	No
Number of outlets	1
Temperature	
Hot Supply To TMV Temperature	56.0°C
Cold Supply To TMV Temperature	8.0°C
Nearest Non-TMV Tap- Max Hot Temperature	N/A
Nearest Non-TMV Tap- Max Cold Temperature	N/A
TMV Outlet Temperature	40.0°C
Can TMV be moved closer to the POU	No
Can TMV be removed from system	No

Risk Rating	
System Risk	Low

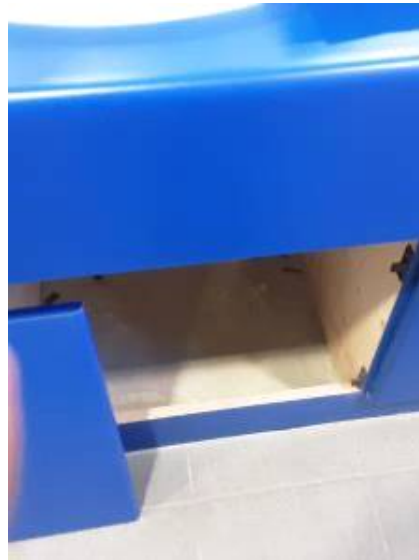
Asset No.	TMV8
Location	2nd/F Female Toilet
TMV Details	
Approximate Number	1
TMV Type	TMV
Fed from Hot	Calorifier
Fed from Cold	Mains
Accessible	Yes
At Each Individual Outlet	No
Supplying Multiple Outlets	Yes
Number of outlets	4
Temperature	
Hot Supply To TMV Temperature	56.0°C
Cold Supply To TMV Temperature	8.0°C
Nearest Non-TMV Tap- Max Hot Temperature	N/A
Nearest Non-TMV Tap- Max Cold Temperature	N/A
TMV Outlet Temperature	40.0°C
Can TMV be moved closer to the POU	No
Can TMV be removed from system	No

Risk Rating	
System Risk	Low

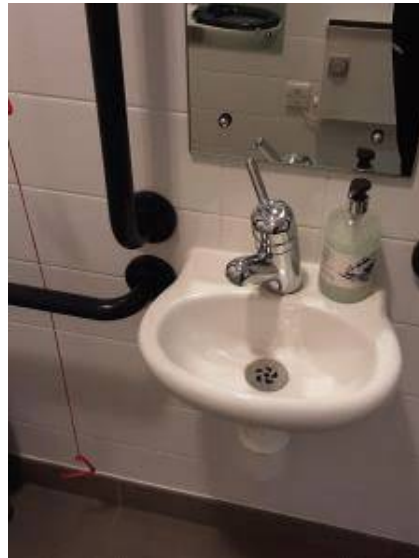
Asset No.	TMV9
	Location	2nd/F Accessible Toilet
TMV Details	Approximate Number	1
	TMV Type	TMV Tap
	Fed from Hot	Calorifier
	Fed from Cold	Mains
	Accessible	Yes
	At Each Individual Outlet	Yes
	Supplying Multiple Outlets	No
	Number of outlets	1
Temperature	Hot Supply To TMV Temperature	56.0°C
	Cold Supply To TMV Temperature	8.0°C
	Nearest Non-TMV Tap- Max Hot Temperature	N/A
	Nearest Non-TMV Tap- Max Cold Temperature	N/A
	TMV Outlet Temperature	40.0°C
	Can TMV be moved closer to the POU	No
	Can TMV be removed from system	No

Risk Rating	
System Risk	Low

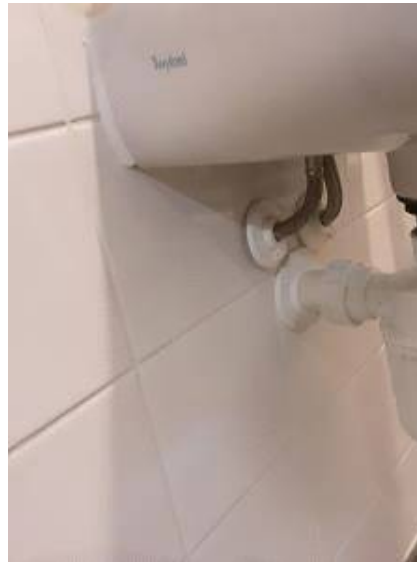
Asset No.	FH1 and 2
	Location	G/F Accessible Toilet
General	Satisfactory	No
Fed From	Fed From	Hot and Cold
	Comments

Risk Rating	
System Risk	Medium

The inner EPDM lining of flexible hosing has been identified to provide conditions promoting the growth of bacteria, therefore it is recommended that flexible hosing is removed and replaced with rigid copper piping pipework during any future refurbishment work.

System Ref	General	Priority	Assigned To	Comments	Date Completed	Signed
FH1 and 2, FH21 and 22, FH23 and 24, FH53 and 54, FH73 and 74	At the time of the survey the WRAS approved numbers could not be identified on the flexible hoses, site shall ensure that these are compliant and either replace or pipe in rigid copper.	Medium / Category 3

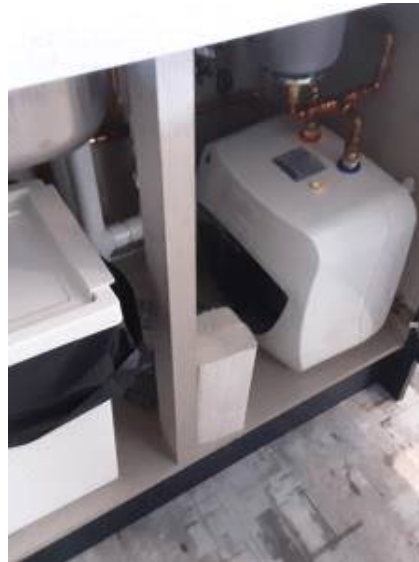
Asset No.	PV1
	Location	Water Heater 1
General	Satisfactory	Yes
Fed From	Fed From	Mains
	Comments

Risk Rating	
System Risk	Low

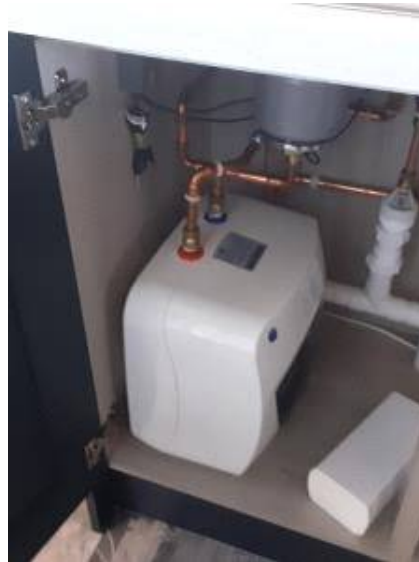
Asset No.	PV2
	Location	Water Heater 2
General	Satisfactory	Yes
Fed From	Fed From	Mains
	Comments

Risk Rating	
System Risk	Low

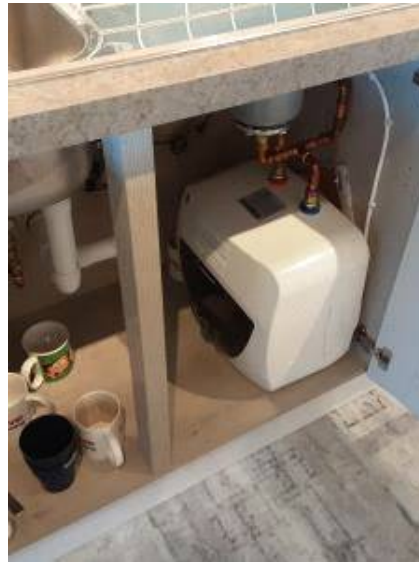
Asset No.	PV3
	Location	Water Heater 3
General	Satisfactory	Yes
Fed From	Fed From	Mains
	Comments

Risk Rating	
System Risk	Low

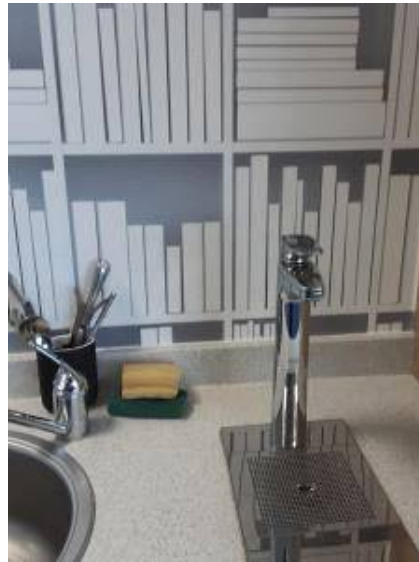
Asset No.	KE1
	Location	G/F Lhs Kitchen
General	Satisfactory	Yes
Fed From	Fed From	Mains
	Comments	Boiler Tap

Risk Rating	
System Risk	Low

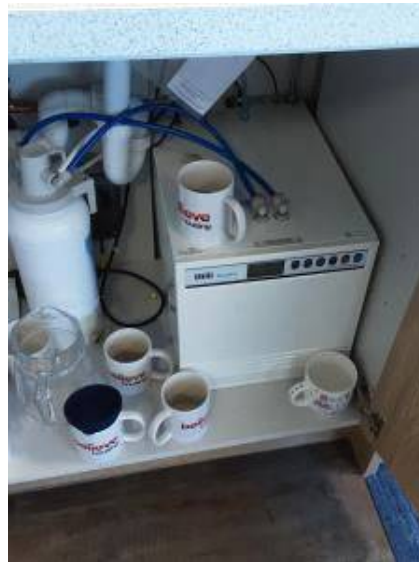
Asset No.	KE2
	Location	G/F Rhs Kitchen
General	Satisfactory	Yes
Fed From	Fed From	Mains
	Comments	Boiler Tap

Risk Rating	
System Risk	Low

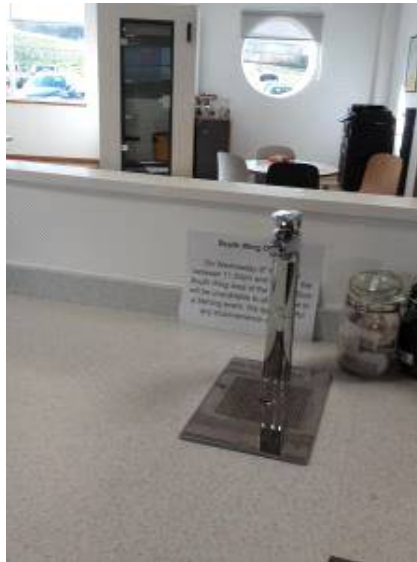
Asset No.	KE5
	Location	F/F Office Kitchen
General	Satisfactory	Yes
Fed From	Fed From	Mains
	Comments	Boiler Tap

Risk Rating	
System Risk	Low

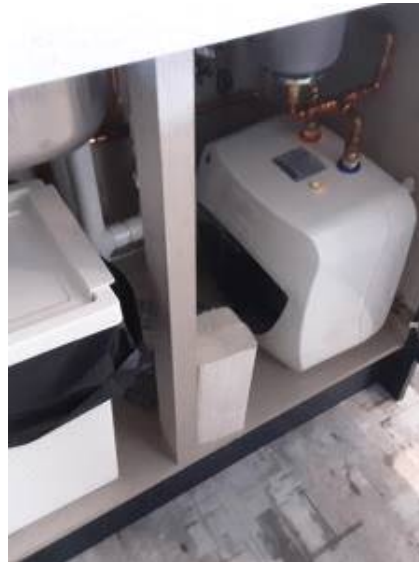
Asset No.	KE7
	Location	2nd/F Office Kitchen Rhs
General	Satisfactory	Yes
Fed From	Fed From	Mains
	Comments	Boiler Tap

Risk Rating	
System Risk	Low
