LEGIONELLA RISK ASSESSMENT

Geo Tag: ,
Customer: Believe Housing
Site: Country House 27 Longfield Road South Church Enterprise Park
Bishop Auckland, DL14 6XB
Date: 1st February 2024
Risk Assessor: Carleton Waite
Report No: J052354 - 664703

Water systems found at Country House 27 Longfield Road South Church Enterprise Park Bishop Auckland

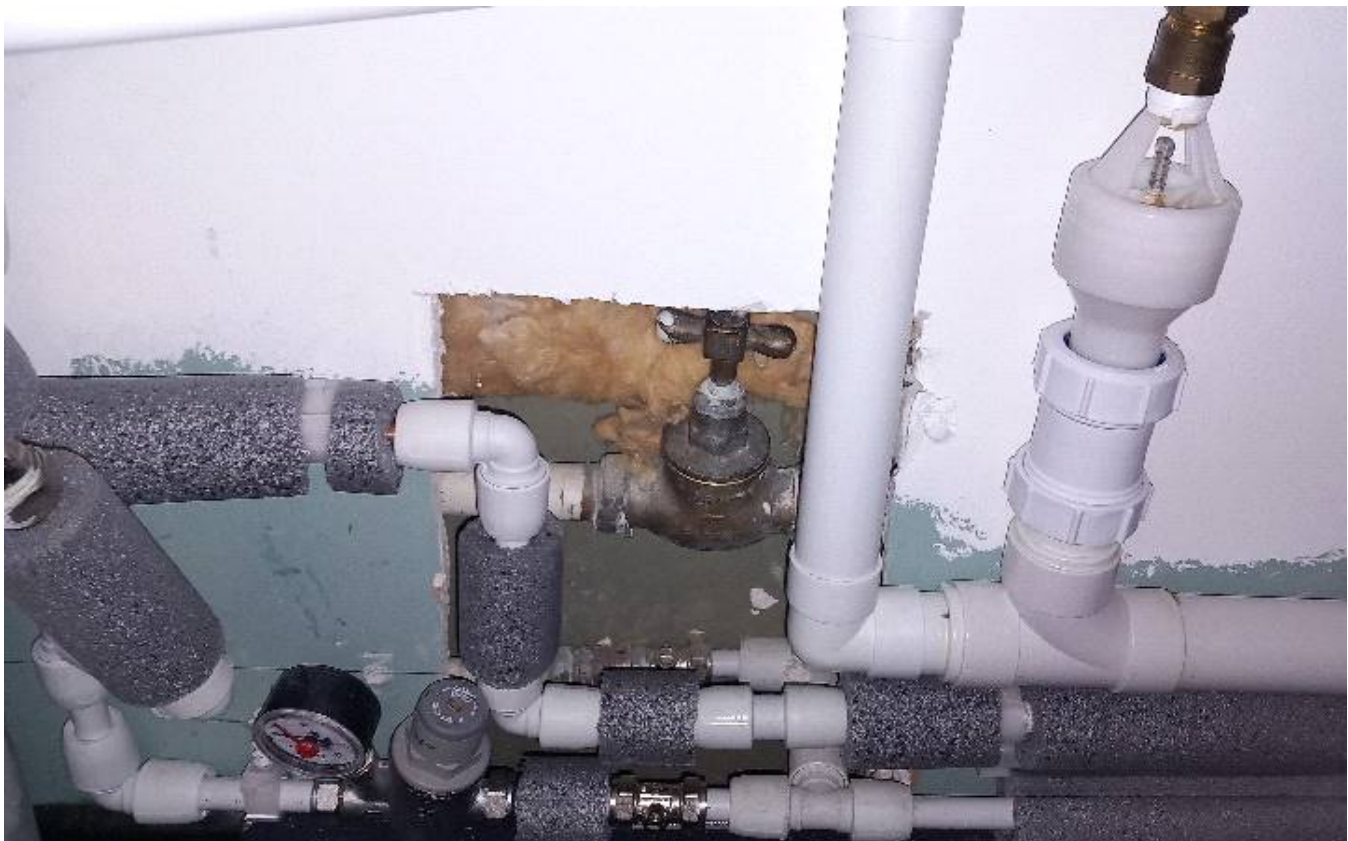
Asset No.	MAINS 1
	Location	GF - Male WC
Details	Mains Supply Stop Cock Location	Male WC
	Serving Building	Building
	Mains Supply Source	Local Water Board
Material of Construction	Water Treatment In Place	N/A
	Temperature Of Mains Supply	7.0°C
	Supply Pipework	Copper
	Distribution Pipework	Copper
	Incoming Pipework Insulated	Yes
	Strainer Fitted	N/A
	Strainer Fitted Correctly	N/A
	Water Meter Installed	U/D
	Drinking Water Outlets Labelled	N/A
	WRAS Approved Materials	Yes
Records	Chemical Dosing System	N/A
	Filtration System	N/A
	UV System	N/A
	Temperatures	NC 7.0°C FC 8.0°C

Risk Rating	
System Risk	Low

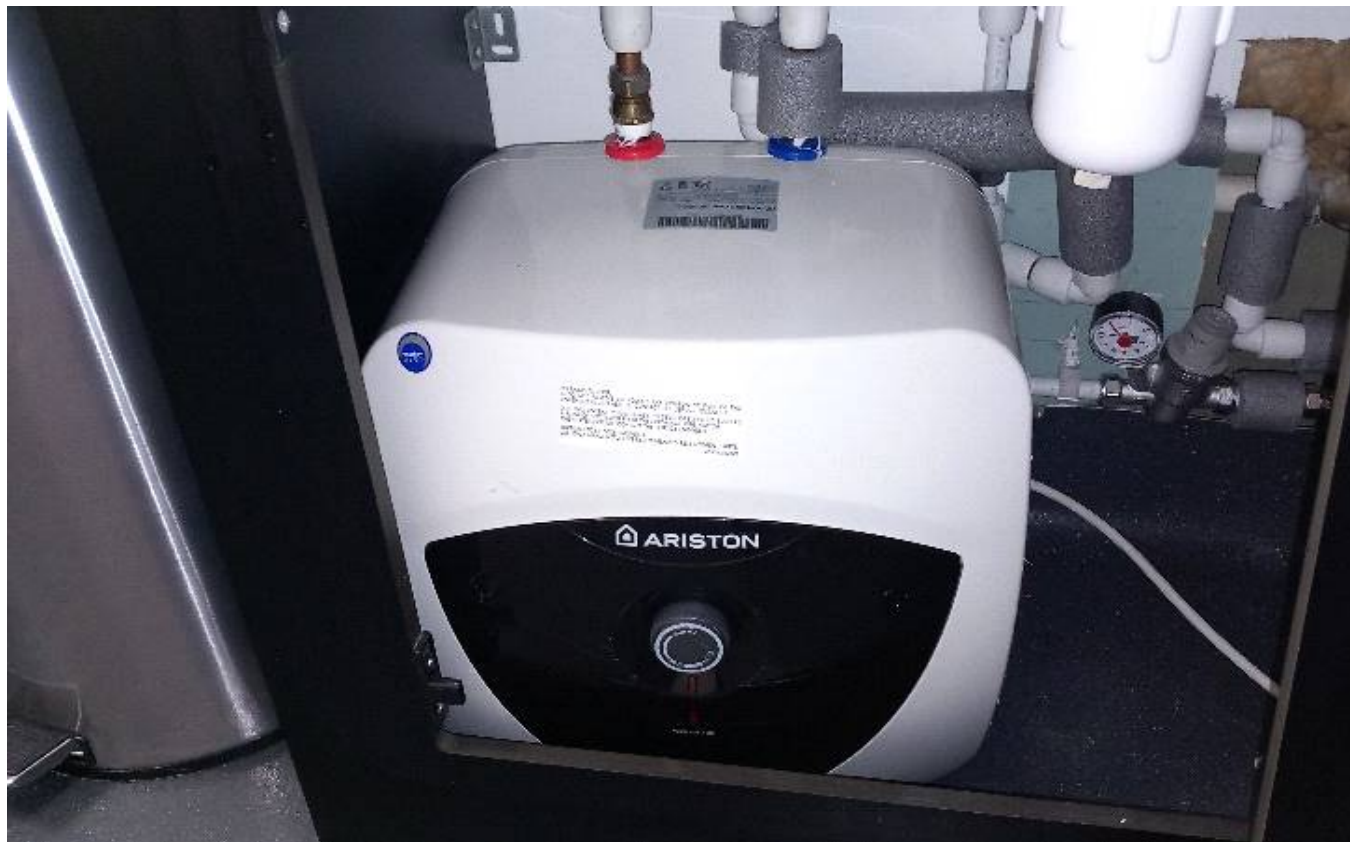
Asset No.	WH1
Location	GF - Male WC
Water Heater Details	
Fed from	Mains
Heating Source	Electric
Storage	Low Storage Less 15 Ltrs
Power Supply To Units	On
Number Of Outlets	3
Max Temperature	59.0°C
WRAS Approved Materials	Yes
High Turn Over	Yes
Is Aerosol Likely	No
Condition Of Units Satisfactory	Yes
Temperatures	NH 59.0°C FH 59.0°C

Risk Rating	
System Risk	Low

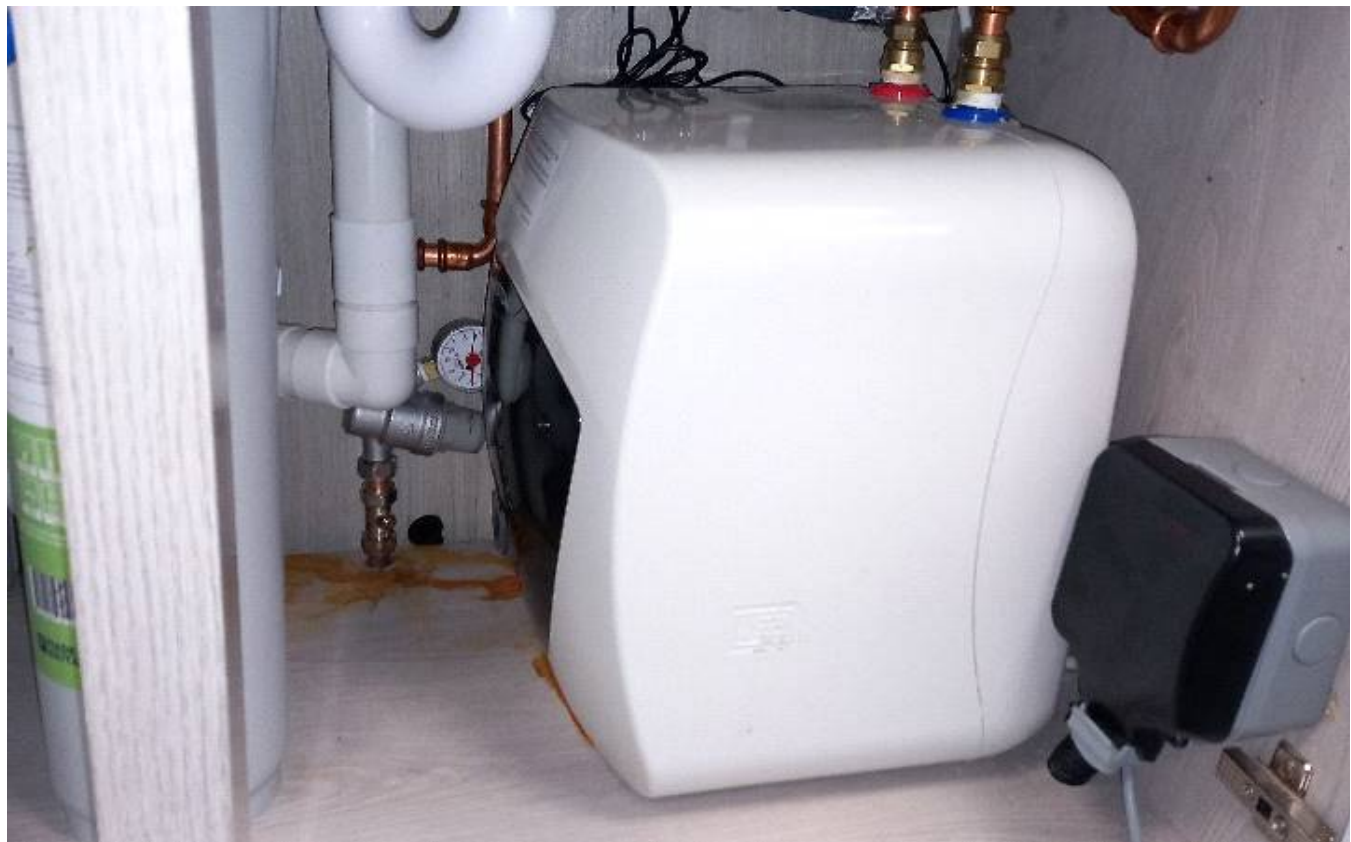
Asset No.	WH2
Location	GF - Left Kitchen
Water Heater Details	
Fed from	Mains
Heating Source	Electric
Storage	Low Storage Less 15 Ltrs
Power Supply To Units	On
Number Of Outlets	1
Max Temperature	60.0°C
WRAS Approved Materials	Yes
High Turn Over	Yes
Is Aerosol Likely	No
Condition Of Units Satisfactory	Yes
Temperatures	NH 60.0°C

Risk Rating	
System Risk	Low

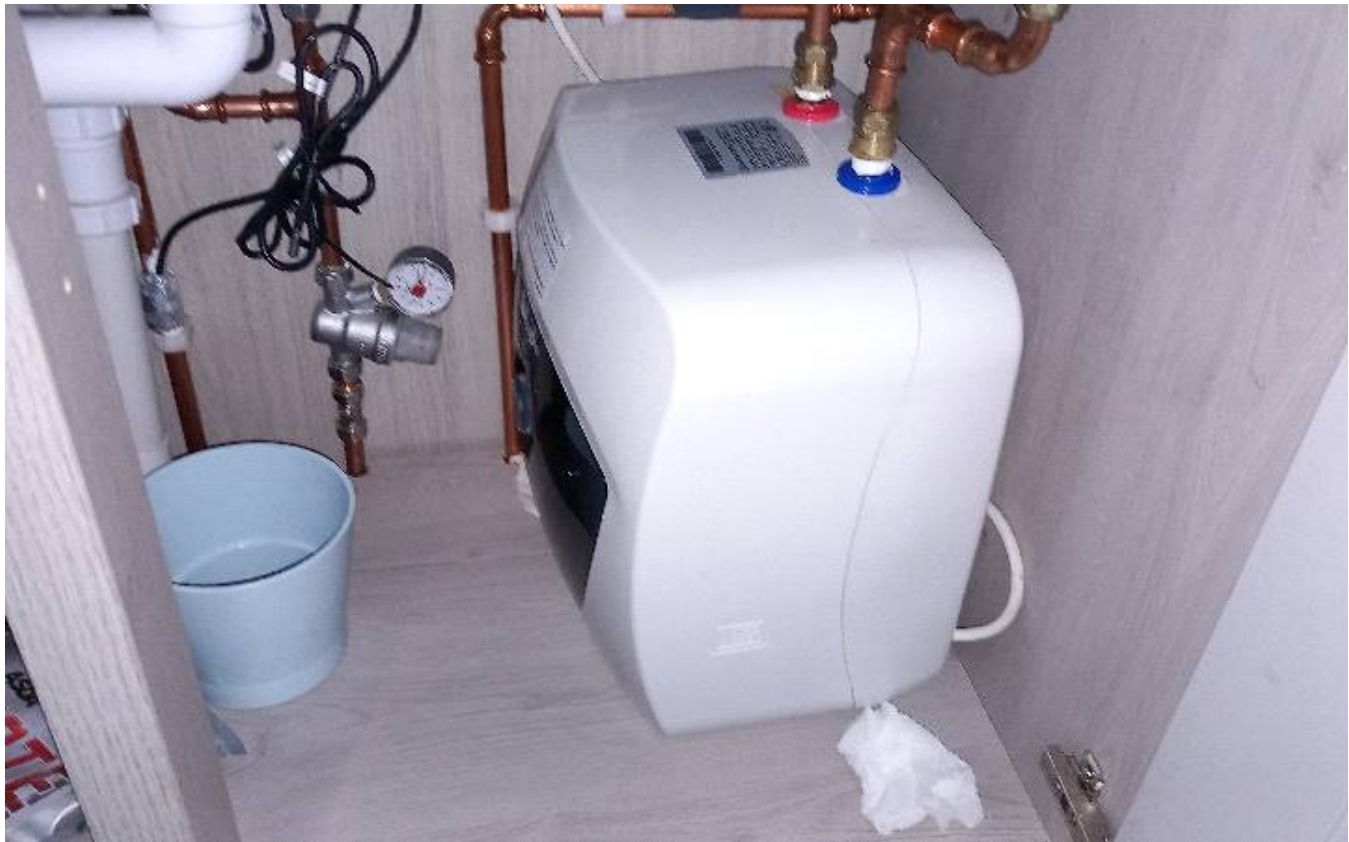
Asset No.	WH3
Location	1st - Main Kitchen
Water Heater Details	
Fed from	Mains
Heating Source	Electric
Storage	Low Storage Less 15 Ltrs
Power Supply To Units	On
Number Of Outlets	2
Max Temperature	62.0°C
WRAS Approved Materials	Yes
High Turn Over	Yes
Is Aerosol Likely	No
Condition Of Units Satisfactory	Yes
Temperatures	NH 62.0°C FH 62.0°C

Risk Rating	
System Risk	Low

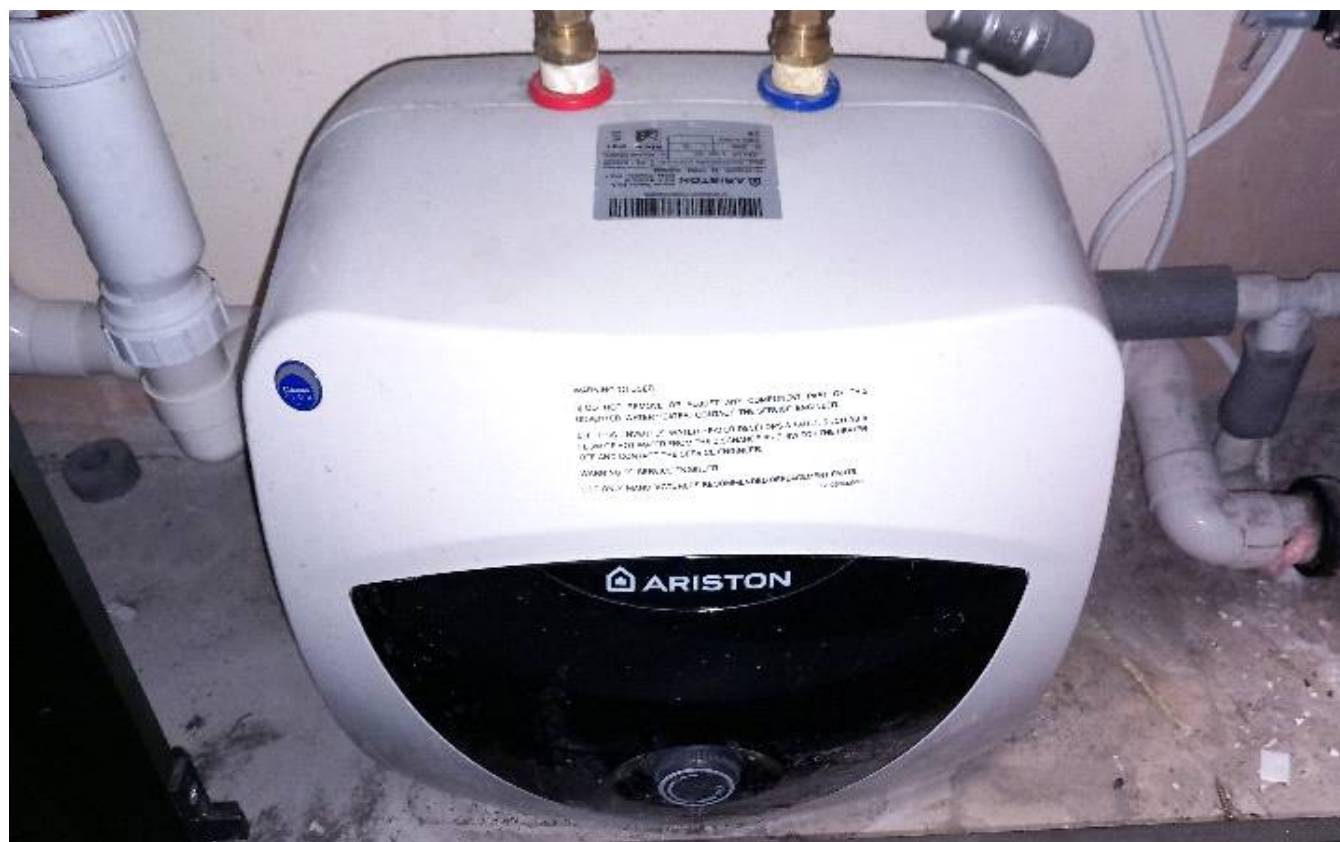
Asset No.	WH4
Location	1st - Female WC
Water Heater Details	
Fed from	Mains
Heating Source	Electric
Storage	Low Storage Less 15 Ltrs
Power Supply To Units	On
Number Of Outlets	3
Max Temperature	53.0°C
WRAS Approved Materials	Yes
High Turn Over	Yes
Is Aerosol Likely	No
Condition Of Units Satisfactory	Yes
Temperatures	NH 53.0°C

Risk Rating	
System Risk	Low

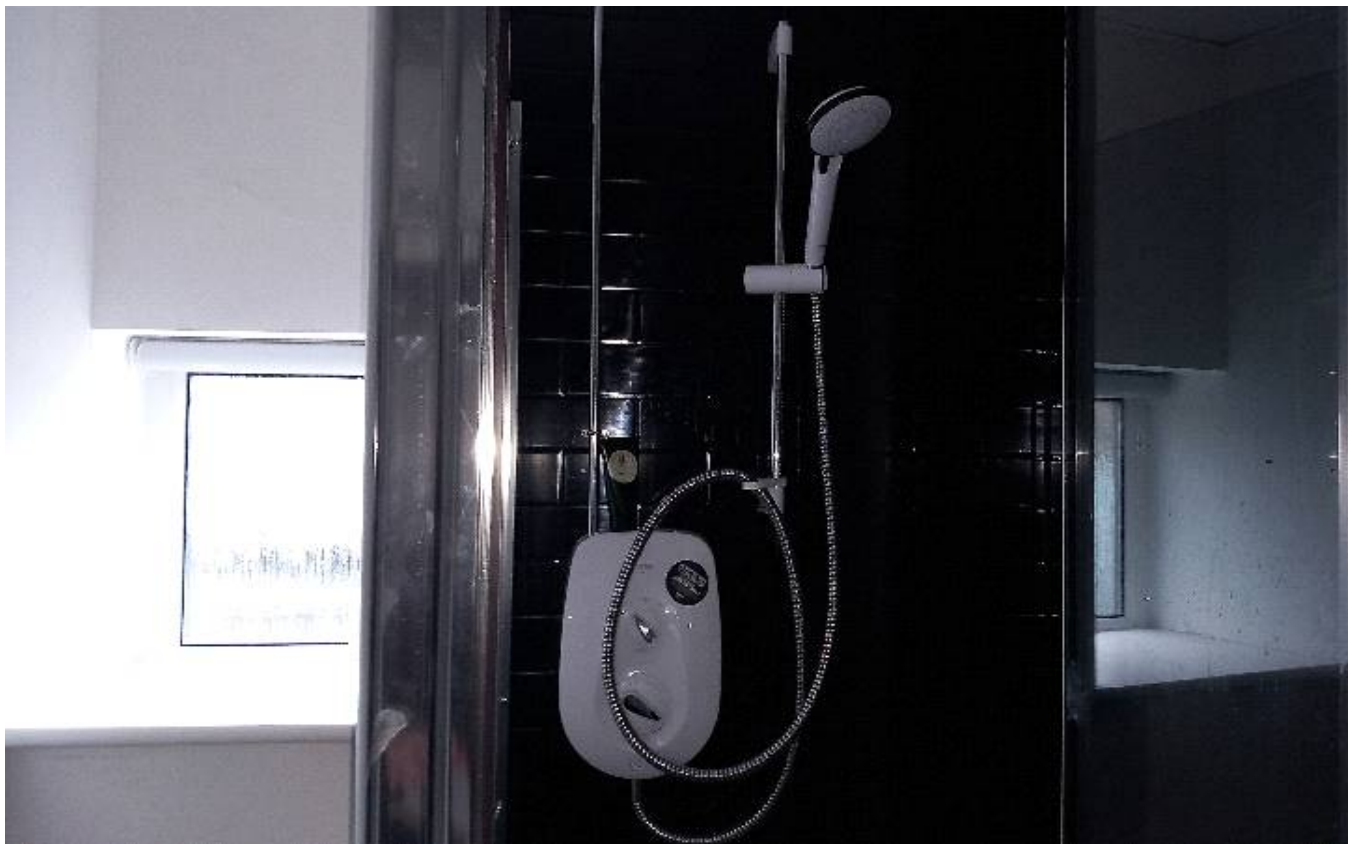
Asset No.	SH1
	Location	GF - Shower
SH Details	Number of Outlets	1
	Fed From Hot	-
	Fed From Cold	Mains
	Type Of Shower	Electric
Unit Type	Fixed Head	No
	Hose And Handset Type	Yes
	Connected To Bath	N/A
TMV Arrangement	Accessible	N/A
	At Each Individual Shower	N/A
	Supplying Multiple Showers	N/A
Showerhead Condition	Scale Present	No
	Algae Growth Present	No
	Usage - Frequently	Yes

Risk Rating	
System Risk	Low

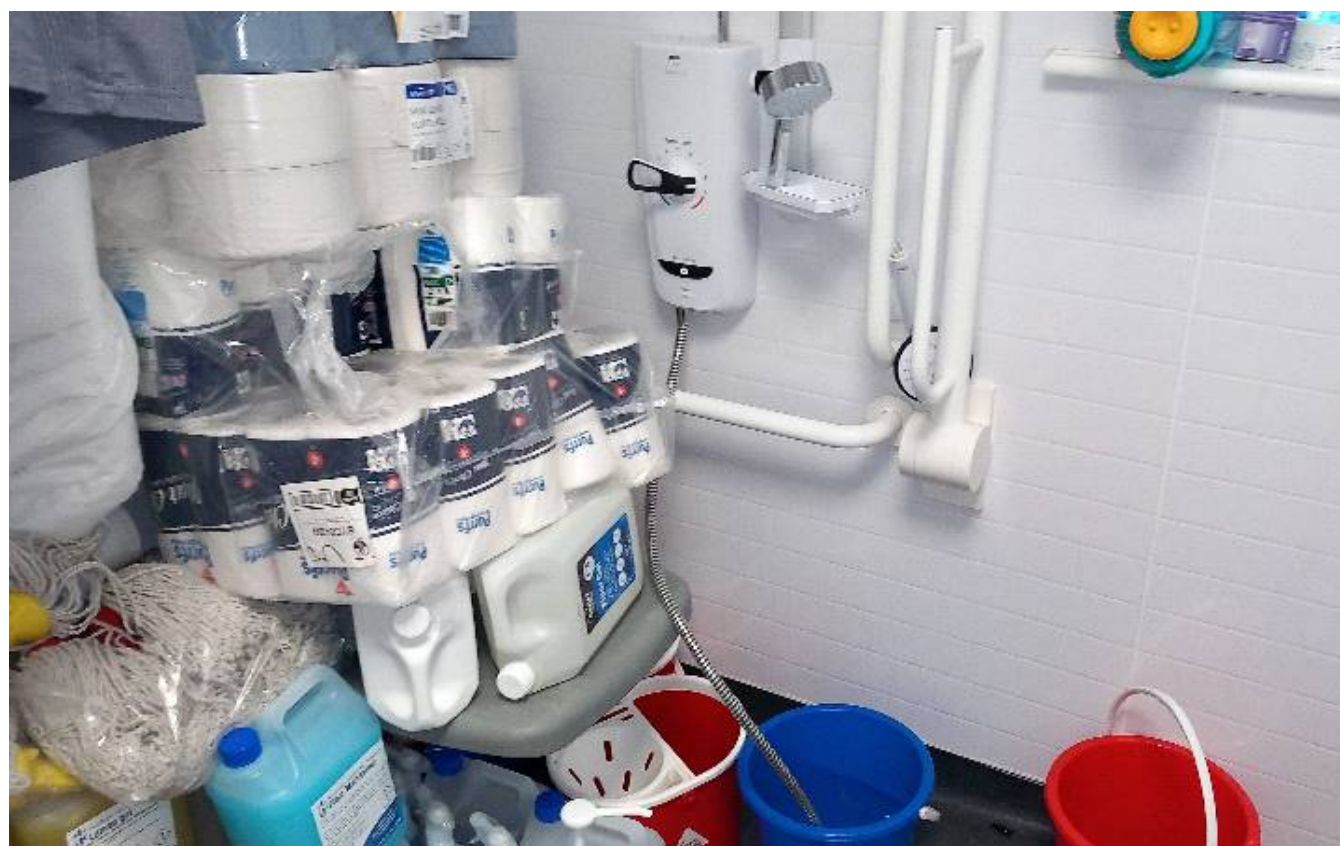
Asset No.	SH2
	Location	GF - Accessible Shower
SH Details	Number of Outlets	1
	Fed From Hot	-
	Fed From Cold	Mains
	Type Of Shower	Electric
Unit Type	Fixed Head	No
	Hose And Handset Type	Yes
	Connected To Bath	N/A
TMV Arrangement	Accessible	N/A
	At Each Individual Shower	N/A
	Supplying Multiple Showers	N/A
Showerhead Condition	Scale Present	No
	Algae Growth Present	No
	Usage - Frequently	Yes

Risk Rating	
System Risk	Low

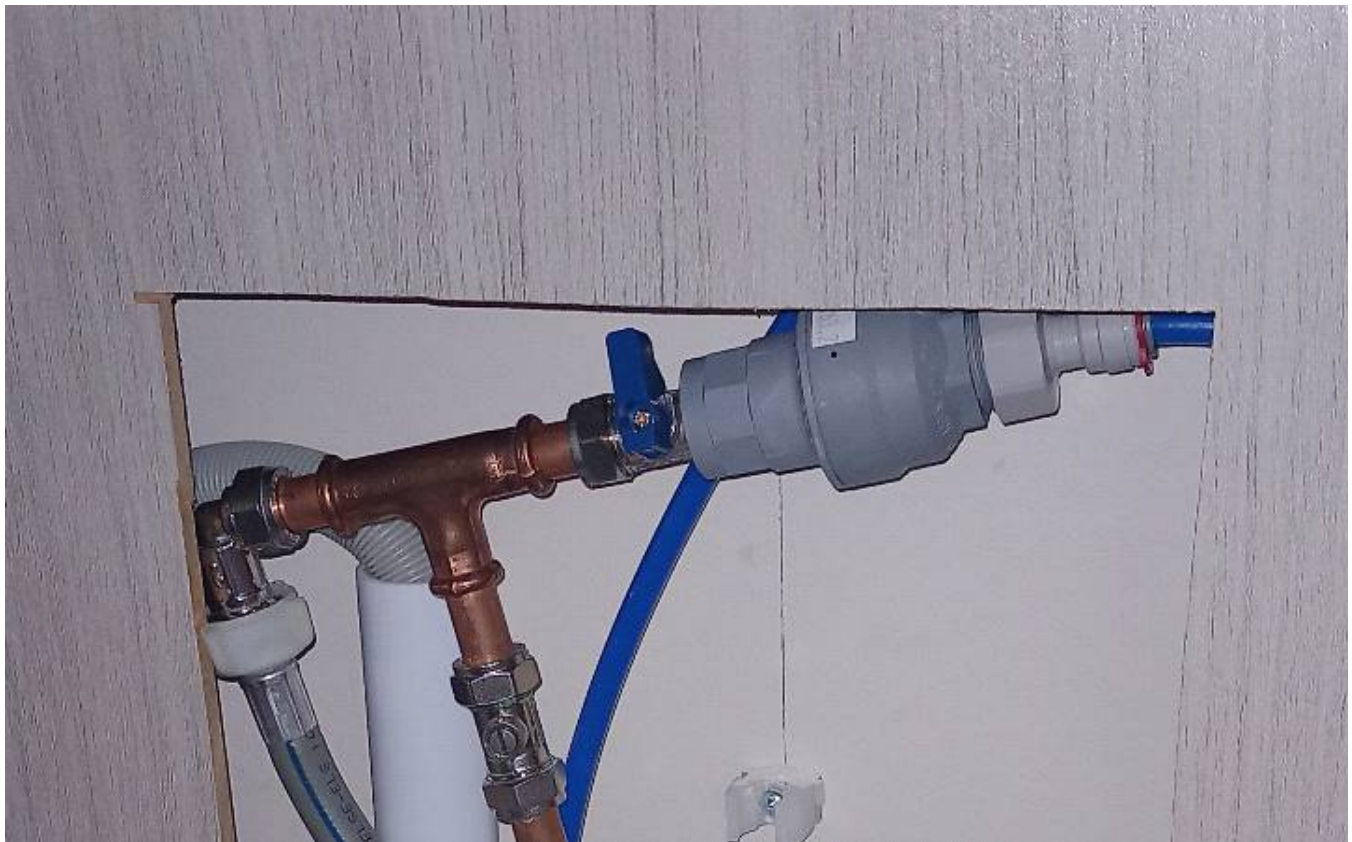
Asset No.	DL1
	Location	1st - Main Kitchen
General	Dead Leg present	Yes
	Fed From Hot	-
	Fed From Cold	Mains
	Flush	Yes
	Remove	Yes
	Comments	-

Risk Rating	
System Risk	High

System Ref	General	Priority	Assigned To	Comments	Date Completed	Signed
DL1	Dead legs were found as part of the survey. These dead legs will cause water to stagnate and should be removed from the system or flushed once a week.	High / Category 2

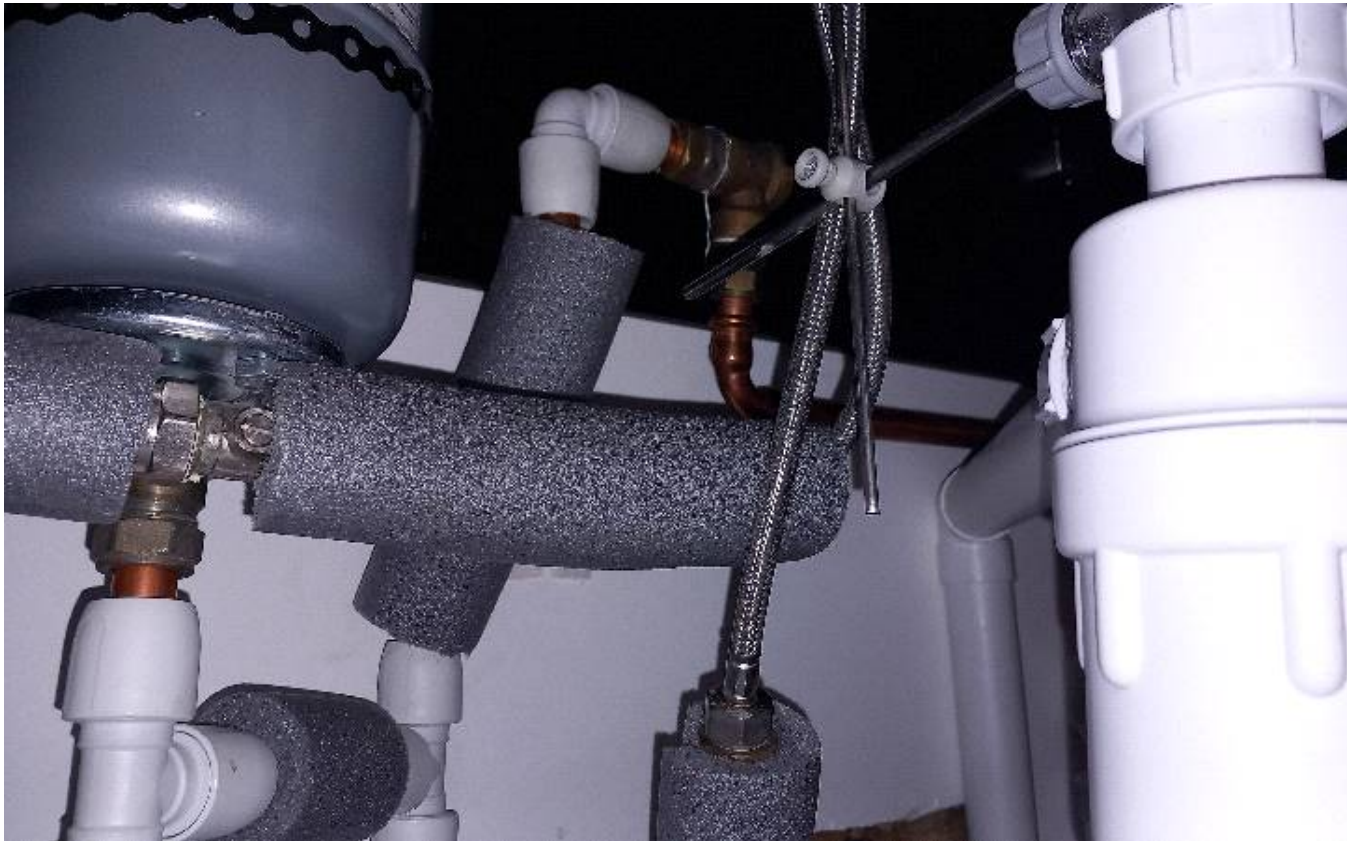
Asset No.	FH1
	Location	GF - Male WC
General	Satisfactory	No
Fed From	Fed From	Domestic
	Comments	-

Risk Rating	
System Risk	Medium

System Ref	General	Priority	Assigned To	Comments	Date Completed	Signed
FH1, FH2, FH3, FH4, FH5, FH6	At the time of the survey the WRAS approved numbers could not be identified on the flexible hoses, site shall ensure that these are compliant and either replace or pipe in rigid copper.	Medium / Category 3

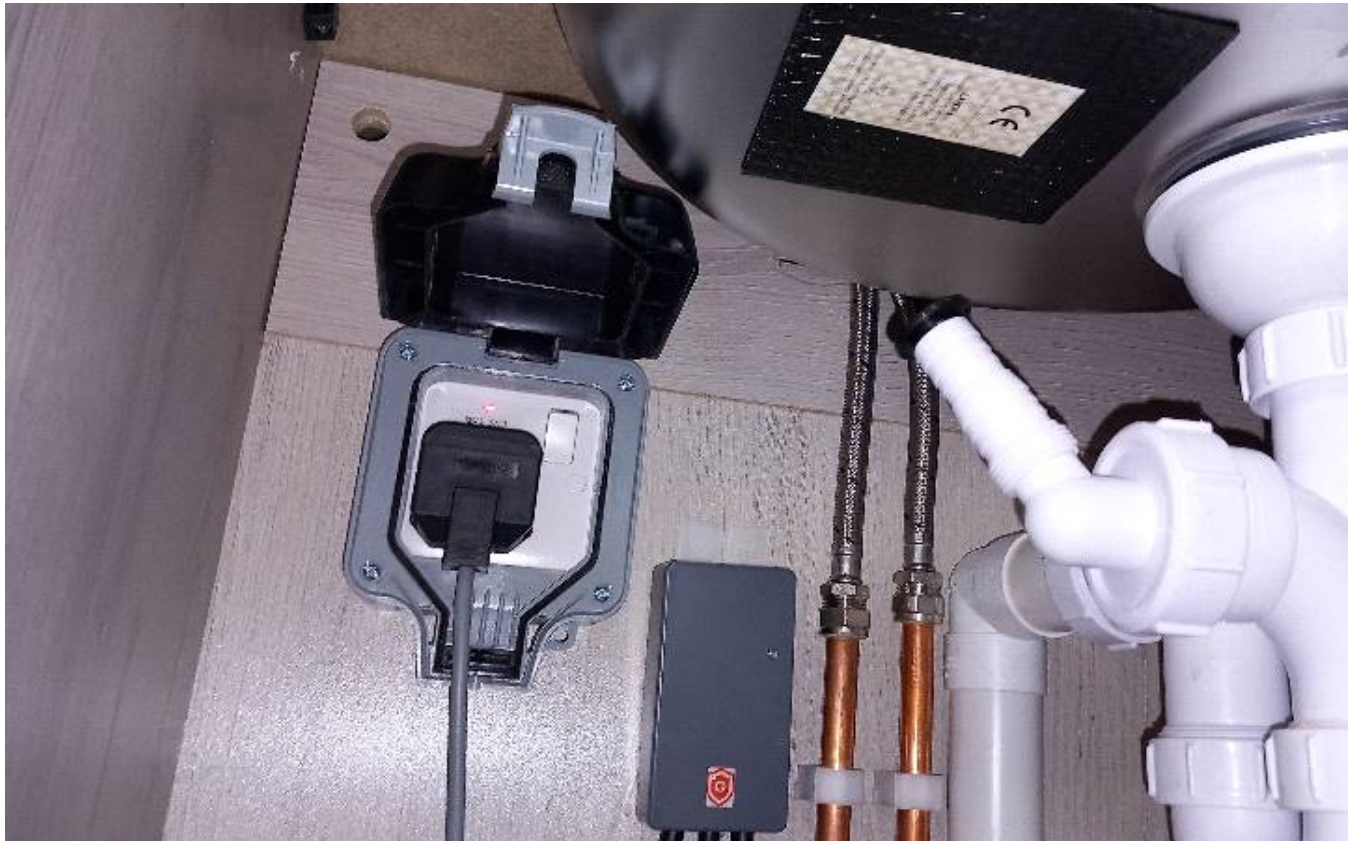
Asset No.	FH2
	Location	GF - Right Kitchen
General	Satisfactory	No
Fed From	Fed From	Domestic
	Comments	-

Risk Rating	
System Risk	Medium

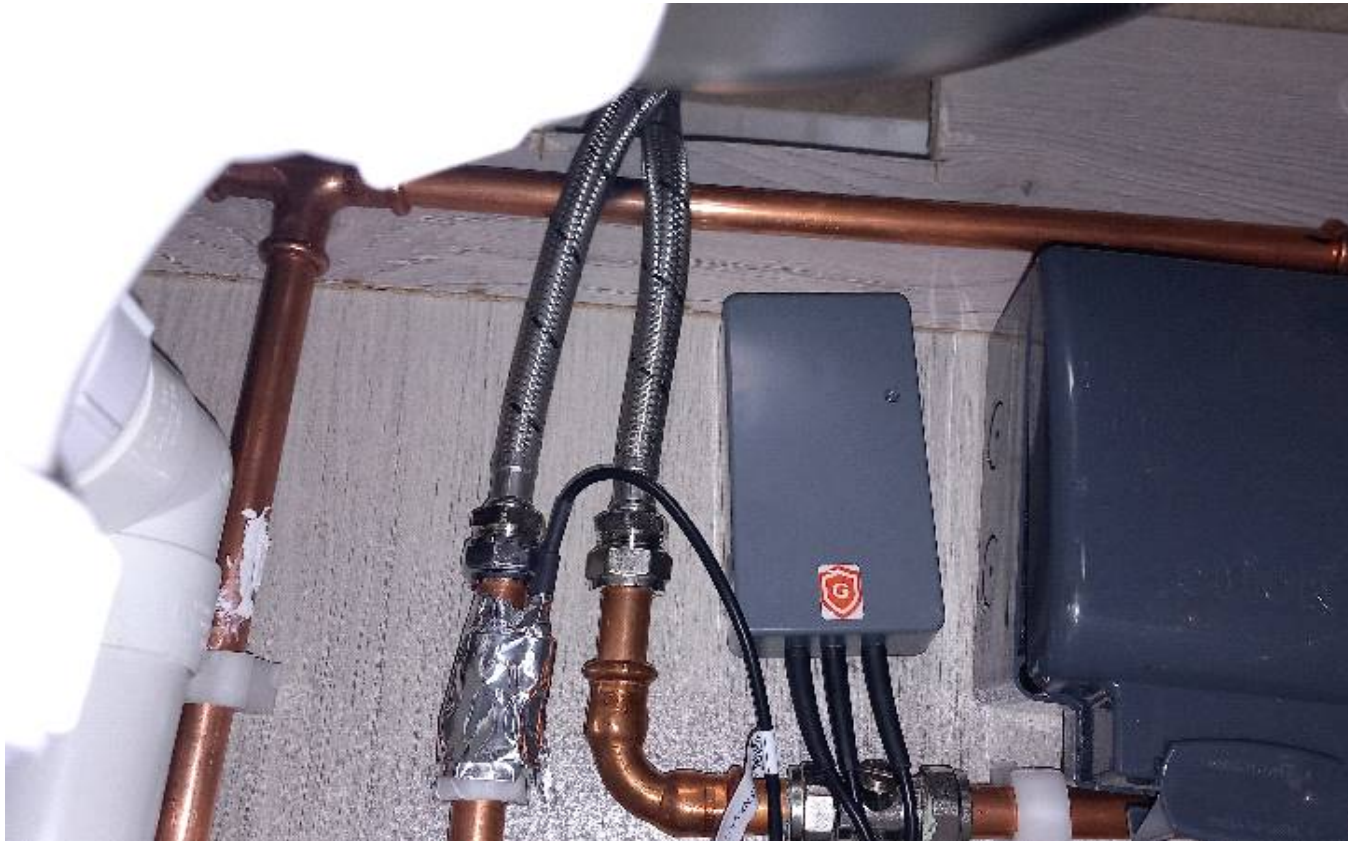
Asset No.	FH3
	Location	GF - Left Kitchen
General	Satisfactory	No
Fed From	Fed From	Domestic
	Comments	-

Risk Rating	
System Risk	Medium

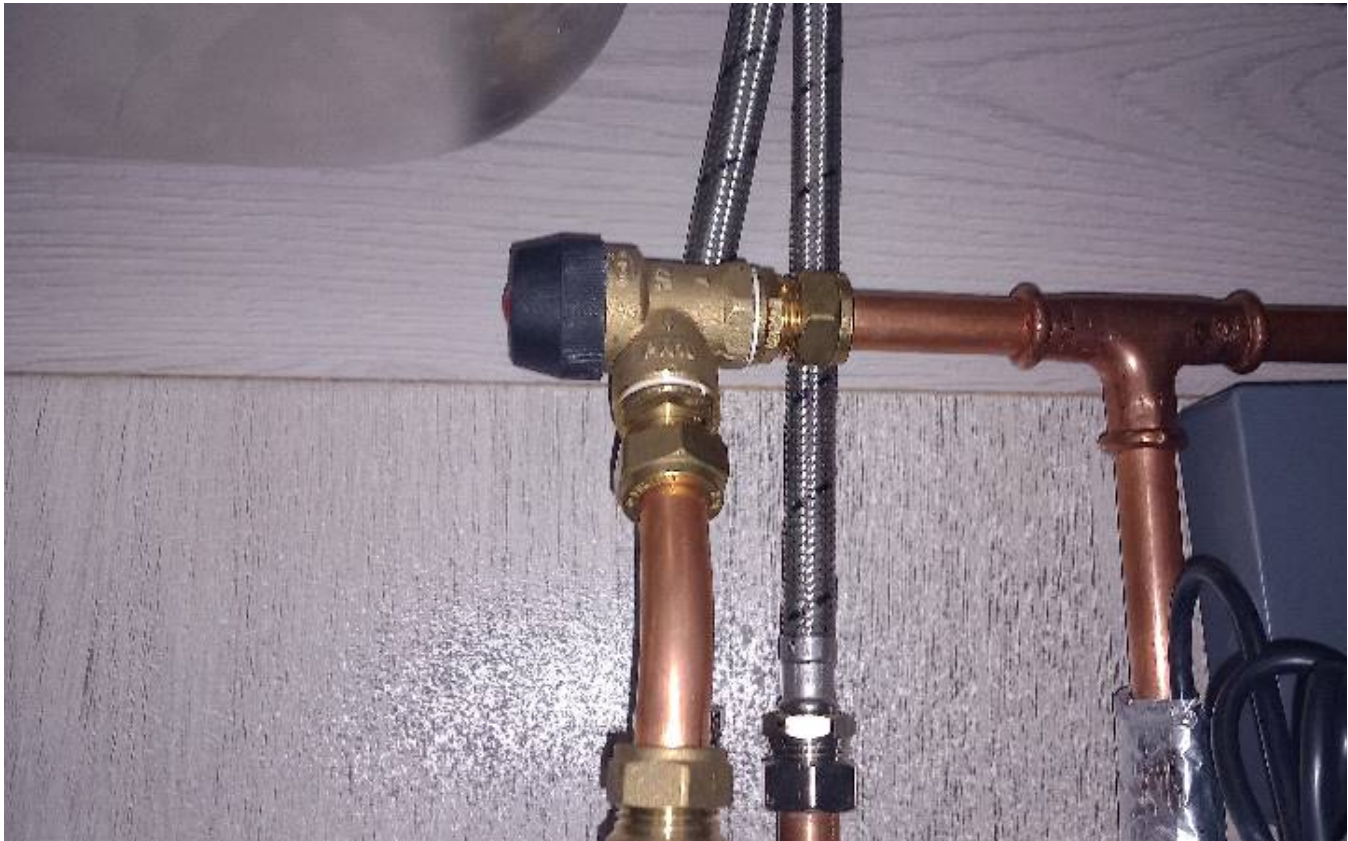
Asset No.	FH4
	Location	1st - Main Kitchen
General	Satisfactory	No
Fed From	Fed From	Domestic
	Comments	-

Risk Rating	
System Risk	Medium

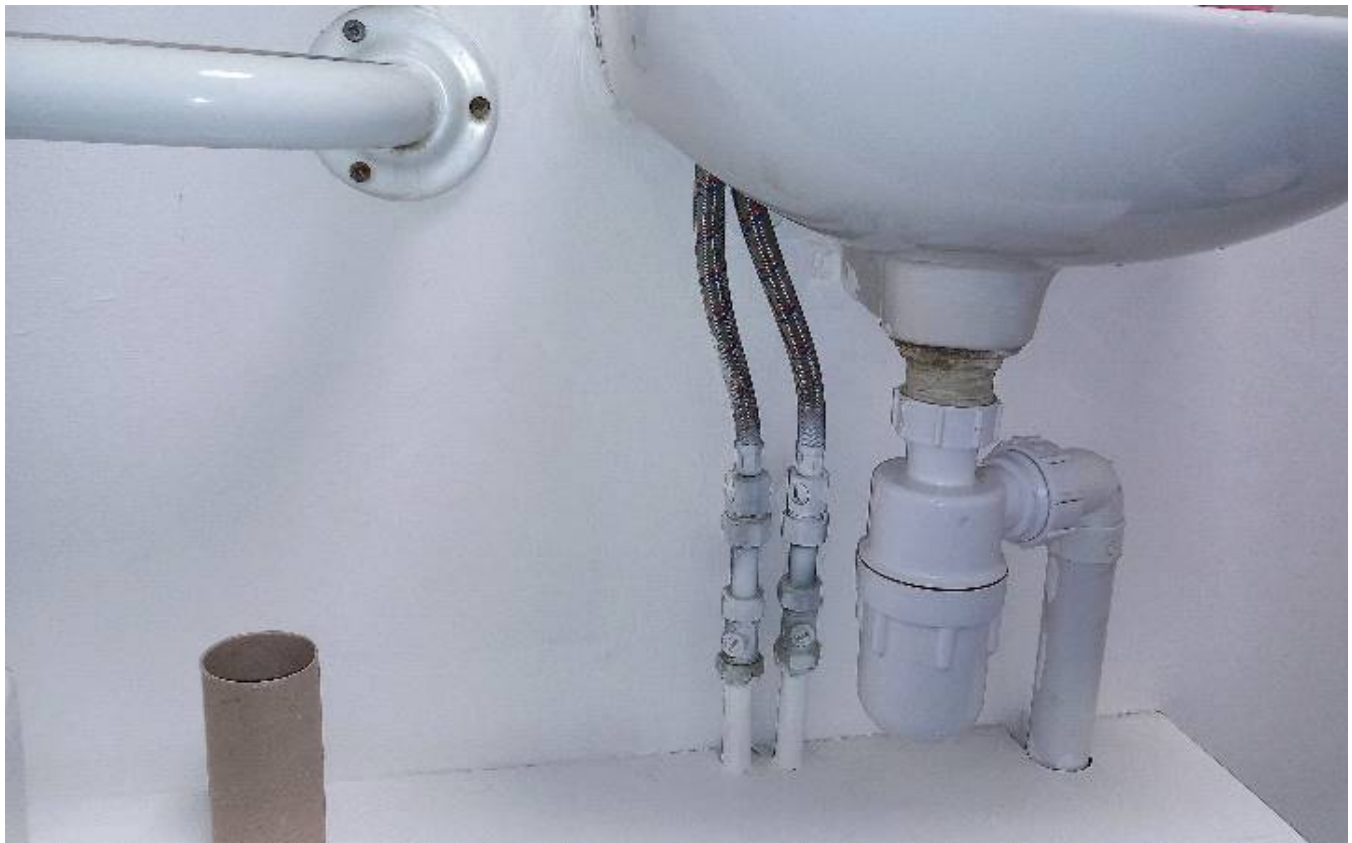
Asset No.	FH5
	Location	1st - Accessible WC
General	Satisfactory	No
Fed From	Fed From	Domestic
	Comments	-

Risk Rating	
System Risk	Medium

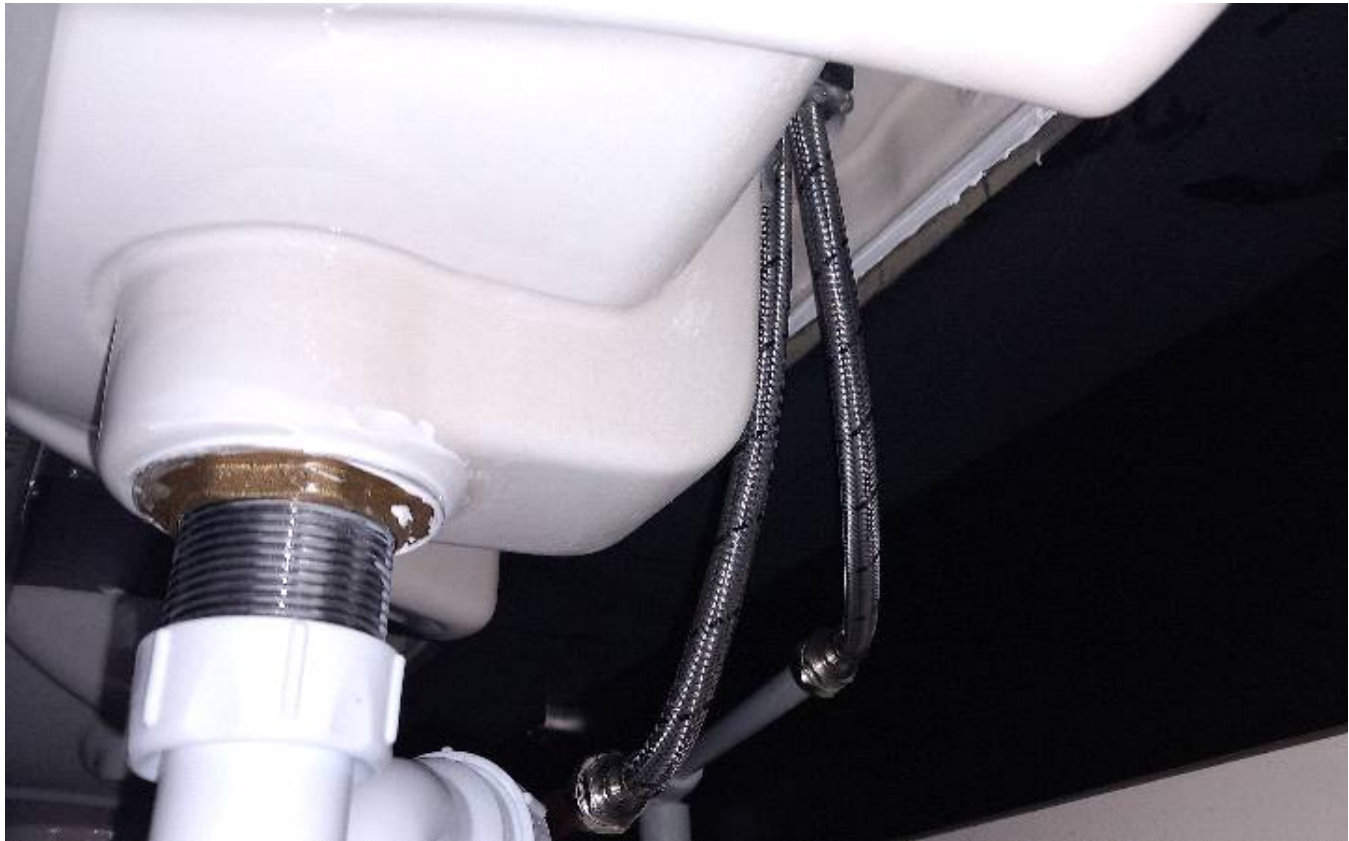
Asset No.	FH6
	Location	1st - Female WC
General	Satisfactory	No
Fed From	Fed From	Domestic
	Comments	-

Risk Rating	
System Risk	Medium

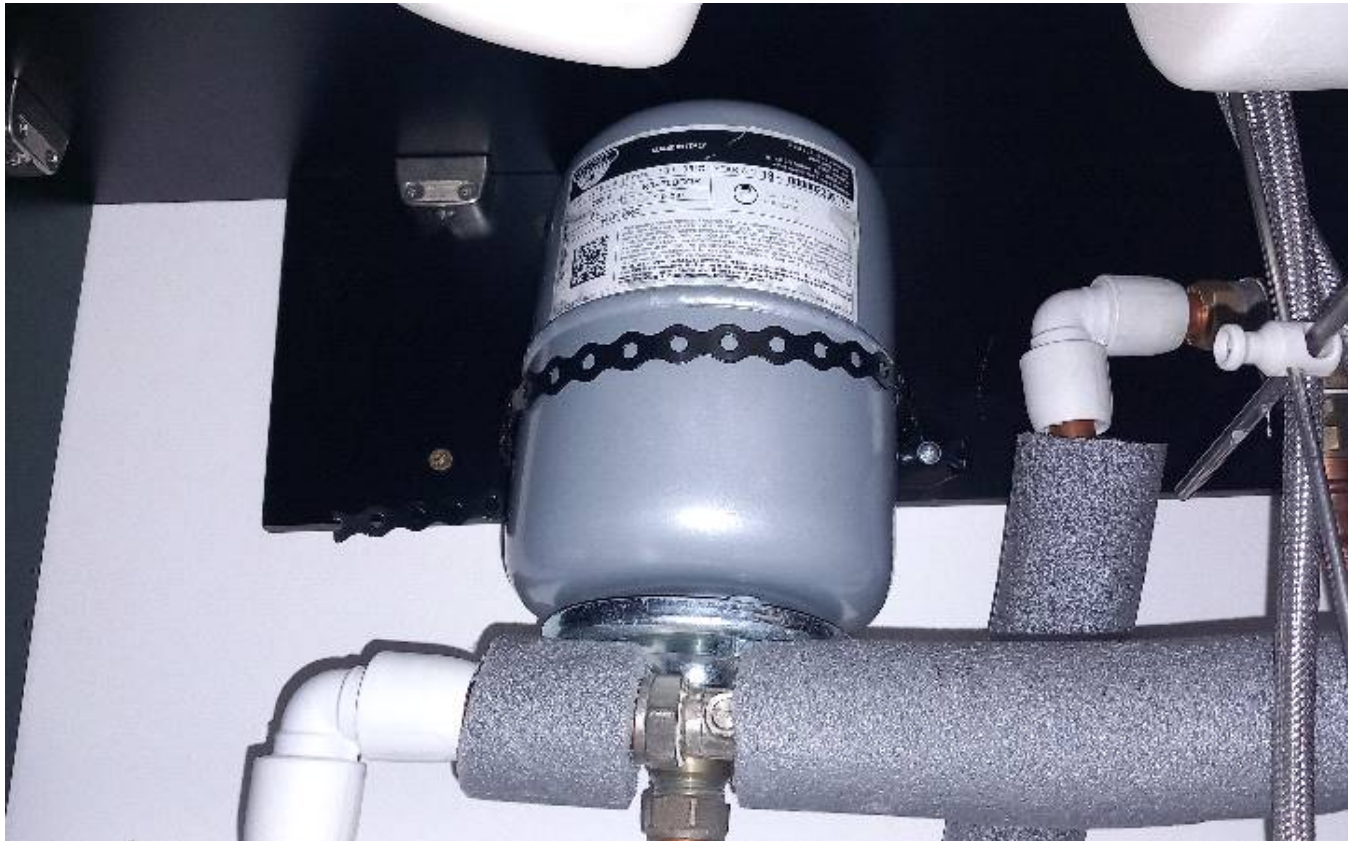
Asset No.	PV1
	Location	GF - Male WC
General	Satisfactory	No
Fed From	Fed From	Mains
	Comments	-

Risk Rating	
System Risk	High

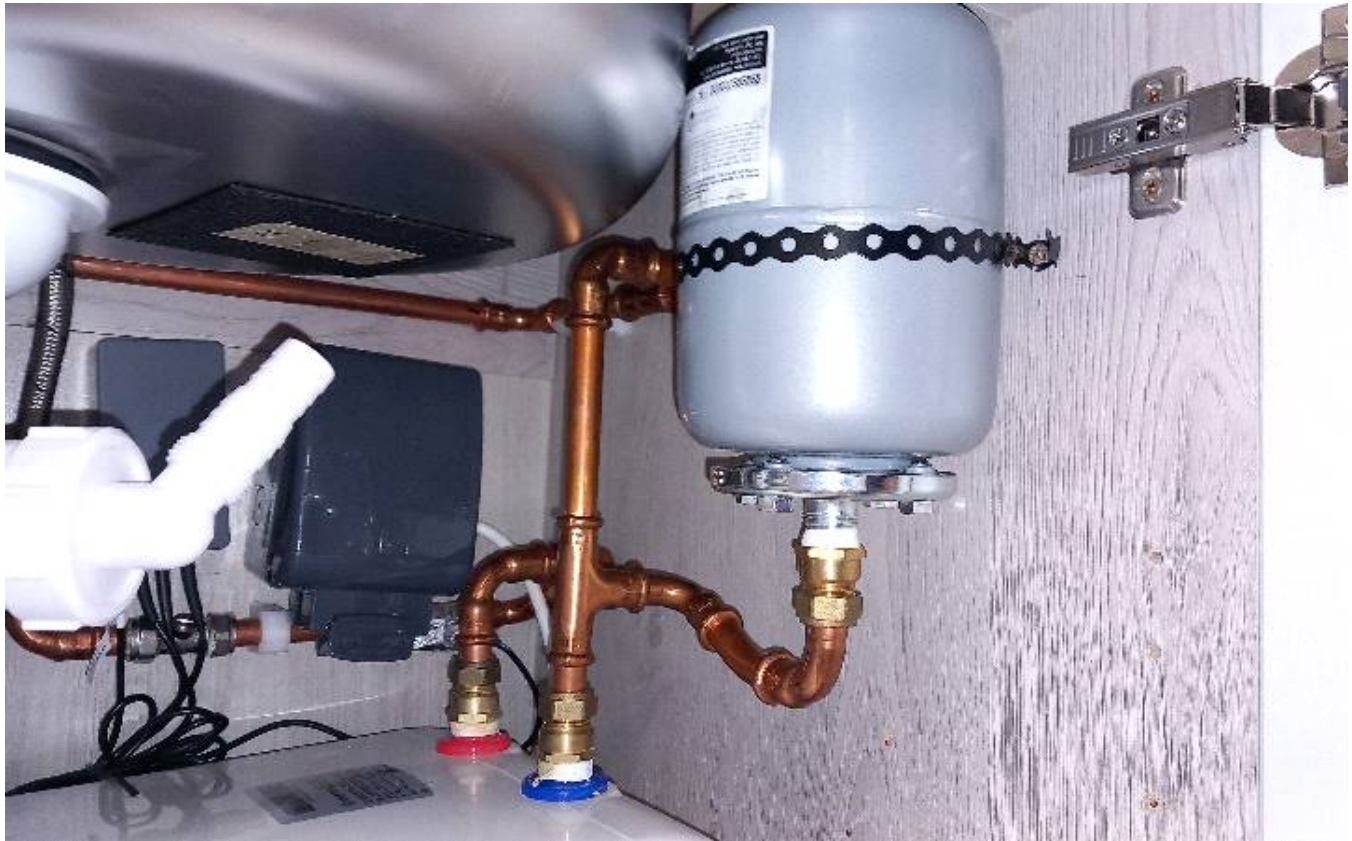
Asset No.	PV2
	Location	GF - Left Kitchen
General	Satisfactory	No
Fed From	Fed From	Mains
	Comments	-

Risk Rating	
System Risk	High

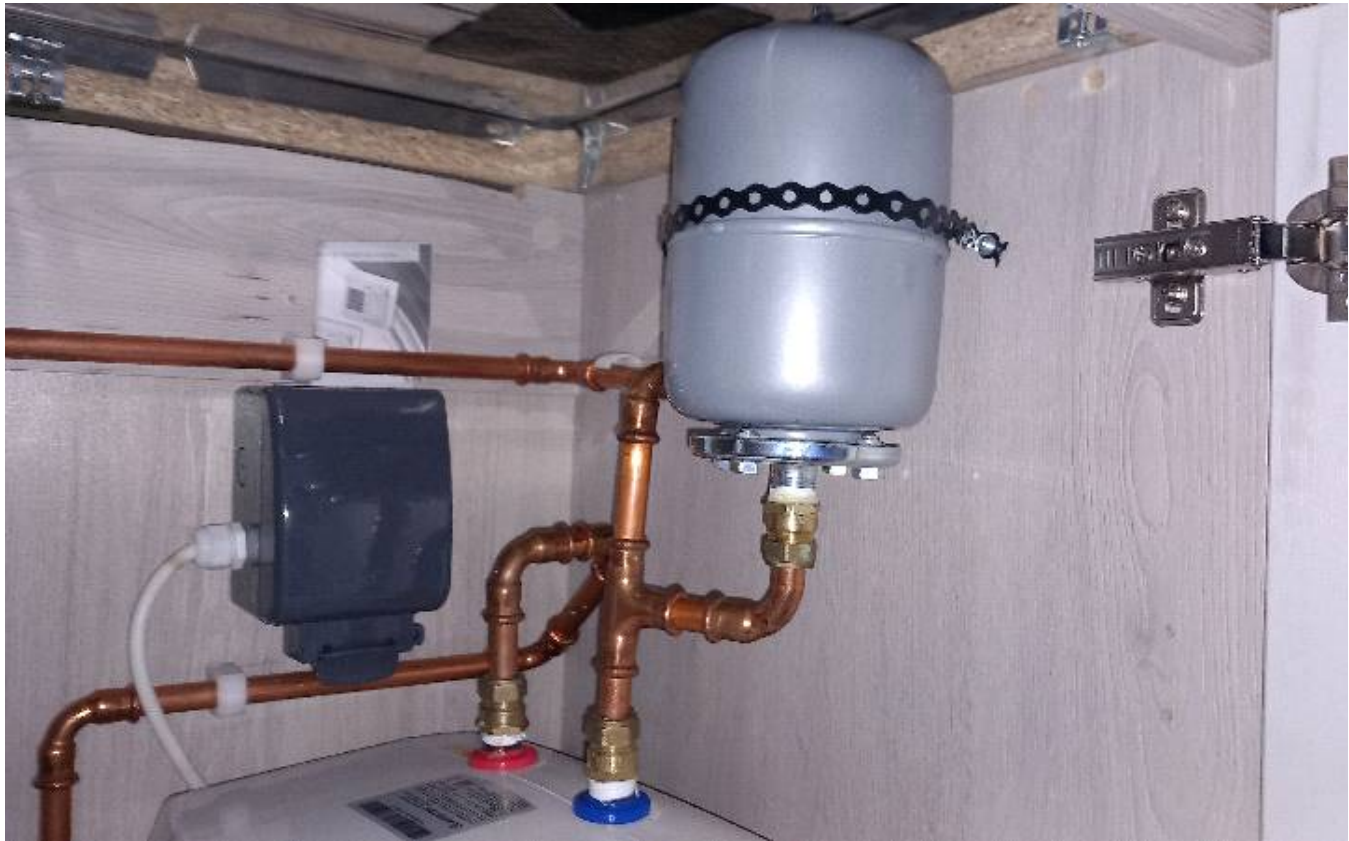
Asset No.	PV3
	Location	1st - Main Kitchen
General	Satisfactory	No
Fed From	Fed From	Mains
	Comments	-

Risk Rating	
System Risk	High

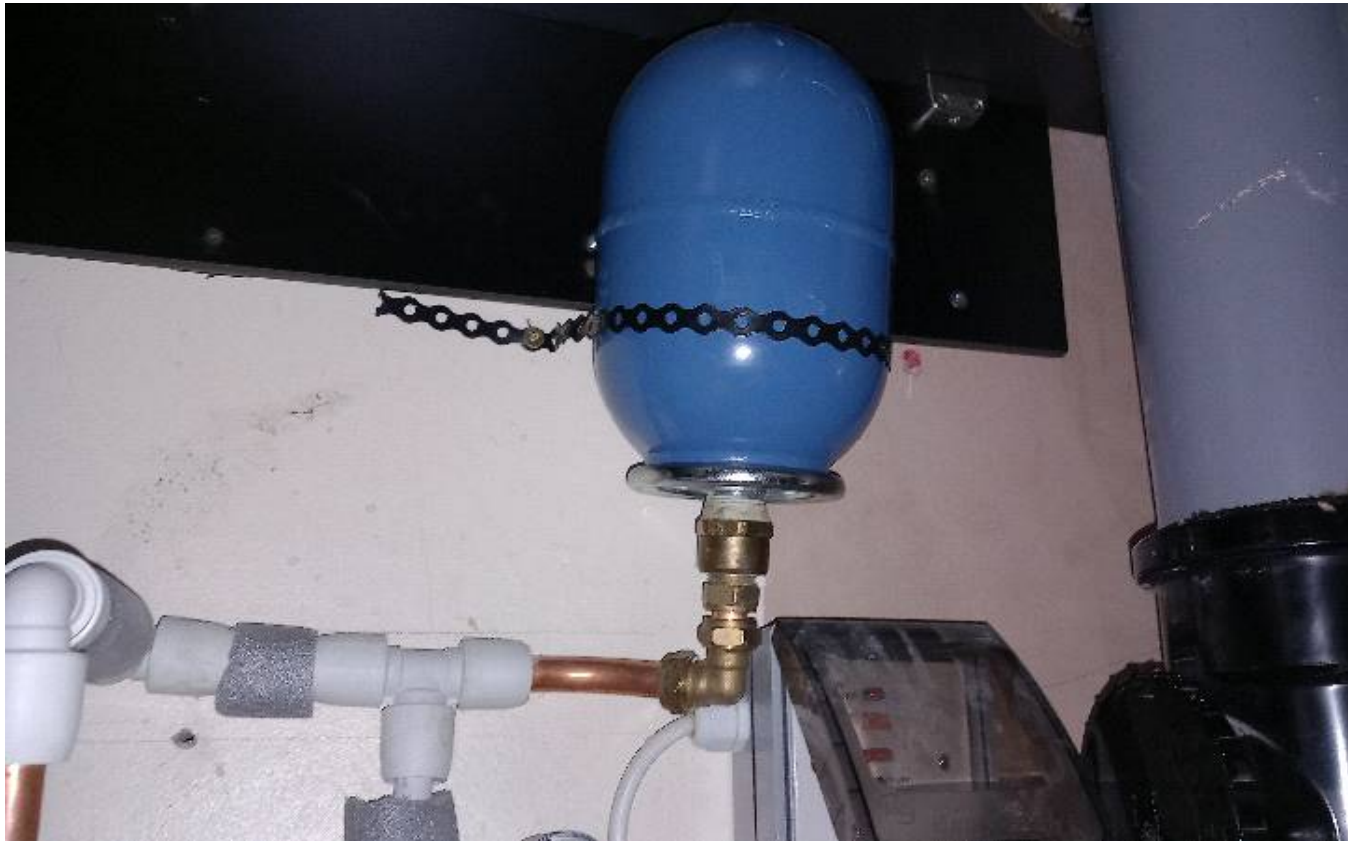
Asset No.	PV4
	Location	1st - Female WC
General	Satisfactory	No
Fed From	Fed From	Mains
	Comments	-

Risk Rating	
System Risk	High

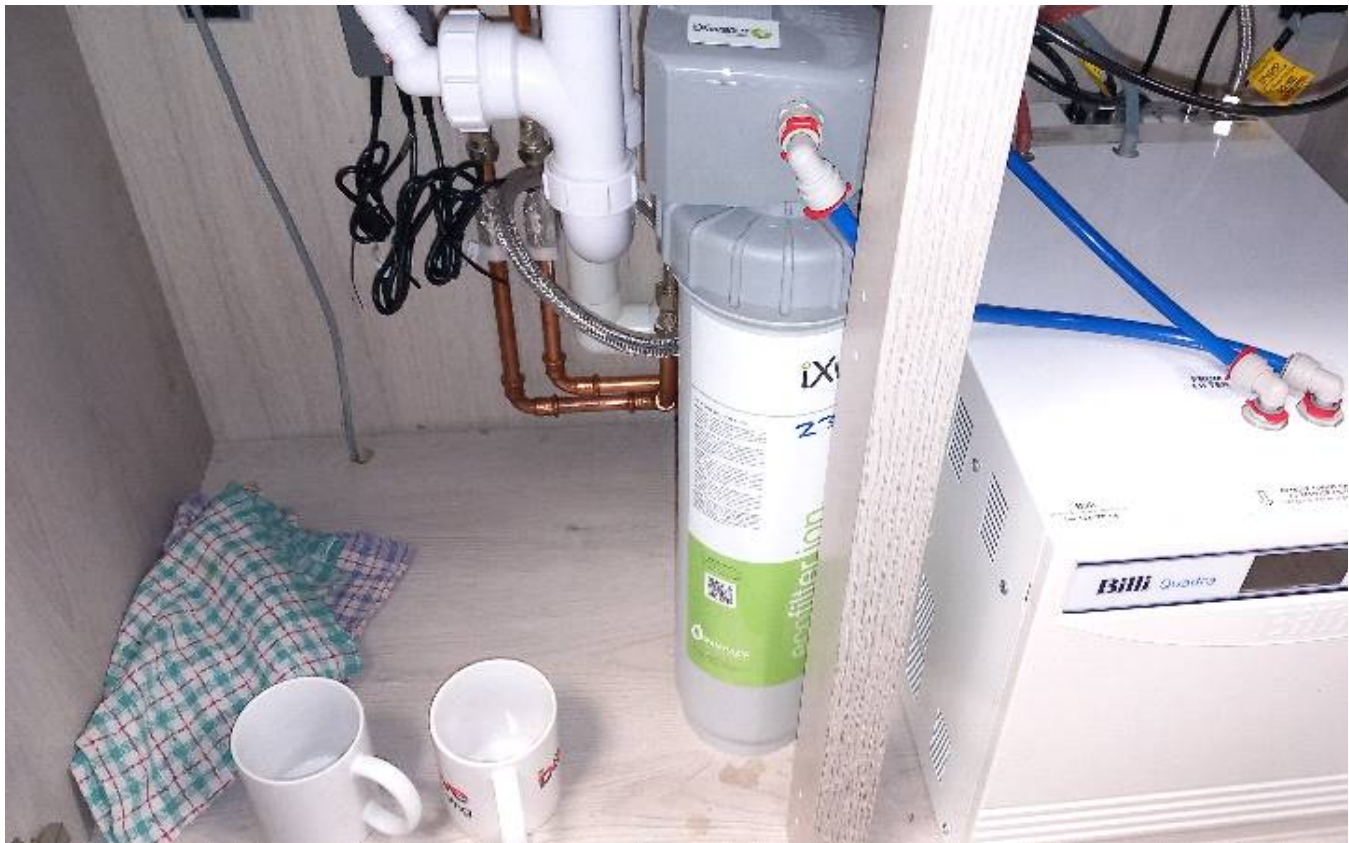
Asset No.	FIL1
	Location	GF - Right Kitchen
General	Satisfactory	Yes
Fed From	Fed From	Mains
	Comments	-

Risk Rating	
System Risk	Low
