LEGIONELLA RISK ASSESSMENT

Geo Tag: ,
Customer: Believe Housing
Site: Country House 27 Longfield Road South Church Enterprise Park
Bishop Auckland, DL14 6XB
Date: 1st February 2024
Risk Assessor: Carleton Waite
Report No: J052354 - 664703

Water systems found at Country House 27 Longfield Road South Church Enterprise Park Bishop Auckland

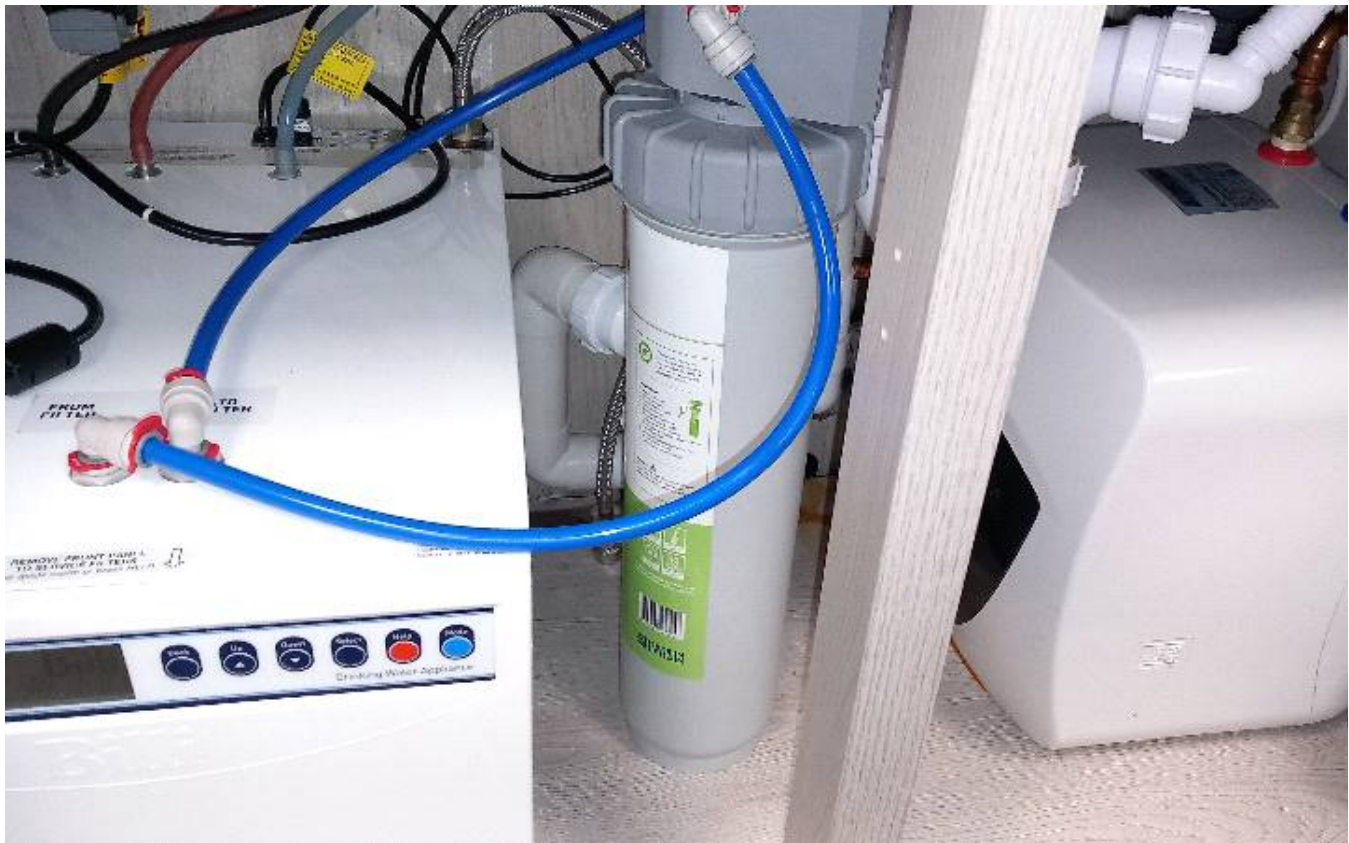
Asset No.	FIL2
	Location	GF - Left Kitchen
General	Satisfactory	Yes
Fed From	Fed From	Mains
	Comments	-

Risk Rating	
System Risk	Low

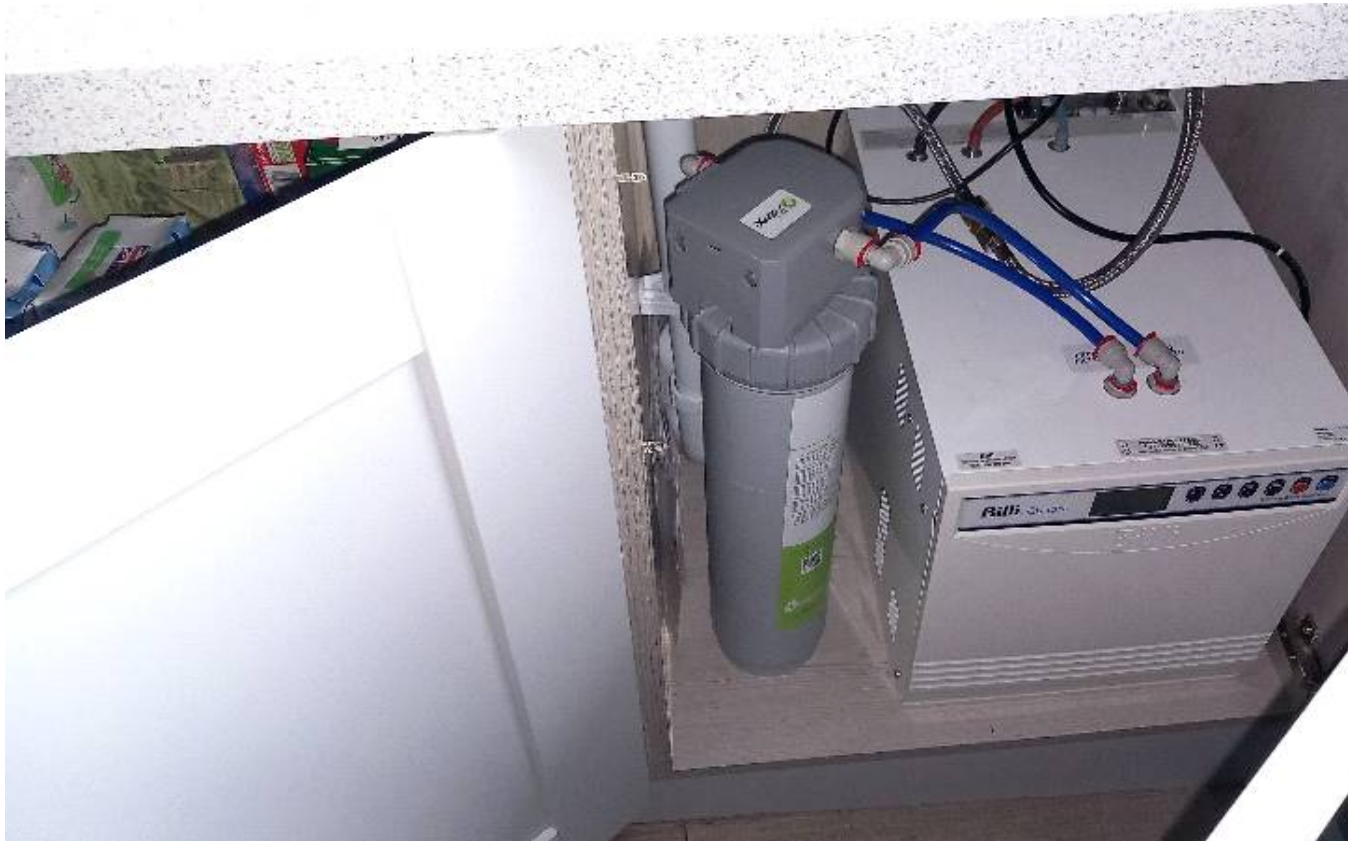
Asset No.	FIL3
	Location	1st - Main Kitchen
General	Satisfactory	Yes
Fed From	Fed From	Mains
	Comments	-

Risk Rating	
System Risk	Low

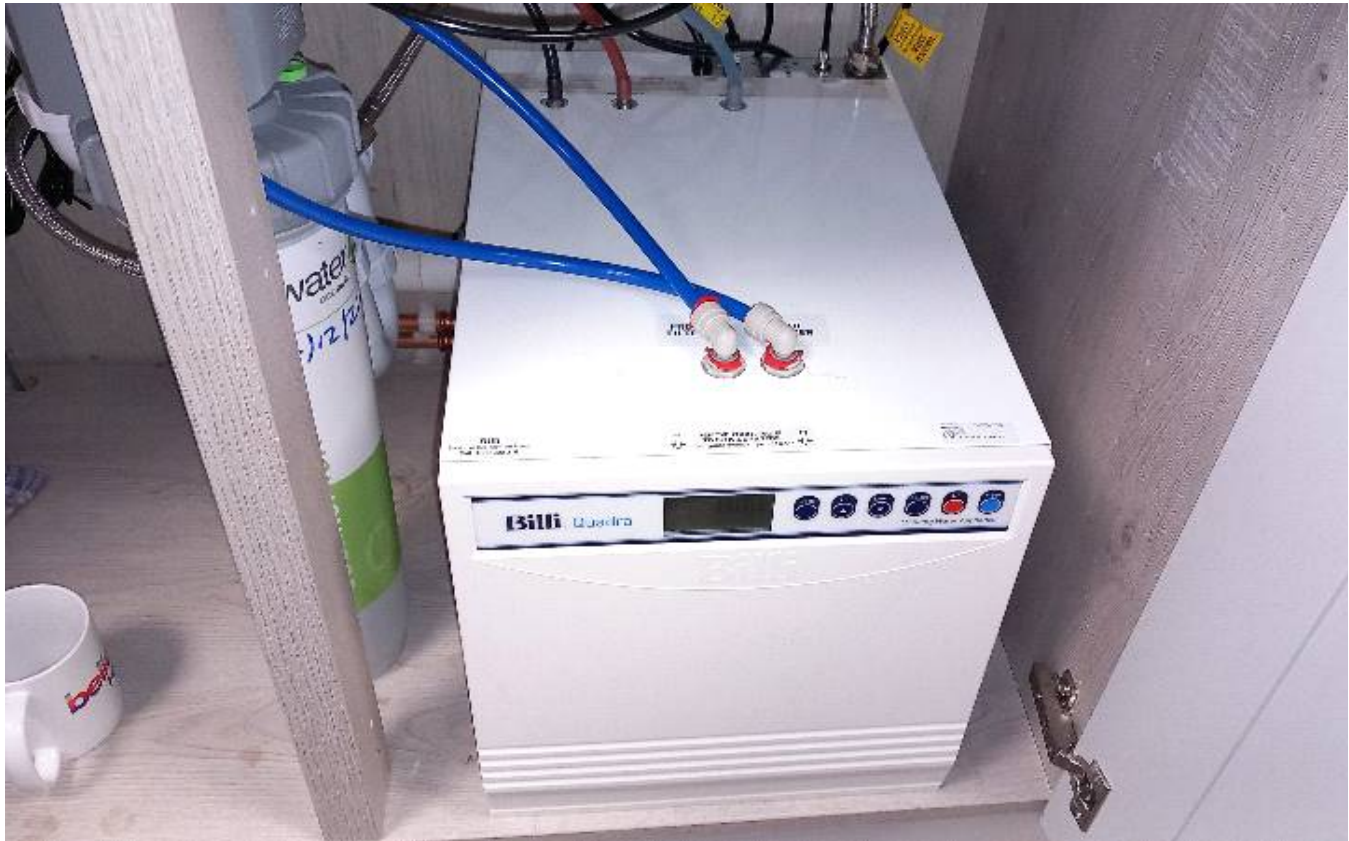
Asset No.	Drinking Water Dispenser
	Location	GF - Right Kitchen
General	Satisfactory	Yes
Fed From	Fed From	Mains
	Comments	-

Risk Rating	
System Risk	Low

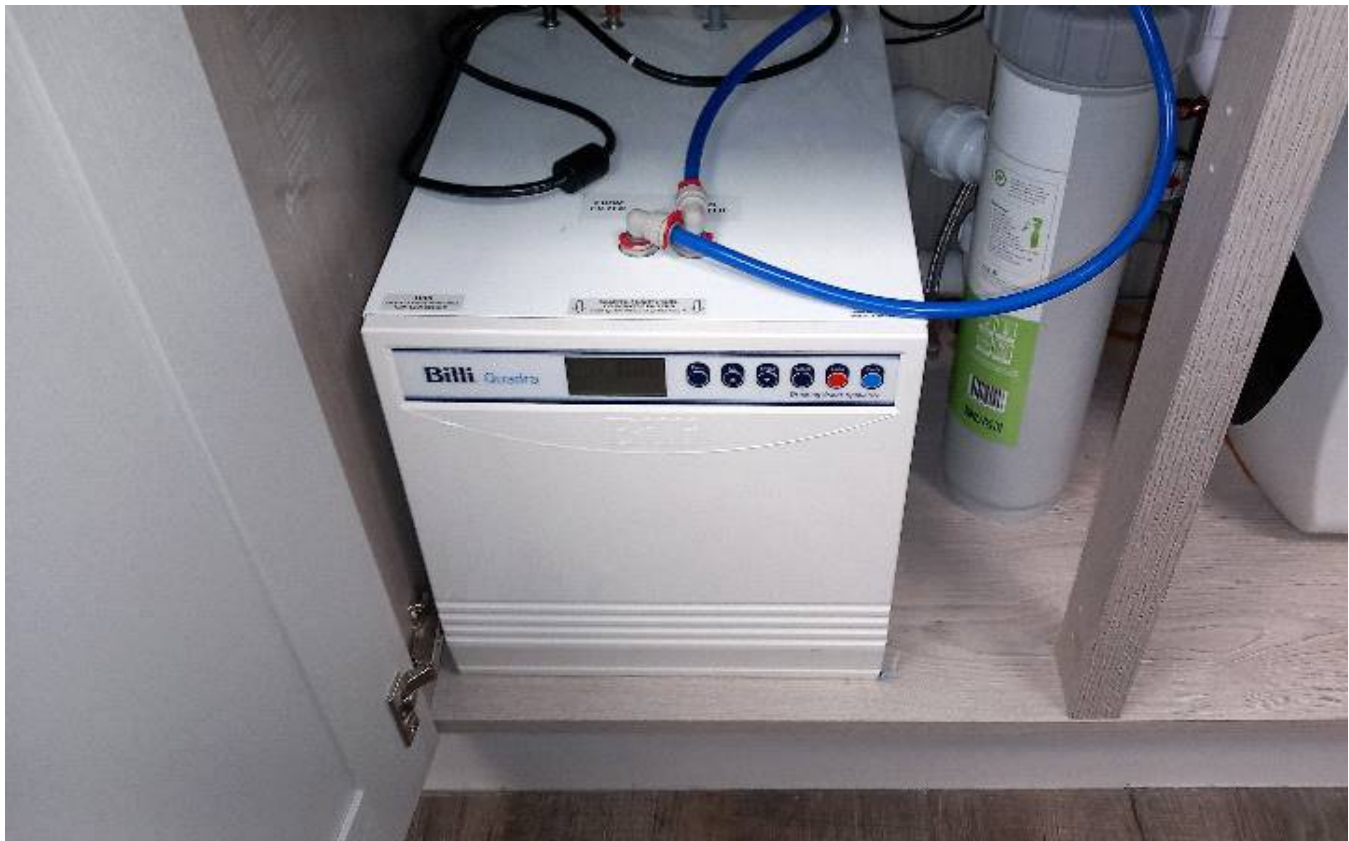
Asset No.	Drinking Water Dispenser
	Location	GF - Left Kitchen
General	Satisfactory	Yes
Fed From	Fed From	Mains
	Comments	-

Risk Rating	
System Risk	Low

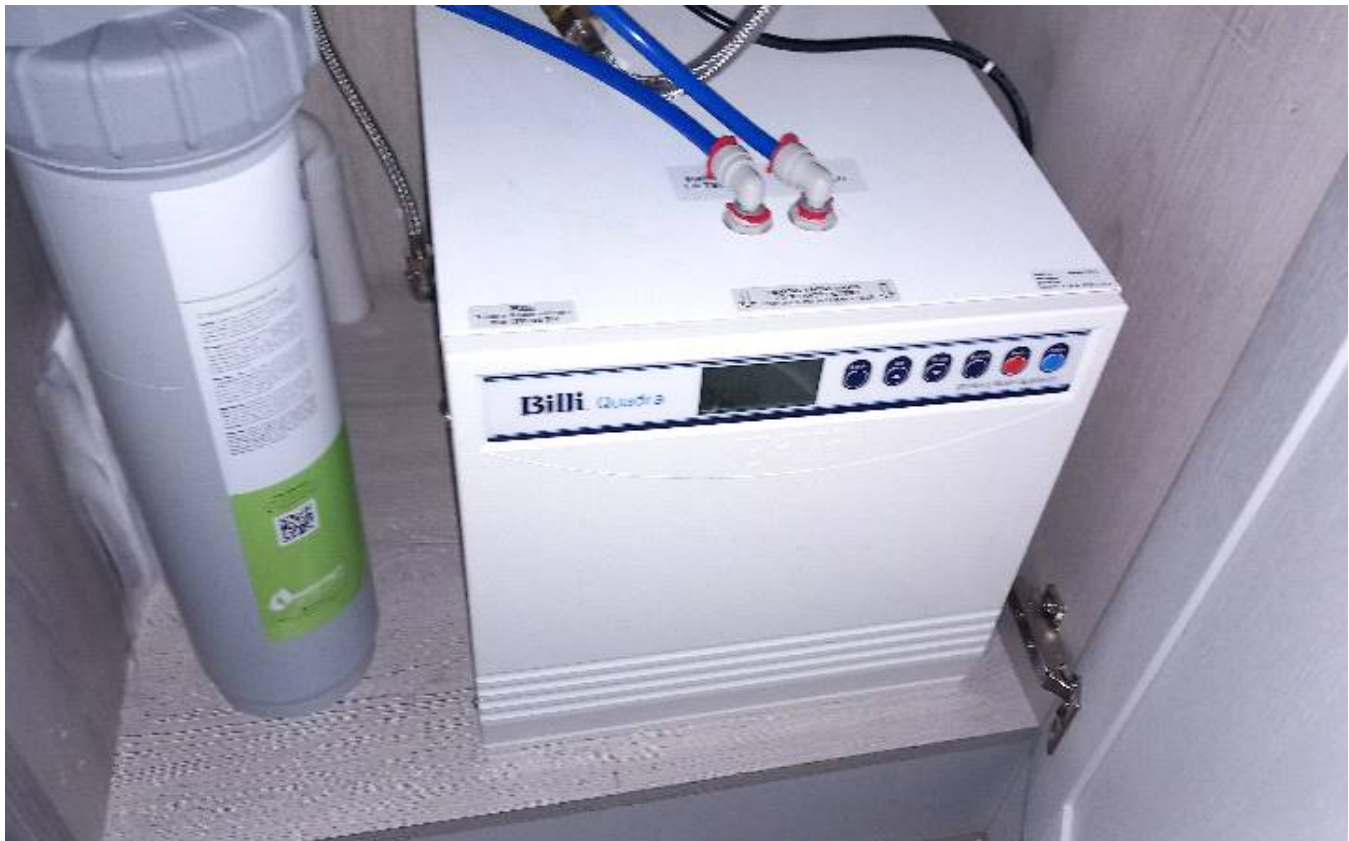
Asset No.	Drinking Water Dispenser
	Location	1st - Main Kitchen
General	Satisfactory	Yes
Fed From	Fed From	Mains
	Comments	-

Risk Rating	
System Risk	Low

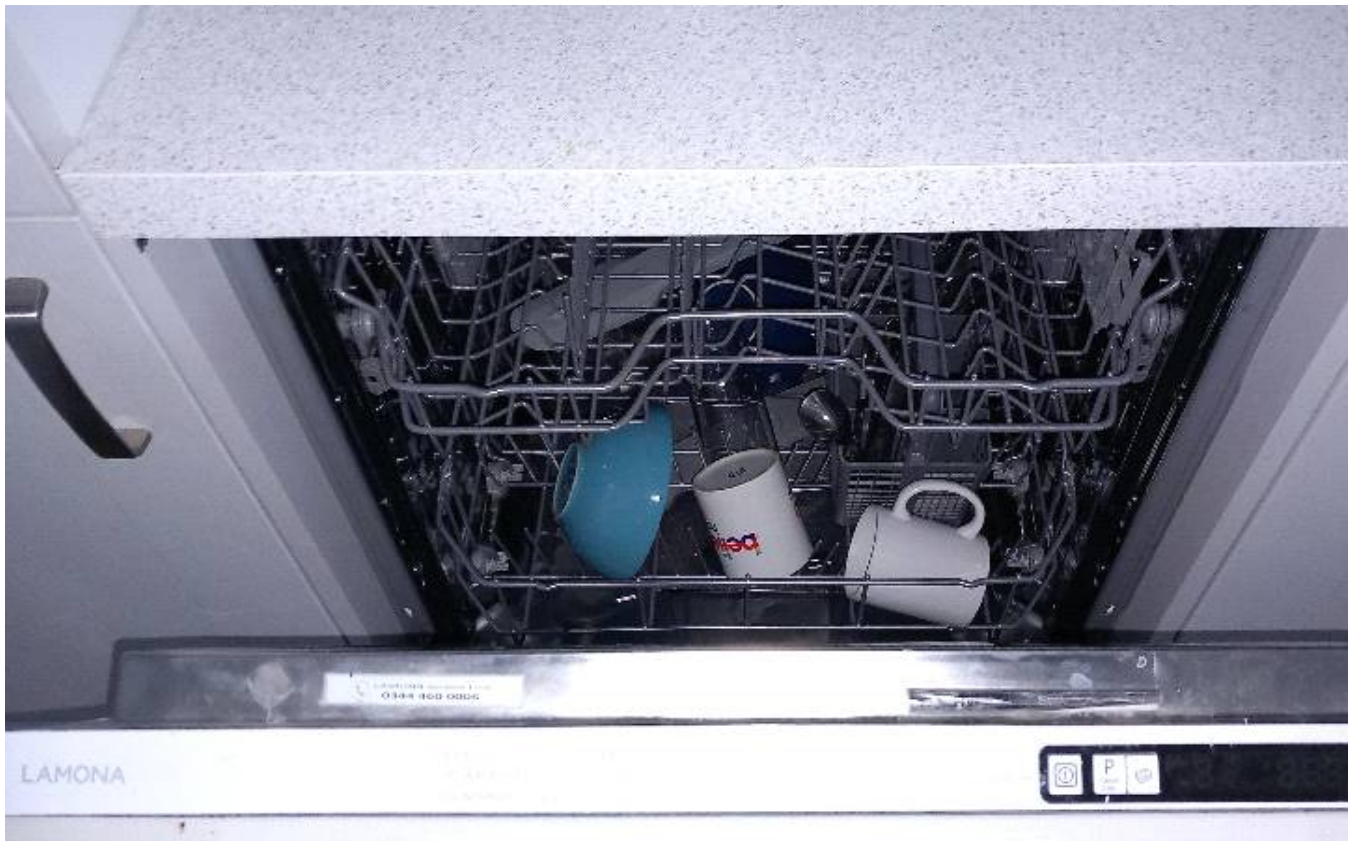
Asset No.	Dishwasher
	Location	1st - Main Kitchen
General	Satisfactory	Yes
Fed From	Fed From	Mains
	Comments	-

Risk Rating	
System Risk	Low
