LEGIONELLA RISK ASSESSMENT

Geo Tag: ,
Customer: Believe Housing
Site: Grey Gardens Community Centre 34 Grey Gardens Coundon , DL14 8LZ
Date: 4th August 2022
Risk Assessor: Mark Henderson
Report No: J046033 - 517820

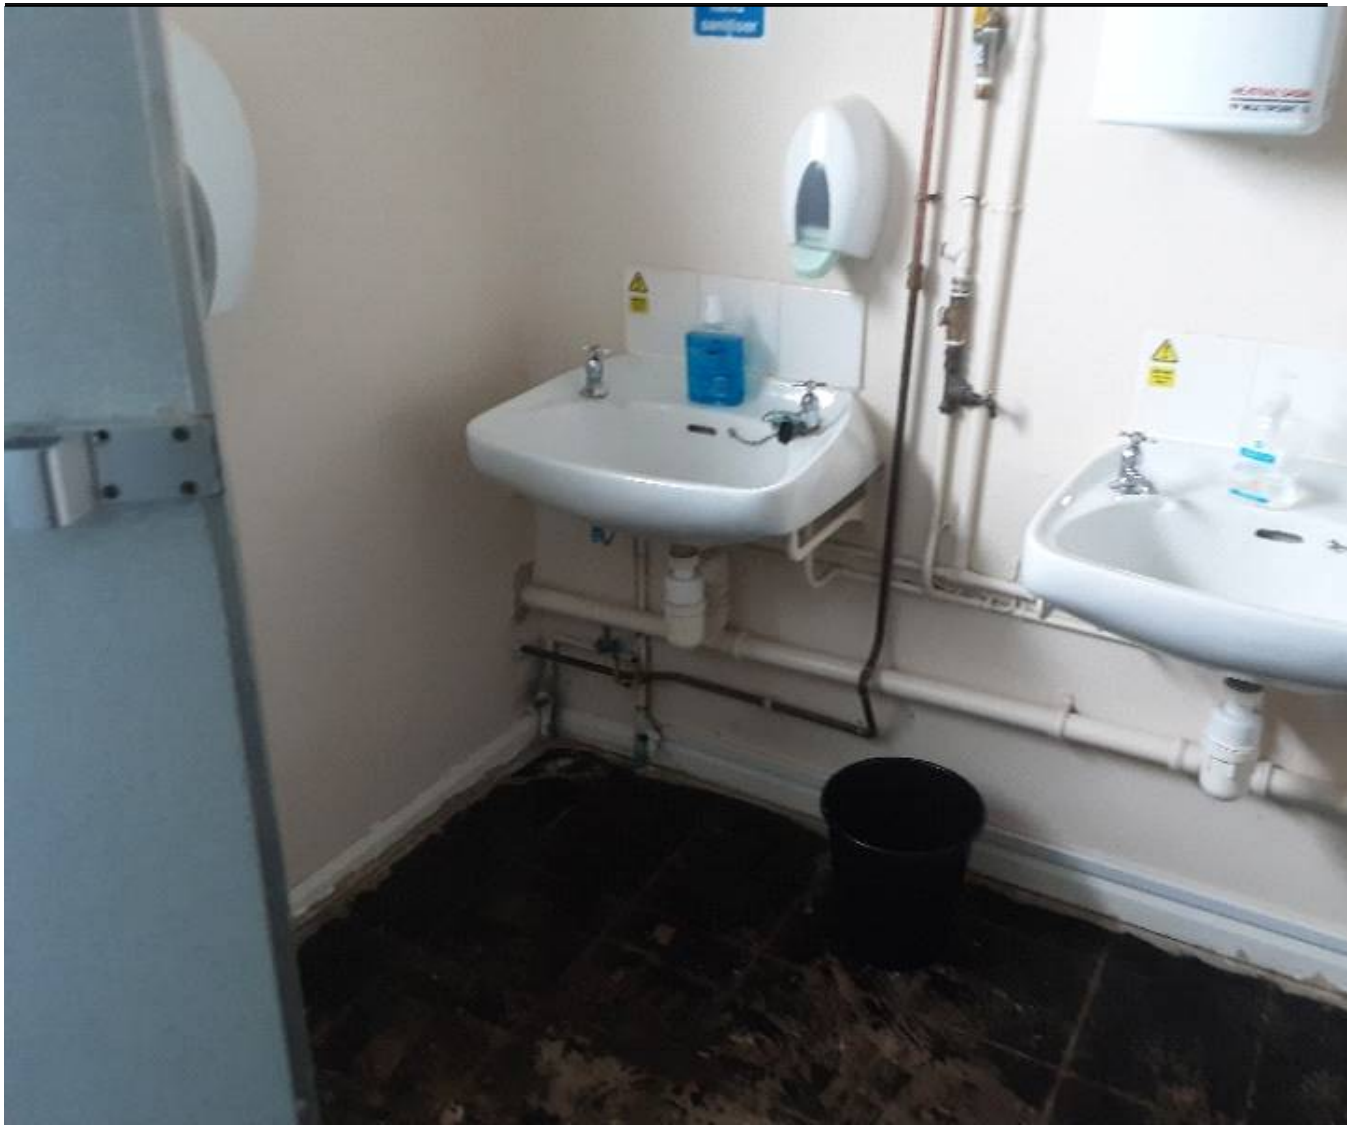
Asset No.	MAINS 1
	Location	Male Toilet
Details	Mains Supply Stop Cock Location	Male Toilet
	Serving	DCWS
	Mains Supply Source	Local Water Board
Material of Construction	Water Treatment In Place	N/A
	Temperature Of Mains Supply	16.0°C
	Supply Pipework	Copper
	Distribution Pipework	Copper
	Incoming Pipework Insulated	No
	Strainer Fitted	N/A
	Strainer Fitted Correctly	N/A
	Water Meter Installed	U/D
	Drinking Water Outlets Labelled	N/A
	WRAS Approved Materials	Yes
Records	Chemical Dosing System	N/A
	Filtration System	N/A
	UV System	N/A
	Temperatures	NC 12.0°C FC 12.0°C

Risk Rating	
System Risk	Medium

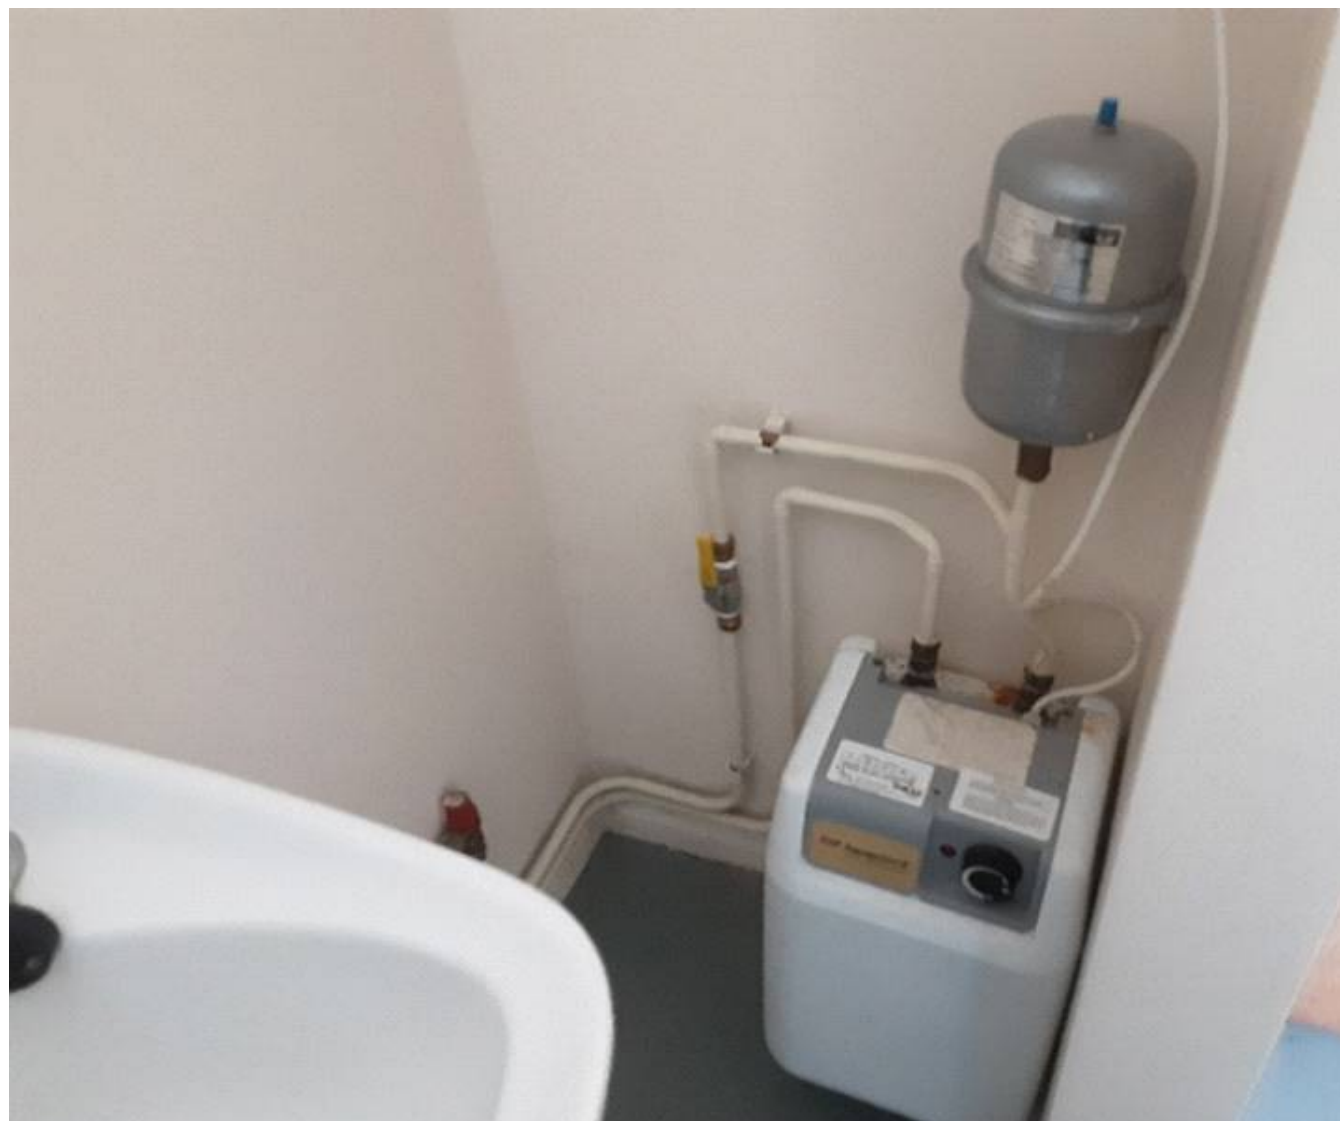
Asset No.	WH2
Location	Female Toilet
Water Heater Details	
Fed from	Mains
Heating Source	Electric
Storage	Low Storage Less 15 Ltrs
Power Supply To Units	On
Number Of Outlets	1
Max Temperature	55.0°C
WRAS Approved Materials	Yes
High Turn Over	Yes
Is Aerosol Likely	No
Condition Of Units Satisfactory	Yes
Temperatures	NH 55.0°C FH 55.0°C

Risk Rating	
System Risk	Low

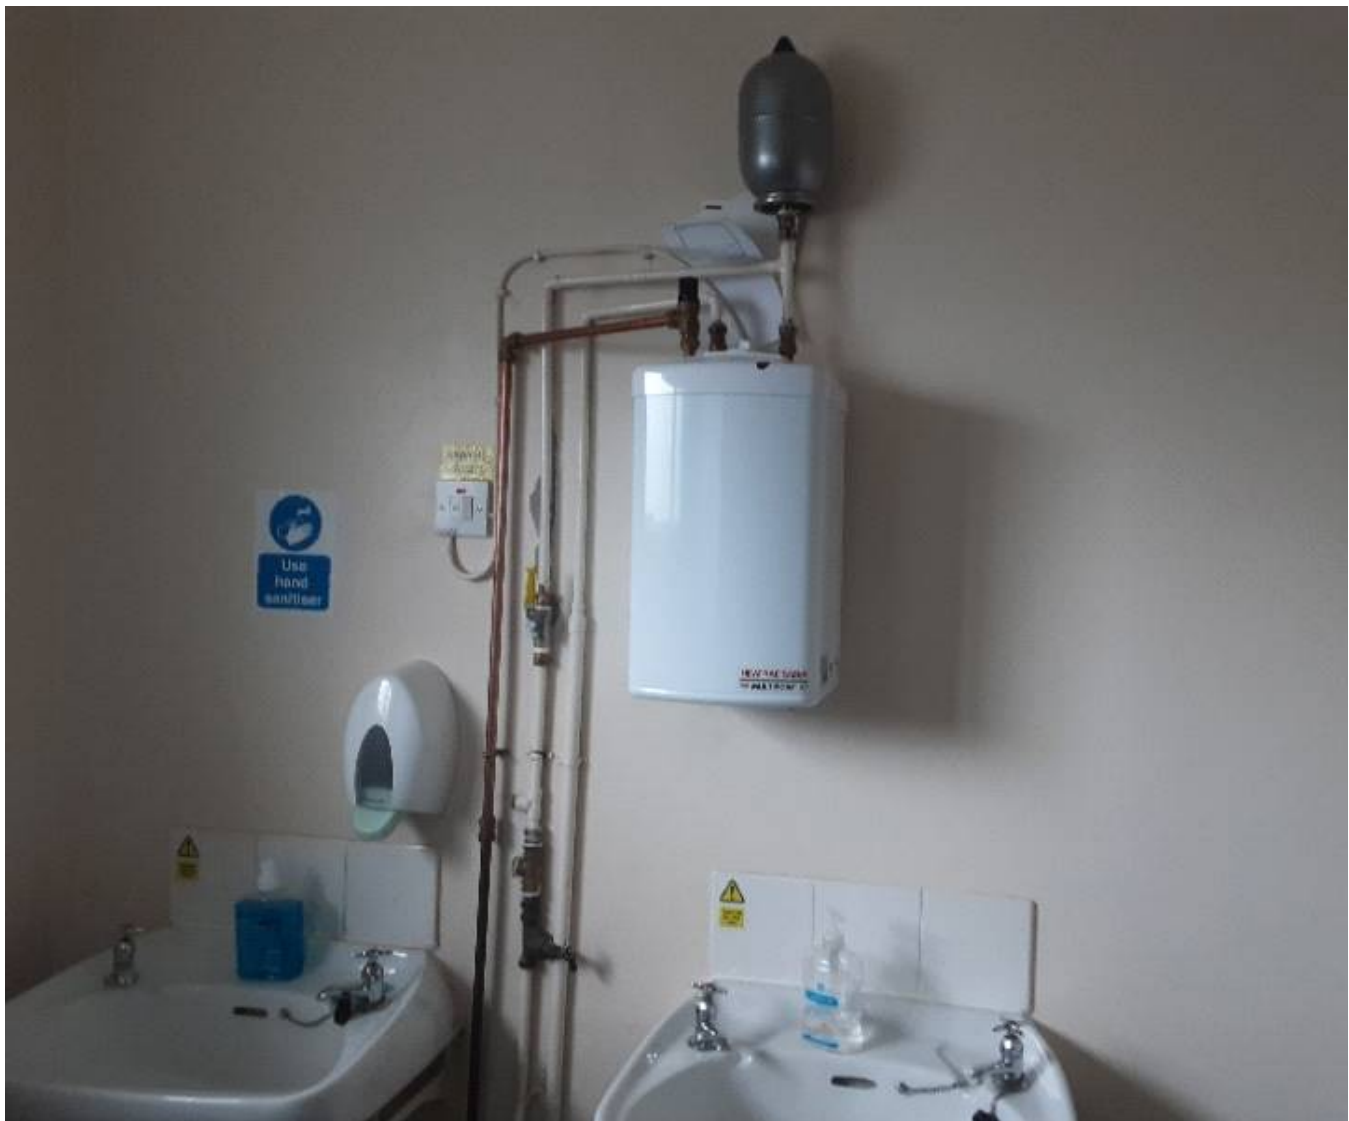
Asset No.	WH3
Location	Male Toilet
Water Heater Details	
Fed from	Mains
Heating Source	Electric
Storage	Low Storage Less 15 Ltrs
Power Supply To Units	On
Number Of Outlets	1
Max Temperature	55.0°C
WRAS Approved Materials	Yes
High Turn Over	Yes
Is Aerosol Likely	No
Condition Of Units Satisfactory	Yes
Temperatures	NH 55.0°C

Risk Rating	
System Risk	Low

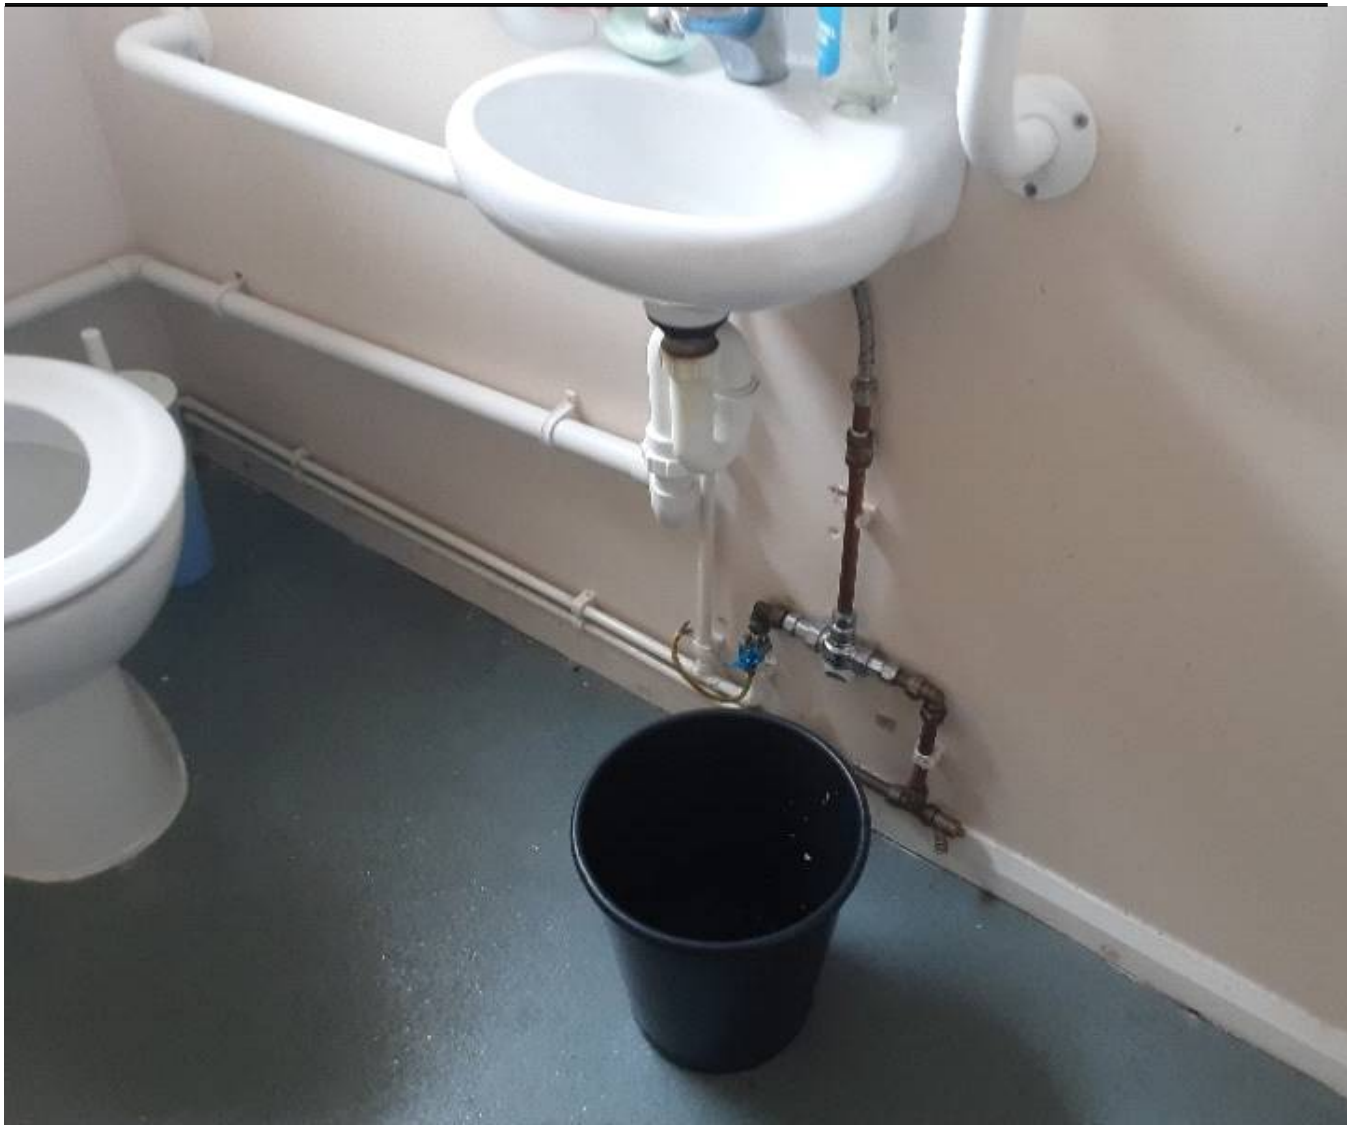
Asset No.	TMV1
Location	Accessible Toilet
TMV Details	
Approximate Number	1
TMV Type	TMV
Fed from Hot	Water Heater 2
Fed from Cold	Mains
Accessible	Yes
At Each Individual Outlet	Yes
Supplying Multiple Outlets	No
Number of outlets	1
Temperature	
Hot Supply To TMV Temperature	50.0°C
Cold Supply To TMV Temperature	16.0°C
Nearest Non-TMV Tap- Max Hot Temperature	N/A
Nearest Non-TMV Tap- Max Cold Temperature	N/A
TMV Outlet Temperature	40.0°C
Can TMV be moved closer to the POU	No
Can TMV be removed from system	No

Risk Rating	
System Risk	Low

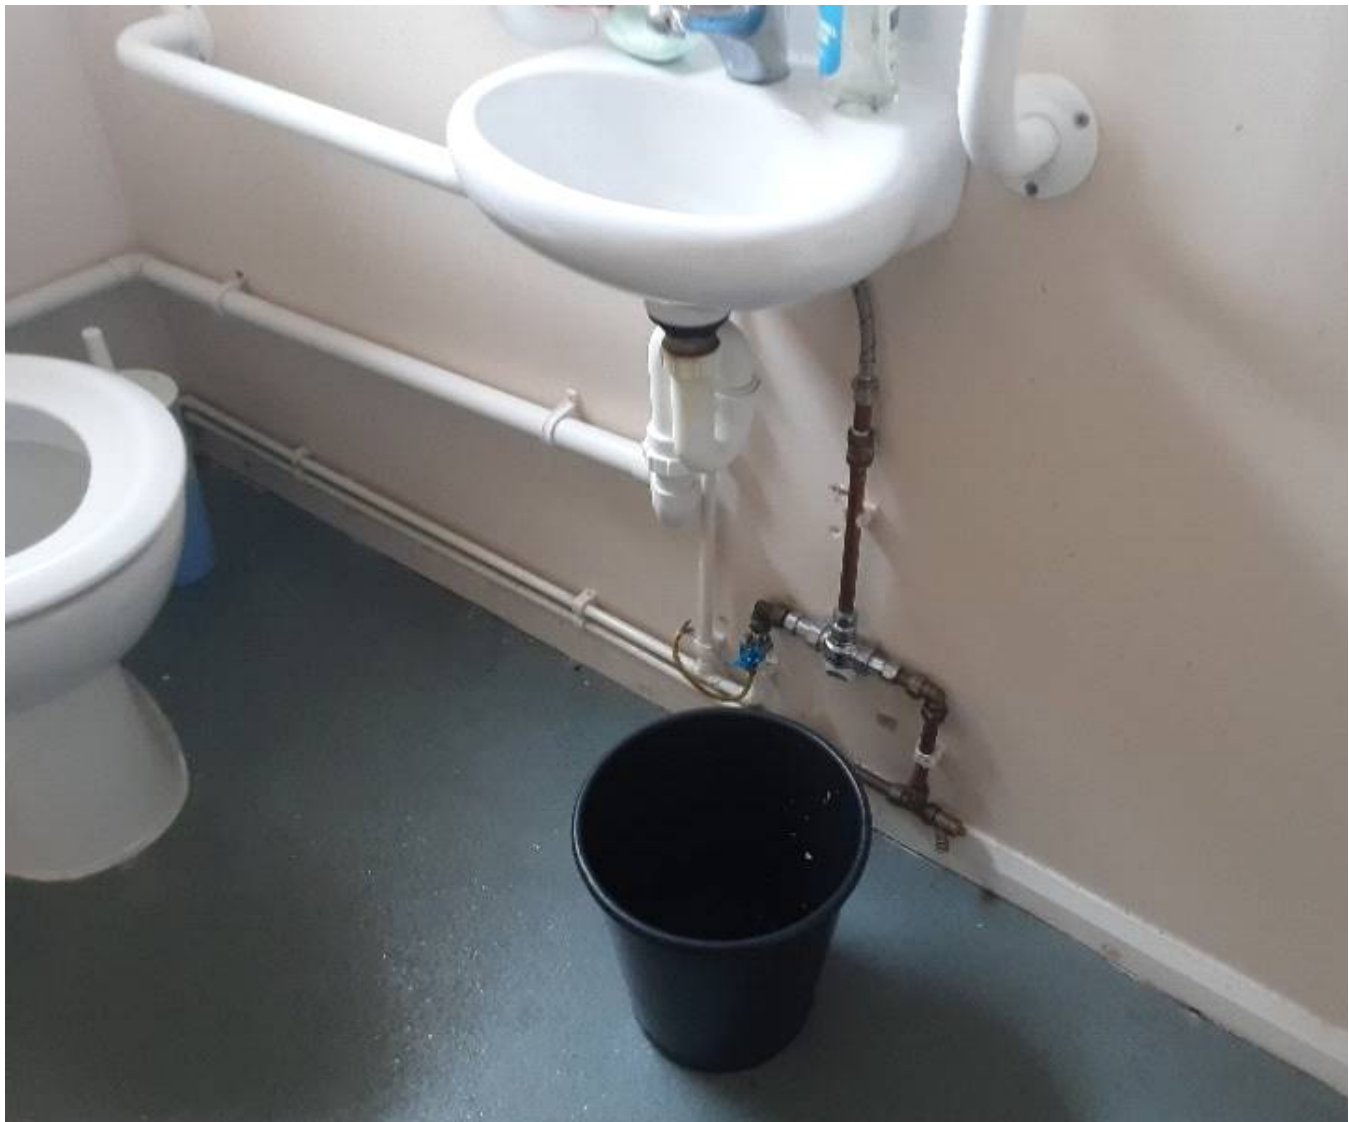
Asset No.	FH1& 2
	Location	Accessible Toilet
General	Satisfactory	Yes
Fed From	Fed From	Hot and Cold
	Comments

Risk Rating	
System Risk	Low

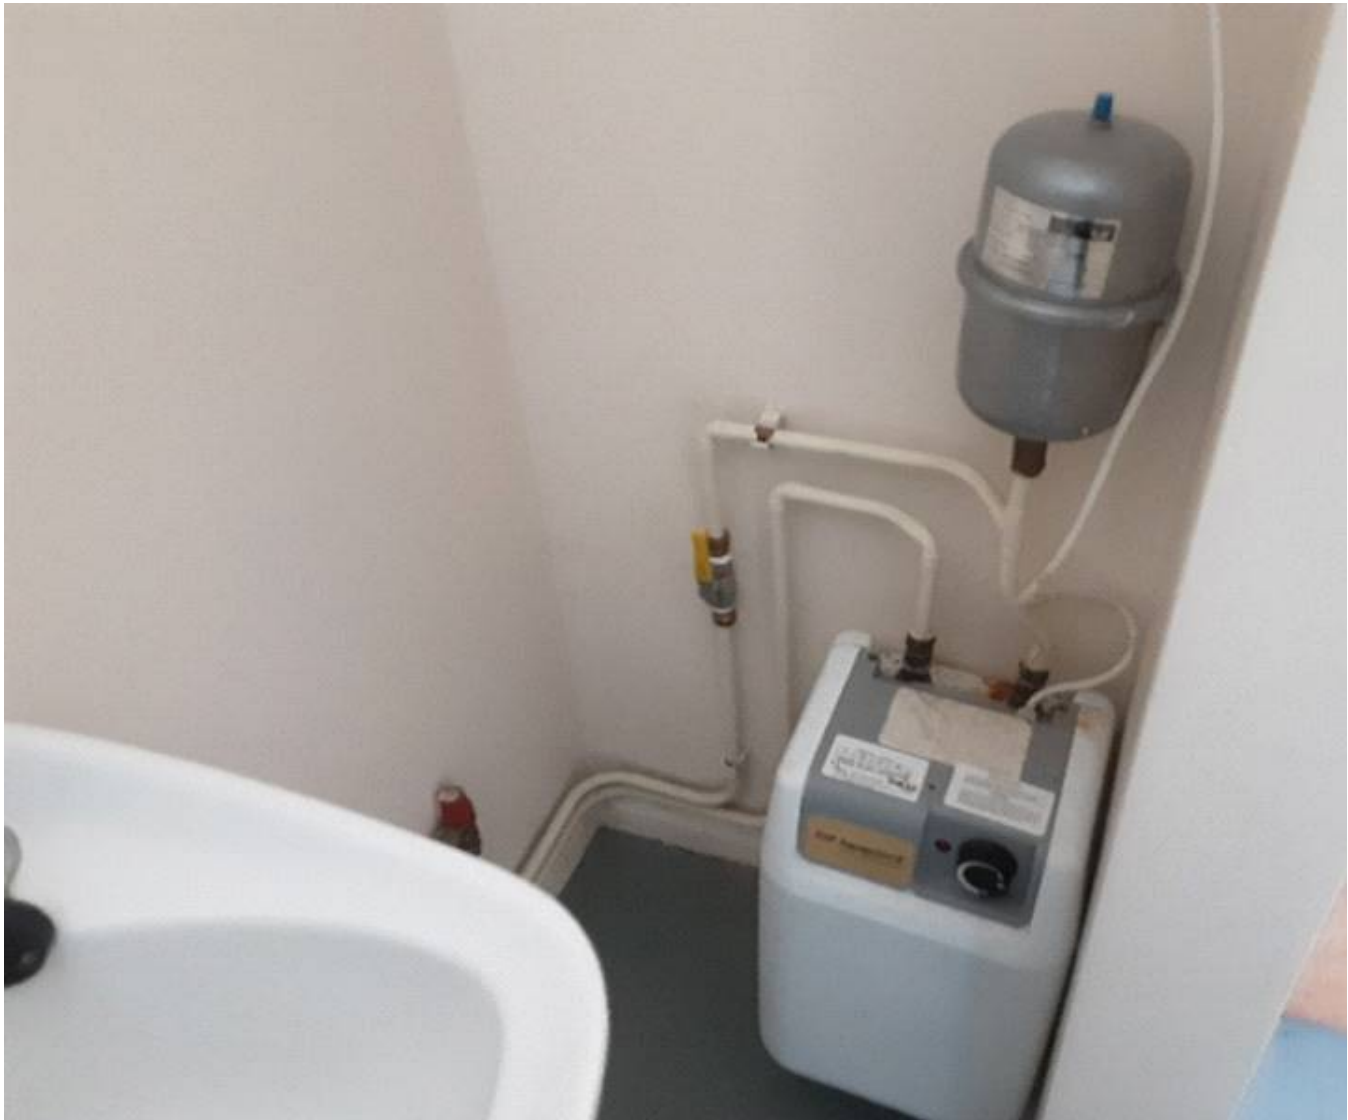
Asset No.	PV1
	Location	Female Toilet
General	Satisfactory	Yes
Fed From	Fed From	Mains
	Comments

Risk Rating	
System Risk	Low

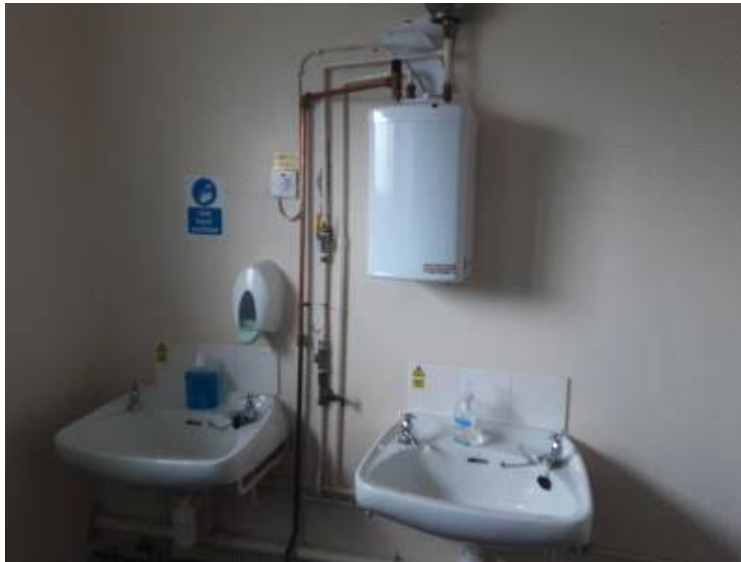
Asset No.	PV2
	Location	Male Toilet
General	Satisfactory	Yes
Fed From	Fed From	Mains
	Comments

Risk Rating	
System Risk	Low

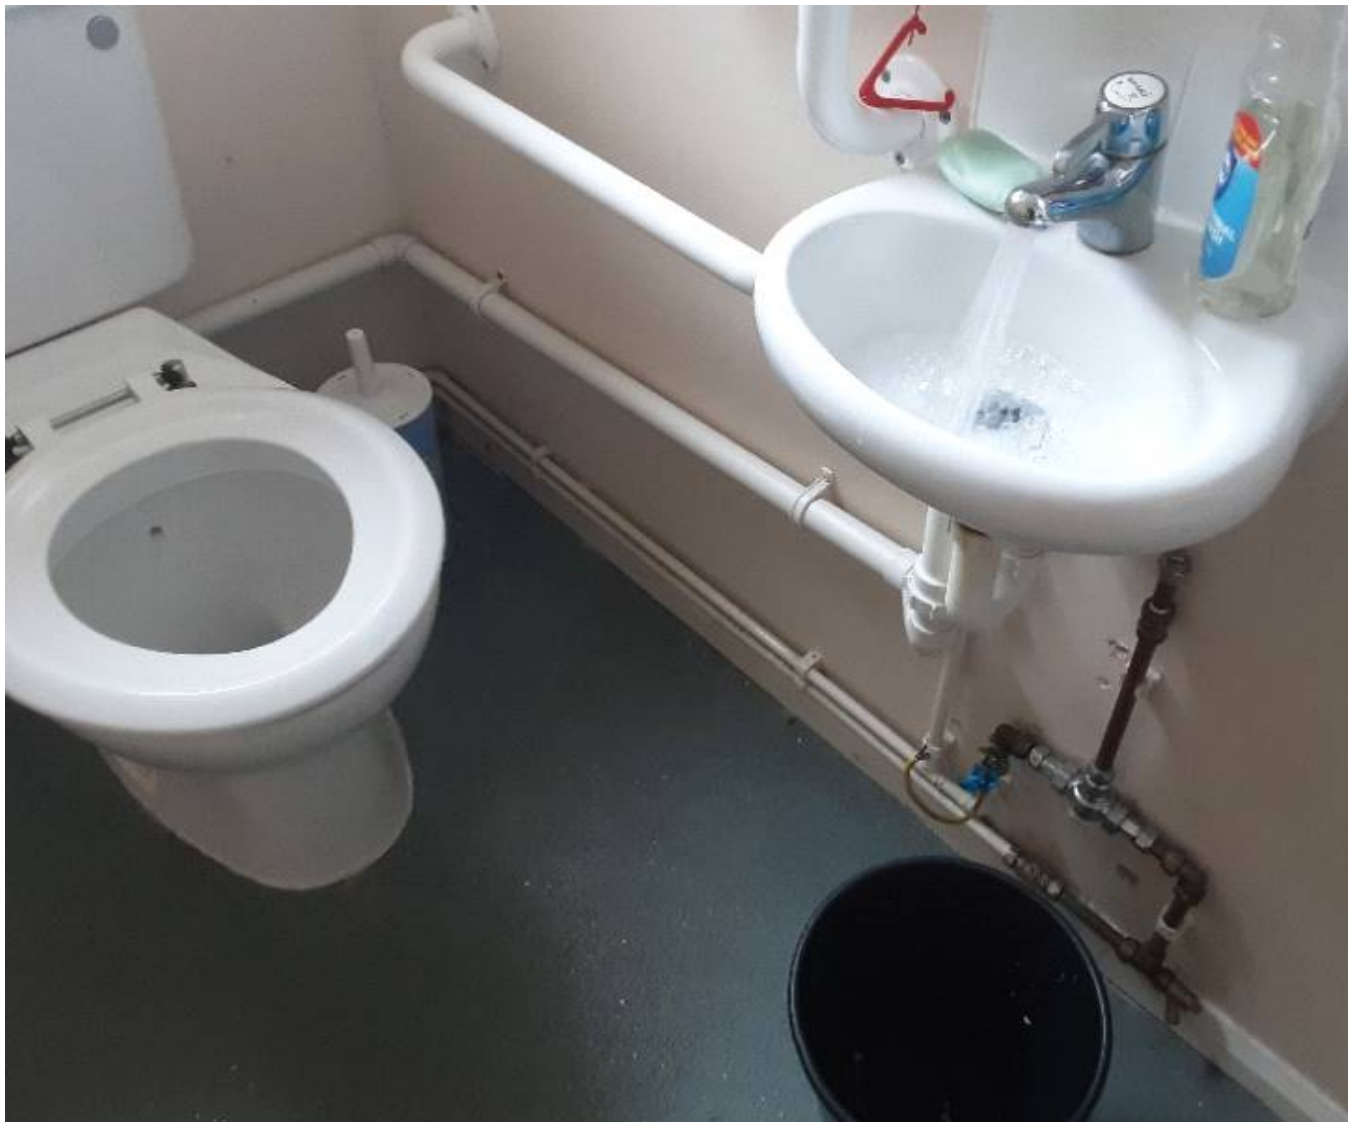
A spray tap was observed on site.

Asset No.	ST1
	Location	Accessible Toilet
General	Satisfactory	No
Fed From	Fed From	Hot and Cold
	Comments

Risk Rating	
System Risk	High

The spray tap should be changed to a normal operation tap which will reduce aerosol release, or the spray head should be removed.

Spray taps create an aerosol. The sprays taps should be changed to normal operation taps which will reduce aerosol release.

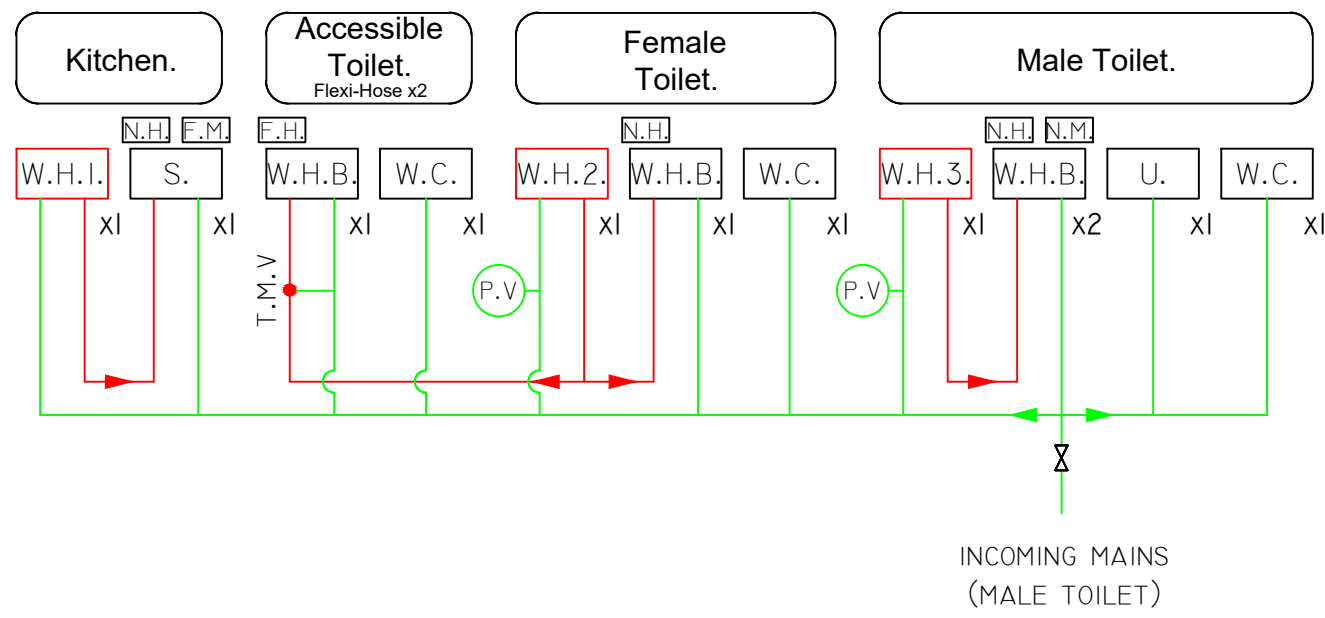
GROUND FLOOR.

HBE Schematics are a representation of the water system. The surveyor uses his/her experience to determine which source supplies the relevant outlet/s. For accurate information on which source supplies each outlet HBE would recommend a dye test is undertaken.
