LEGIONELLA RISK ASSESSMENT

Geo Tag: ,
Customer: Believe Housing
Site: Donnini House Sheltersed Housing, Easington Colliery, Peterlee, SR8 3ER
Date: 7th November 2023
Risk Assessor: Carleton Waite
Report No: J051366 - 643228

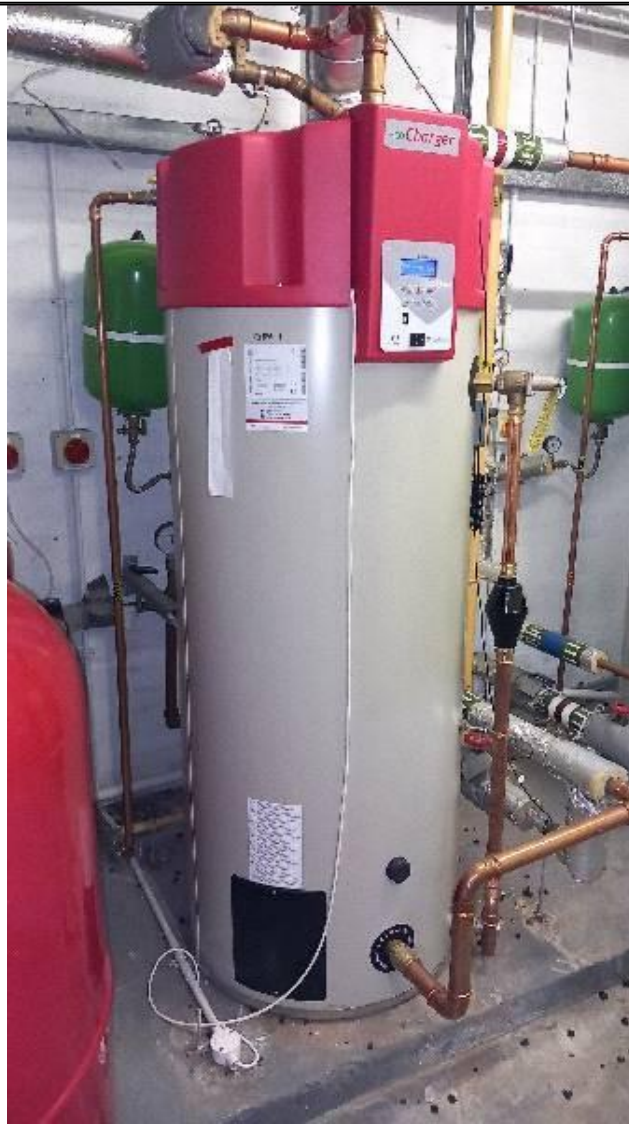
Asset No.	CAL 2
Location	External - Boiler Room
CAL Details	
Supplied from	Mains
Serving Building	Building
Time Of Inspection	10:00
Make and Model	Lochinvar
Calorifier Orientation	Vertical
No of Calorifiers in System	2
Materials Of Construction	Stainless Steel
Capacity	374.0ltrs
Main Heat Source	Gas
Supplementary Heat Source	-
Temp & Flow	
Temperature Gauge Fitted To Calorifier / Flow	Yes
Temperature Gauge Fitted To Return	Yes
Calorifier Off Or On	On
Flow Temperature	66.0°C
Return Temperature	61.0°C
Calorifier Stratification	No
Calorifier Temperature Top	N/A
Calorifier Temperature Middle	N/A
Calorifier Temperature Bottom	N/A
Thermostat Setting	66°C
Drain Fitted	Yes
Complete Draining Of Vessel Possible	Yes
Initial Blow down Appearance	Unable To Determine
Circulation & Insulation	
System Circulated	Yes
Pumps Alternated	N/A
Calorifier Insulation	Yes
Pipe Work Insulation	Yes
Pipe Work labelled	Yes
Open Vent Present	N/A
Safety Valve Present	Yes

System Ref	Calorifiers	Priority	Assigned To	Comments	Date Completed	Signed
CAL 1	Repair and replace corroded pipework on the return	High / Category 2

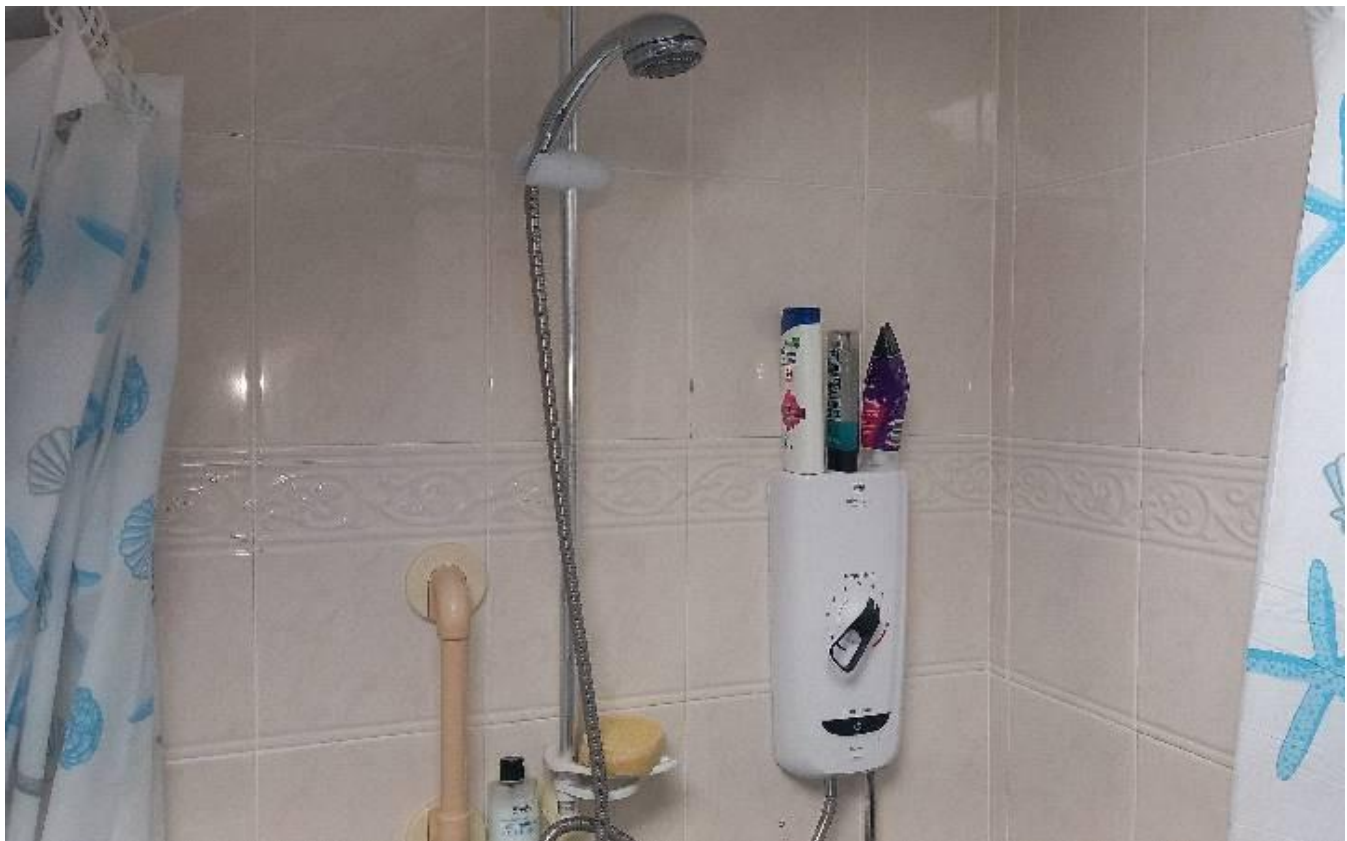
Asset No.	Shower
	Location	GF - Shower
SH Details	Number of Outlets	1
	Fed From Hot	-
	Fed From Cold	Mains
	Type Of Shower	Electric
Unit Type	Fixed Head	No
	Hose And Handset Type	Yes
	Connected To Bath	N/A
TMV Arrangement	Accessible	N/A
	At Each Individual Shower	N/A
	Supplying Multiple Showers	N/A
Showerhead Condition	Scale Present	No
	Algae Growth Present	No
	Usage - Frequently	Yes

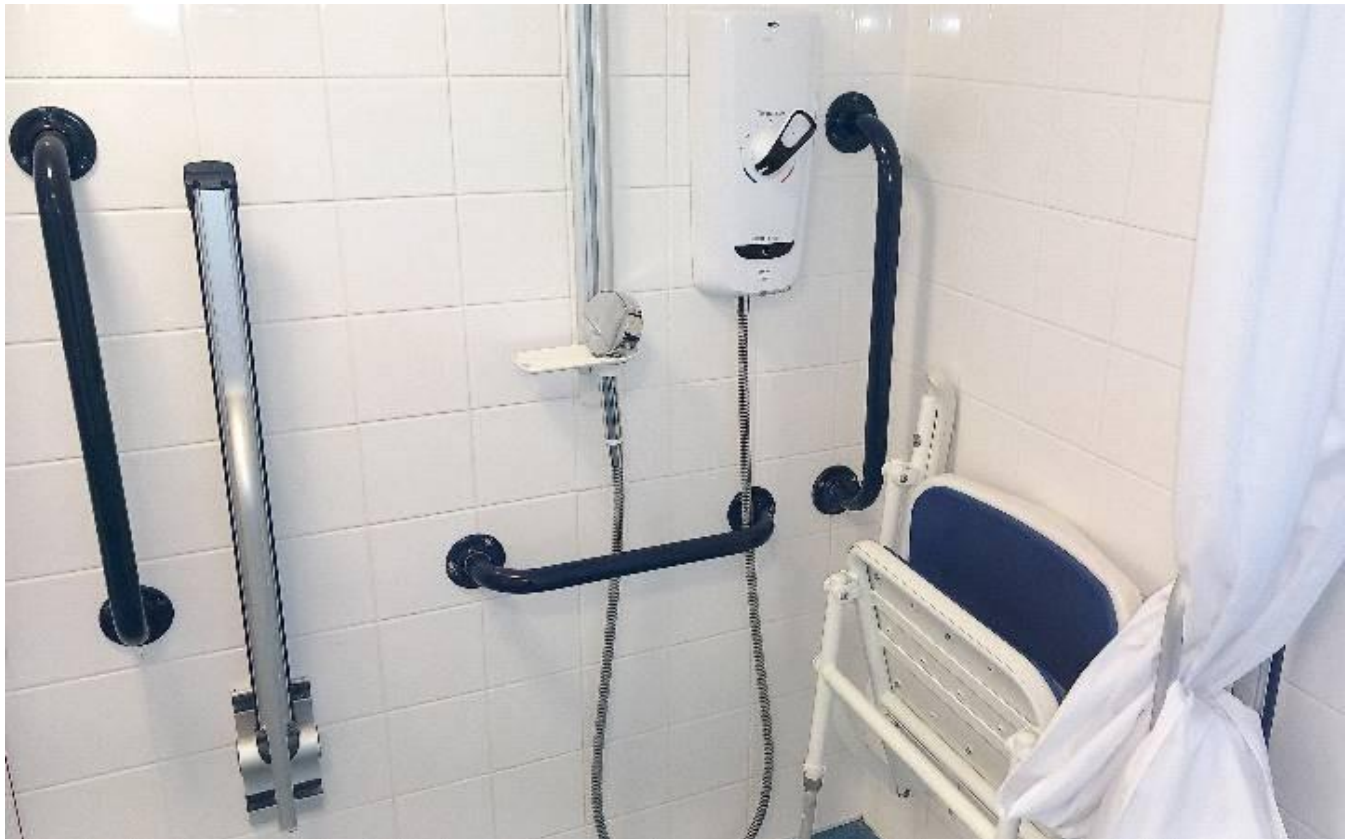
Asset No.	Shower
	Location	1st - Shower Room
SH Details	Number of Outlets	1
	Fed From Hot	-
	Fed From Cold	Mains
	Type Of Shower	Electric
Unit Type	Fixed Head	No
	Hose And Handset Type	Yes
	Connected To Bath	N/A
TMV Arrangement	Accessible	N/A
	At Each Individual Shower	N/A
	Supplying Multiple Showers	N/A
Showerhead Condition	Scale Present	No
	Algae Growth Present	No
	Usage - Frequently	Yes

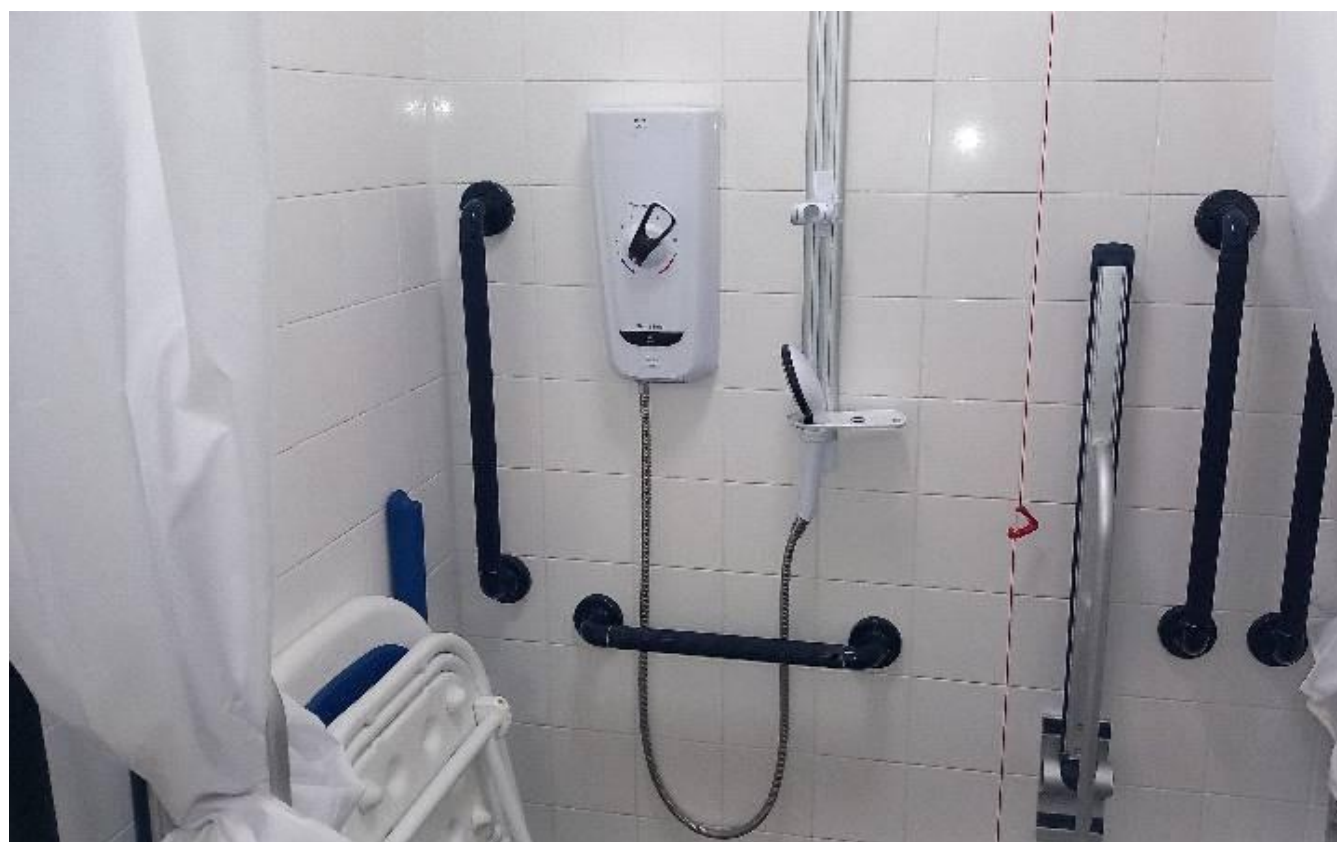
Asset No.	Shower
	Location	Flat 21
SH Details	Number of Outlets	1
	Fed From Hot	-
	Fed From Cold	Mains
	Type Of Shower	Electric
Unit Type	Fixed Head	No
	Hose And Handset Type	Yes
	Connected To Bath	N/A
TMV Arrangement	Accessible	N/A
	At Each Individual Shower	N/A
	Supplying Multiple Showers	N/A
Showerhead Condition	Scale Present	No
	Algae Growth Present	No
	Usage - Frequently	Yes

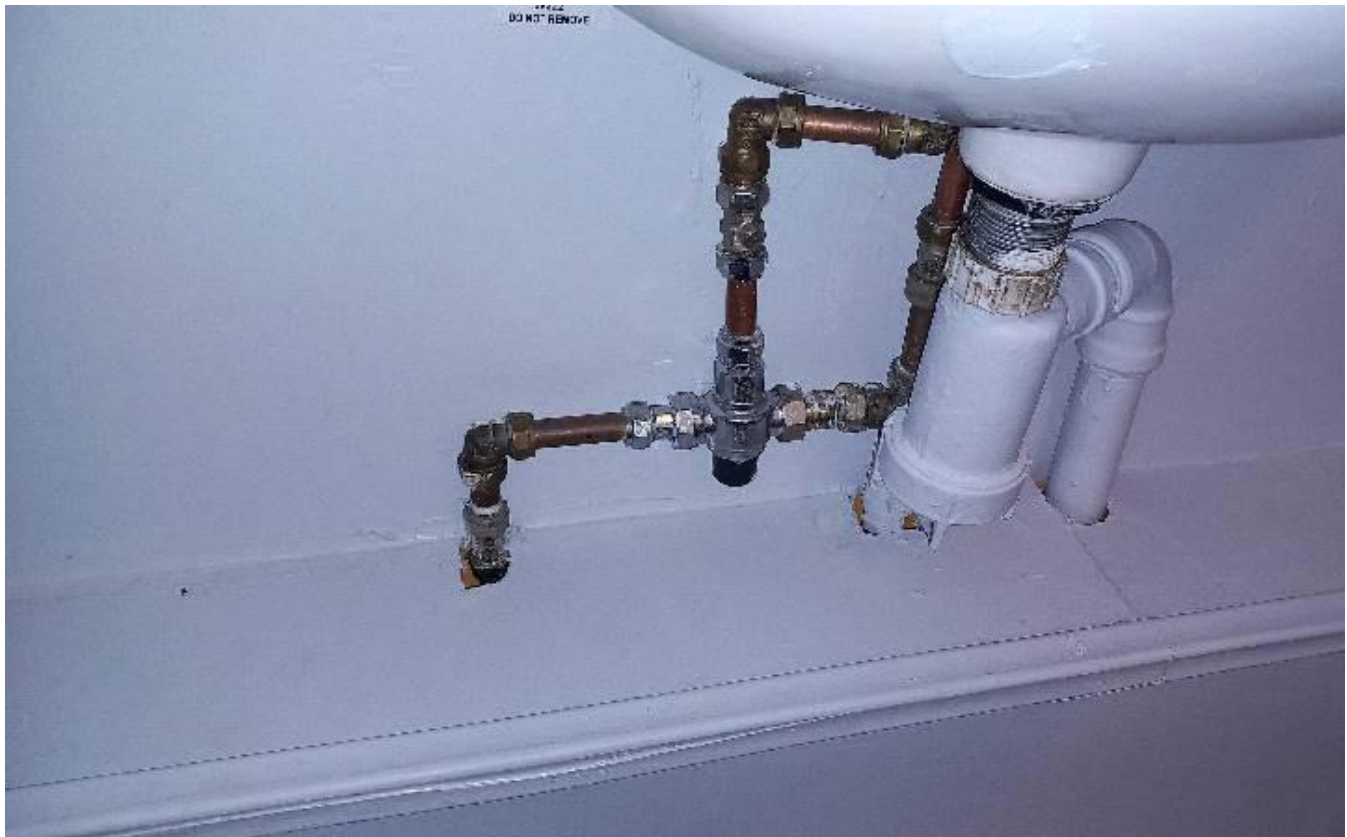
Asset No.	TMV 2
	Location	GF - Accessible WC
TMV Details	Approximate Number	1
	TMV Type	TMV
	Fed from Hot	Cal 1/2
	Fed from Cold	Mains
	Accessible	Yes
	At Each Individual Outlet	Yes
	Supplying Multiple Outlets	No
	Number of outlets	1
Temperature	Hot Supply To TMV Temperature	60.0°C
	Cold Supply To TMV Temperature	15.0°C
	Nearest Non-TMV Tap- Max Hot Temperature	N/A
	Nearest Non-TMV Tap- Max Cold Temperature	N/A
	TMV Outlet Temperature	38.0°C
	Can TMV be moved closer to the POU	No
	Can TMV be removed from system	No

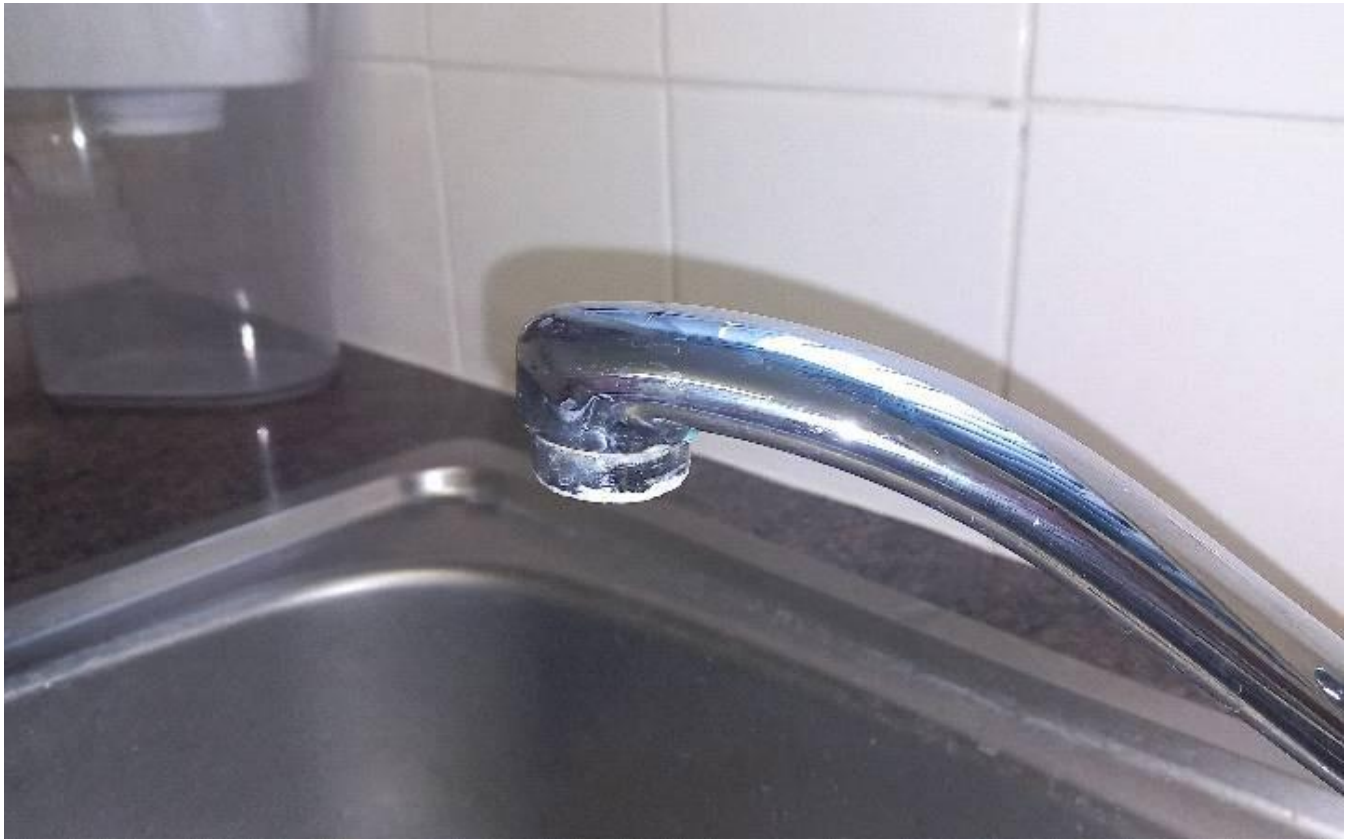
Scale on Taps

Scale was noted on a number of outlets. Scale can harbour and provide nourishment for contaminating micro-organisms. The scale should be removed completely with regular inspections and cleaning thereafter.

SOT1	Site should clean, disinfect and descale taps which are affected on a quarterly basis. This frequency can be reviewed depending on condition of the outlets.	Medium / Category 3				
------	--	---------------------	--	--	--	--

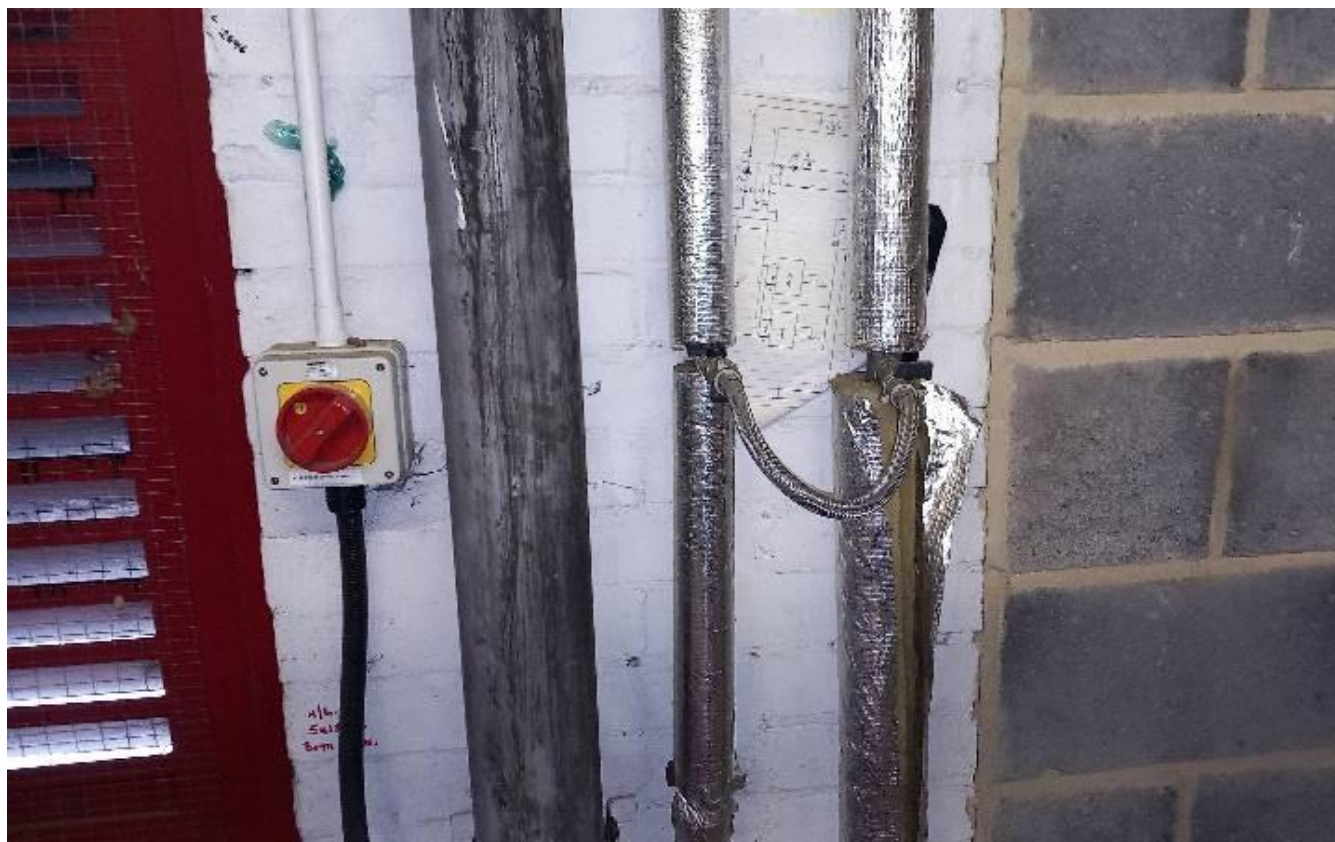
Quick Fill Loops

The presence of connected "Quick fill loops" for heating/chilled systems was observed. Disconnect the quick fill when not in use to prevent the potential of stagnant water contaminating the domestic water system. If a dead leg is created, then it will require flushing on a weekly basis and recorded within the logbook.
