LEGIONELLA RISK ASSESSMENT

Geo Tag: ,
Customer: Believe Housing
Site: Charlton House Community Centre Forest Gate Wingate, TS28 5LG
Date: 3rd August 2022
Risk Assessor: Mark Henderson
Report No: J046013 - 517635

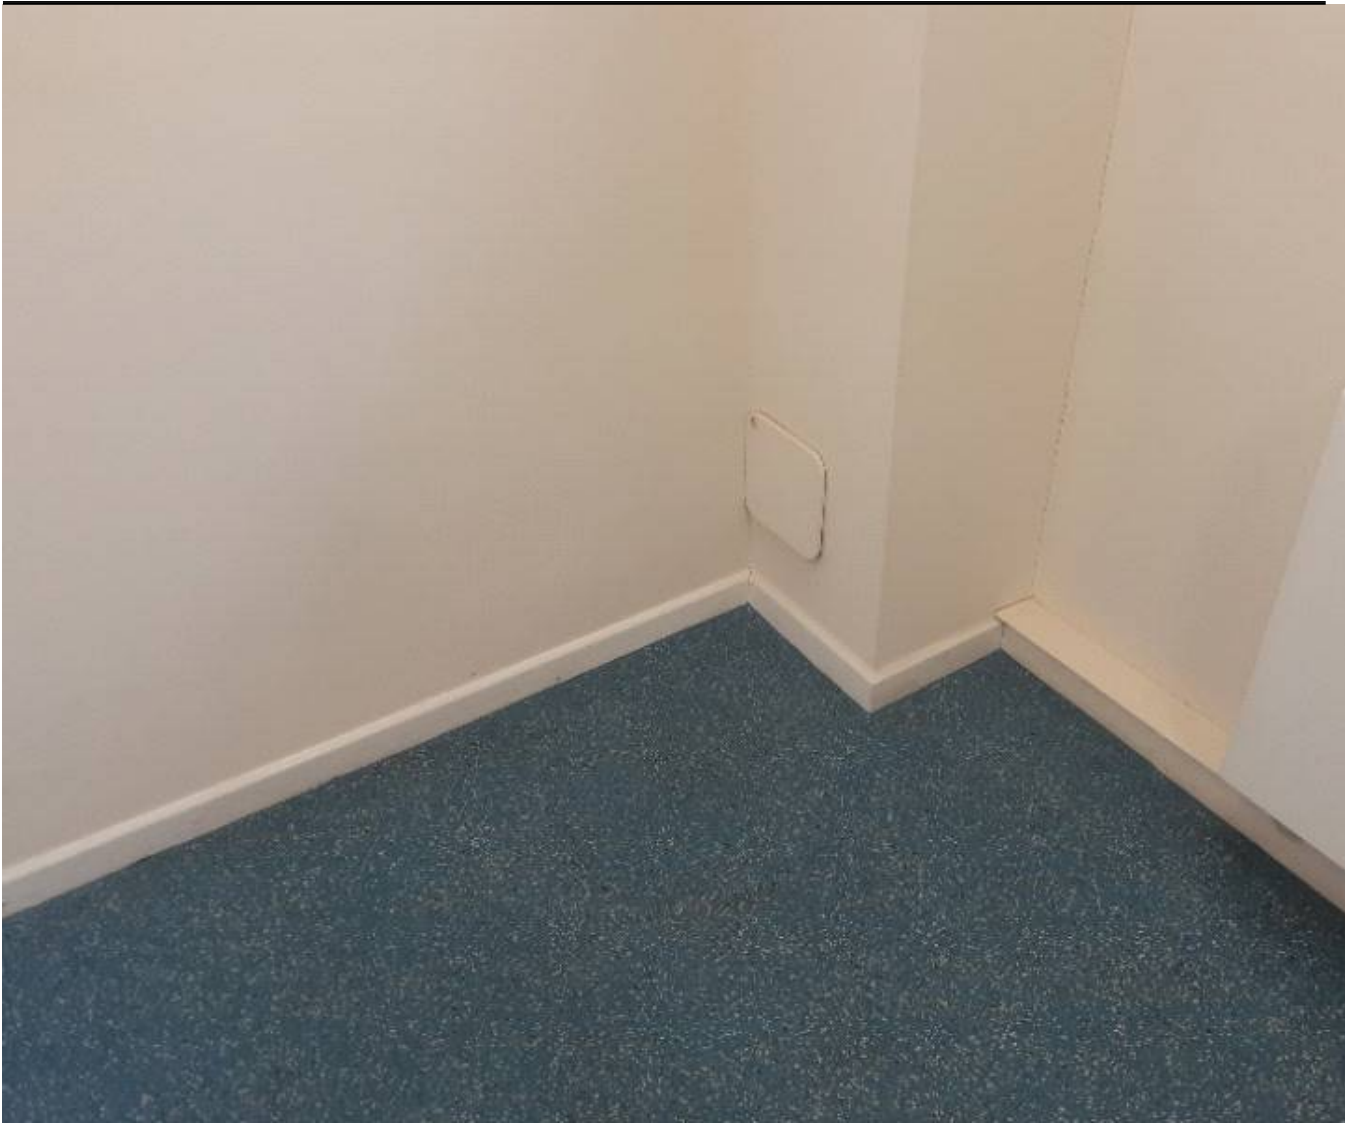
Asset No.		MAINS 1
Location		Accessible Toilet
Details	Mains Supply Stop Cock Location	Accessible Toilet
	Serving	DCWS
	Mains Supply Source	Local Water Board
Material of Construction	Water Treatment In Place	N/A
	Temperature Of Mains Supply	16.0°C
	Supply Pipework	Copper
	Distribution Pipework	Copper
	Incoming Pipework Insulated	Yes
	Strainer Fitted	N/A
	Strainer Fitted Correctly	N/A
	Water Meter Installed	U/D
	Drinking Water Outlets Labelled	N/A
Records	WRAS Approved Materials	Yes
	Chemical Dosing System	N/A
	Filtration System	N/A
	UV System	N/A
Temperatures		NC 12.0°C FC 12.0°C

Risk Rating	
System Risk	Low

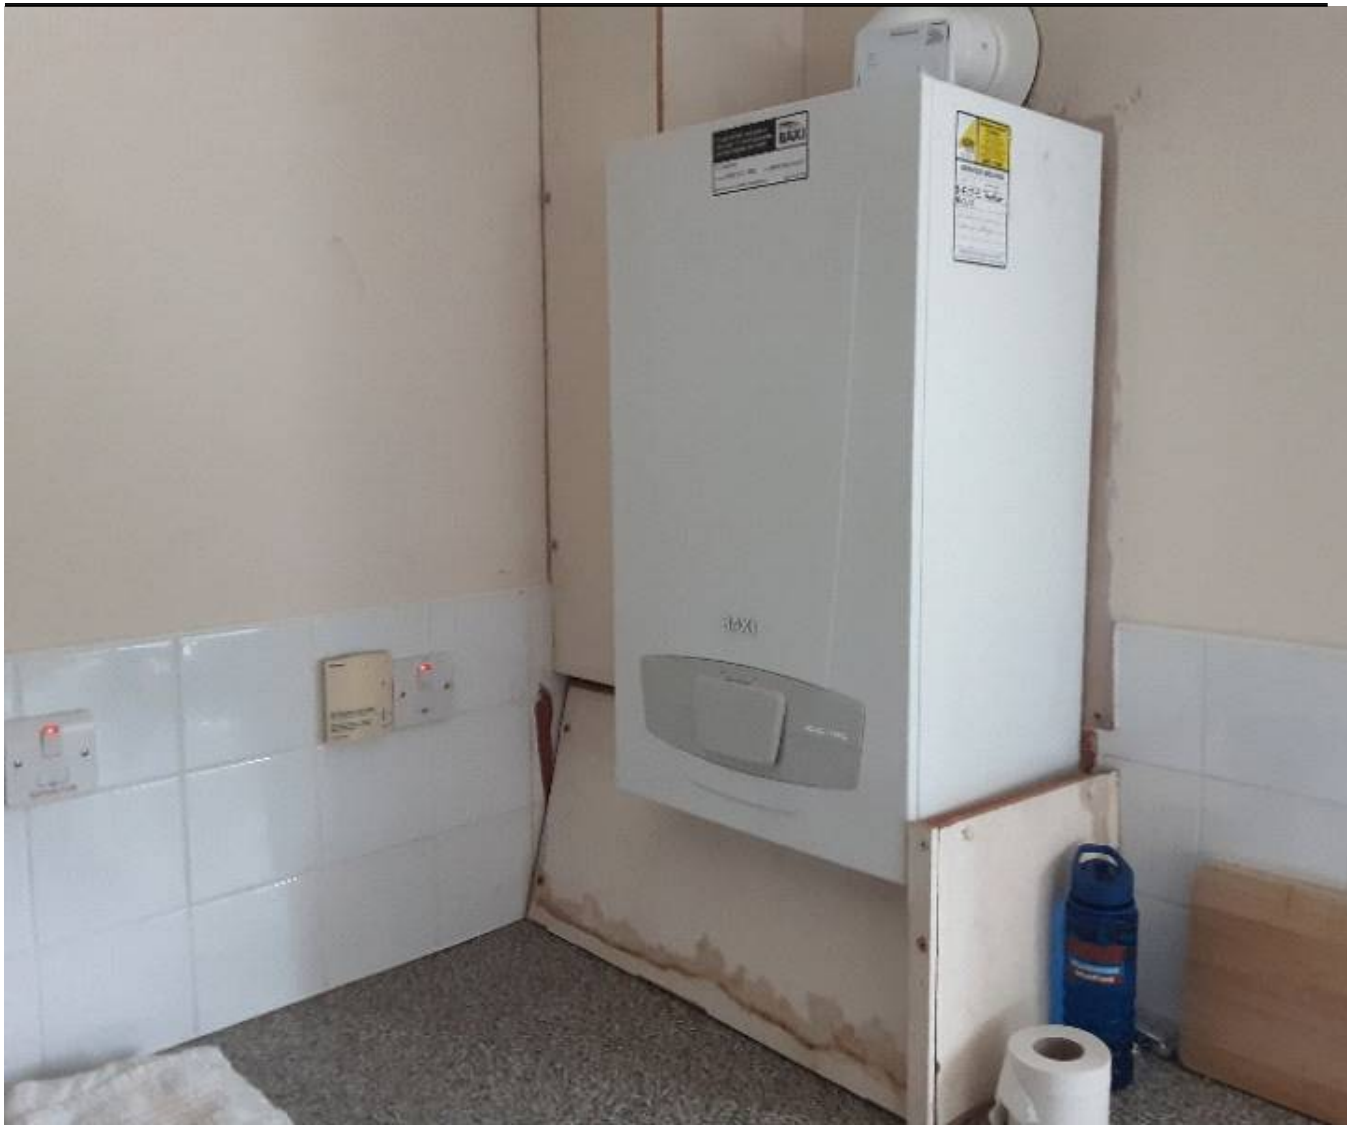
Asset No.	IWH1
Location	Kitchen
Water Heater Details	
Fed from	Mains
Power Supply To Units	On
Number Of Outlets	1
Max Temperature	56.0°C
WRAS Approved Materials	Yes
High Turn Over	Yes
Is Aerosol Likely	No
Condition Of Units Satisfactory	Yes
Spray Head Fitted	N/A
Scale Present	No
Algae Growth Present	No
Heat Source	Gas
Temperatures	NH 55.0°C

Risk Rating	
System Risk	Low

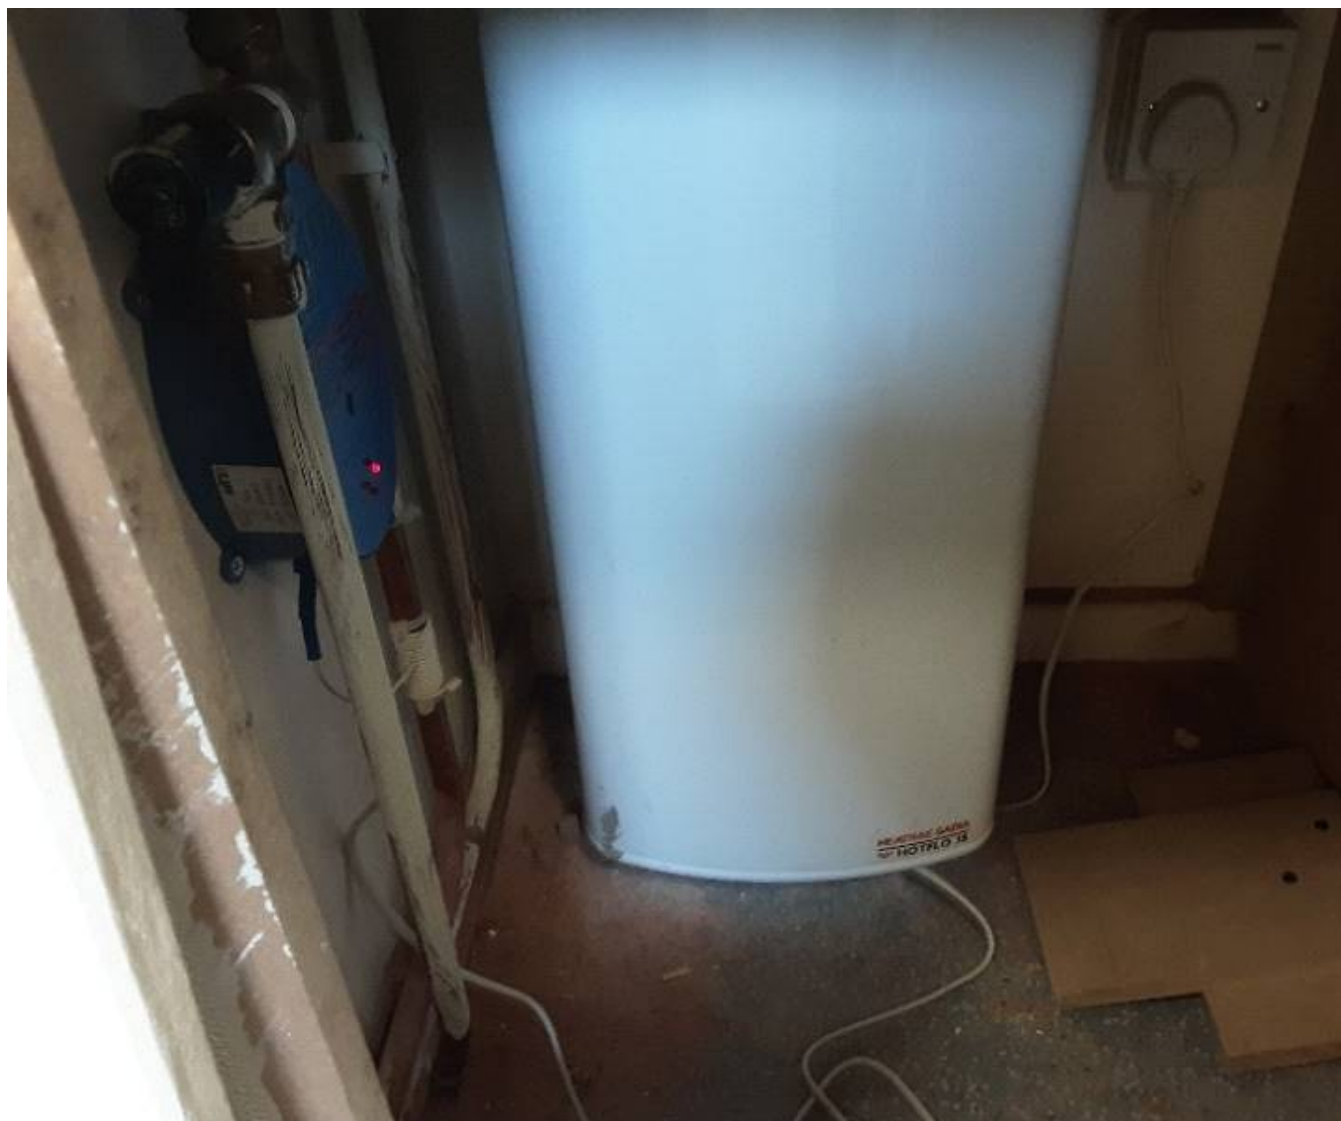
Asset No.	WH1
Location	Accessible Toilet
Water Heater Details	
Fed from	Mains
Heating Source	Electric
Storage	Low Storage Less 15 Ltrs
Power Supply To Units	On
Number Of Outlets	3
Max Temperature	56.0°C
WRAS Approved Materials	Yes
High Turn Over	Yes
Is Aerosol Likely	No
Condition Of Units Satisfactory	Yes
Temperatures	NH 55.0°C FH 55.0°C

Risk Rating	
System Risk	Low

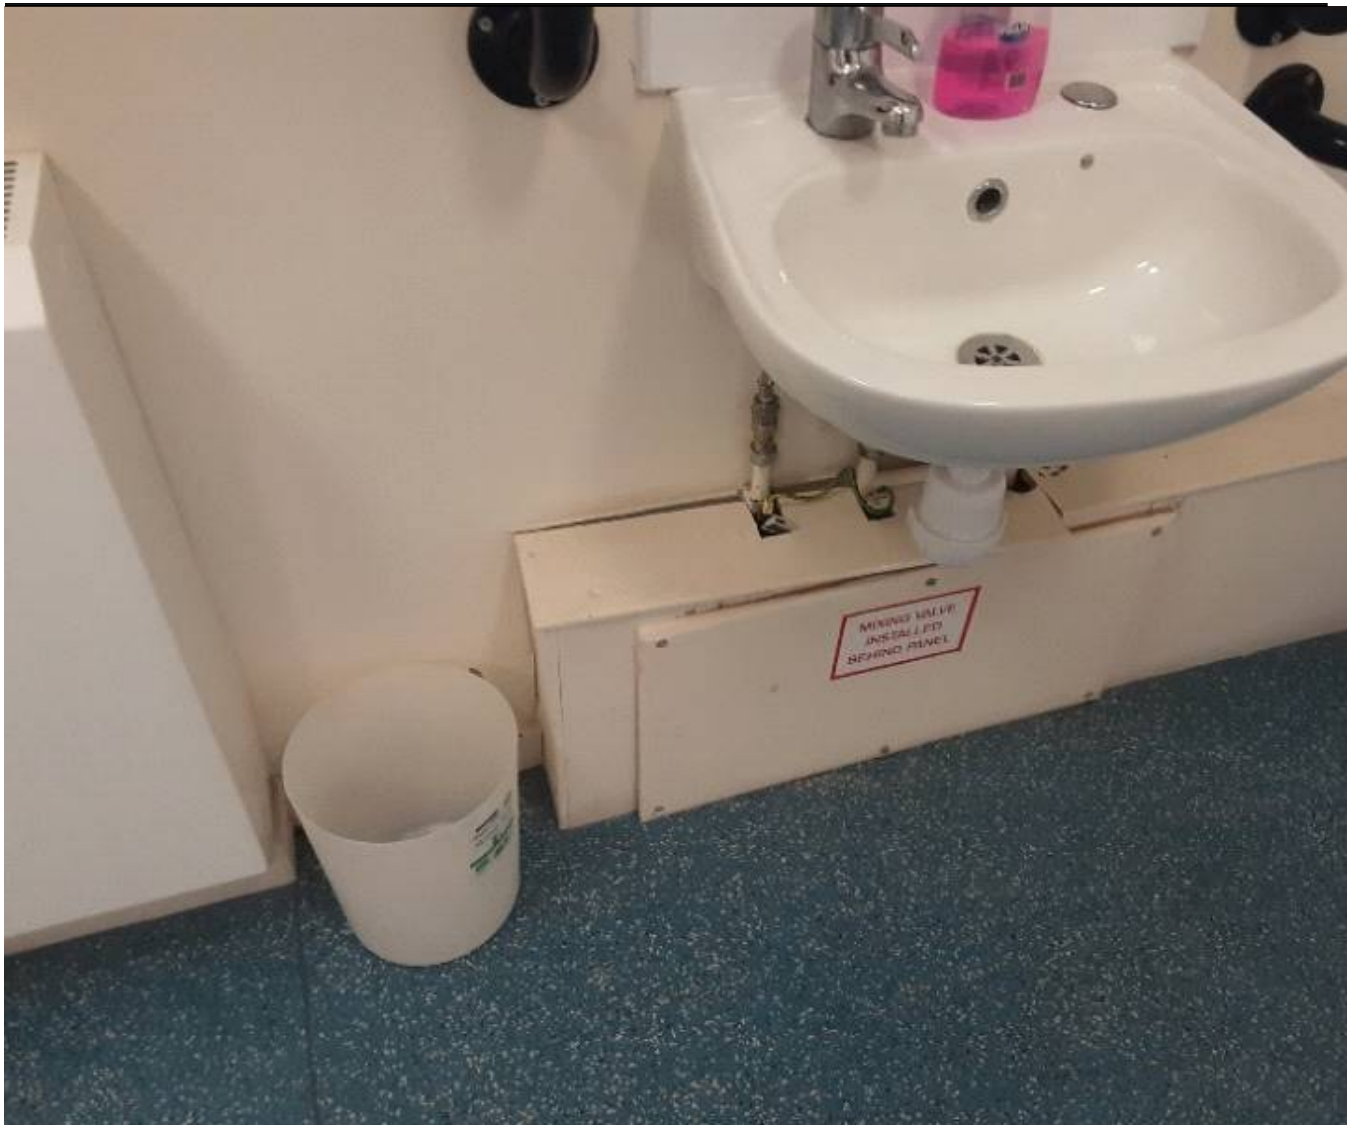
Asset No.	TMV1
Location	Accessible Toilet
TMV Details	
Approximate Number	1
TMV Type	TMV
Fed from Hot	Water Heater
Fed from Cold	Mains
Accessible	Yes
At Each Individual Outlet	Yes
Supplying Multiple Outlets	No
Number of outlets	1
Temperature	
Hot Supply To TMV Temperature	55.0°C
Cold Supply To TMV Temperature	16.0°C
Nearest Non-TMV Tap- Max Hot Temperature	N/A
Nearest Non-TMV Tap- Max Cold Temperature	N/A
TMV Outlet Temperature	41.0°C
Can TMV be moved closer to the POU	No
Can TMV be removed from system	No

Risk Rating	
System Risk	Low

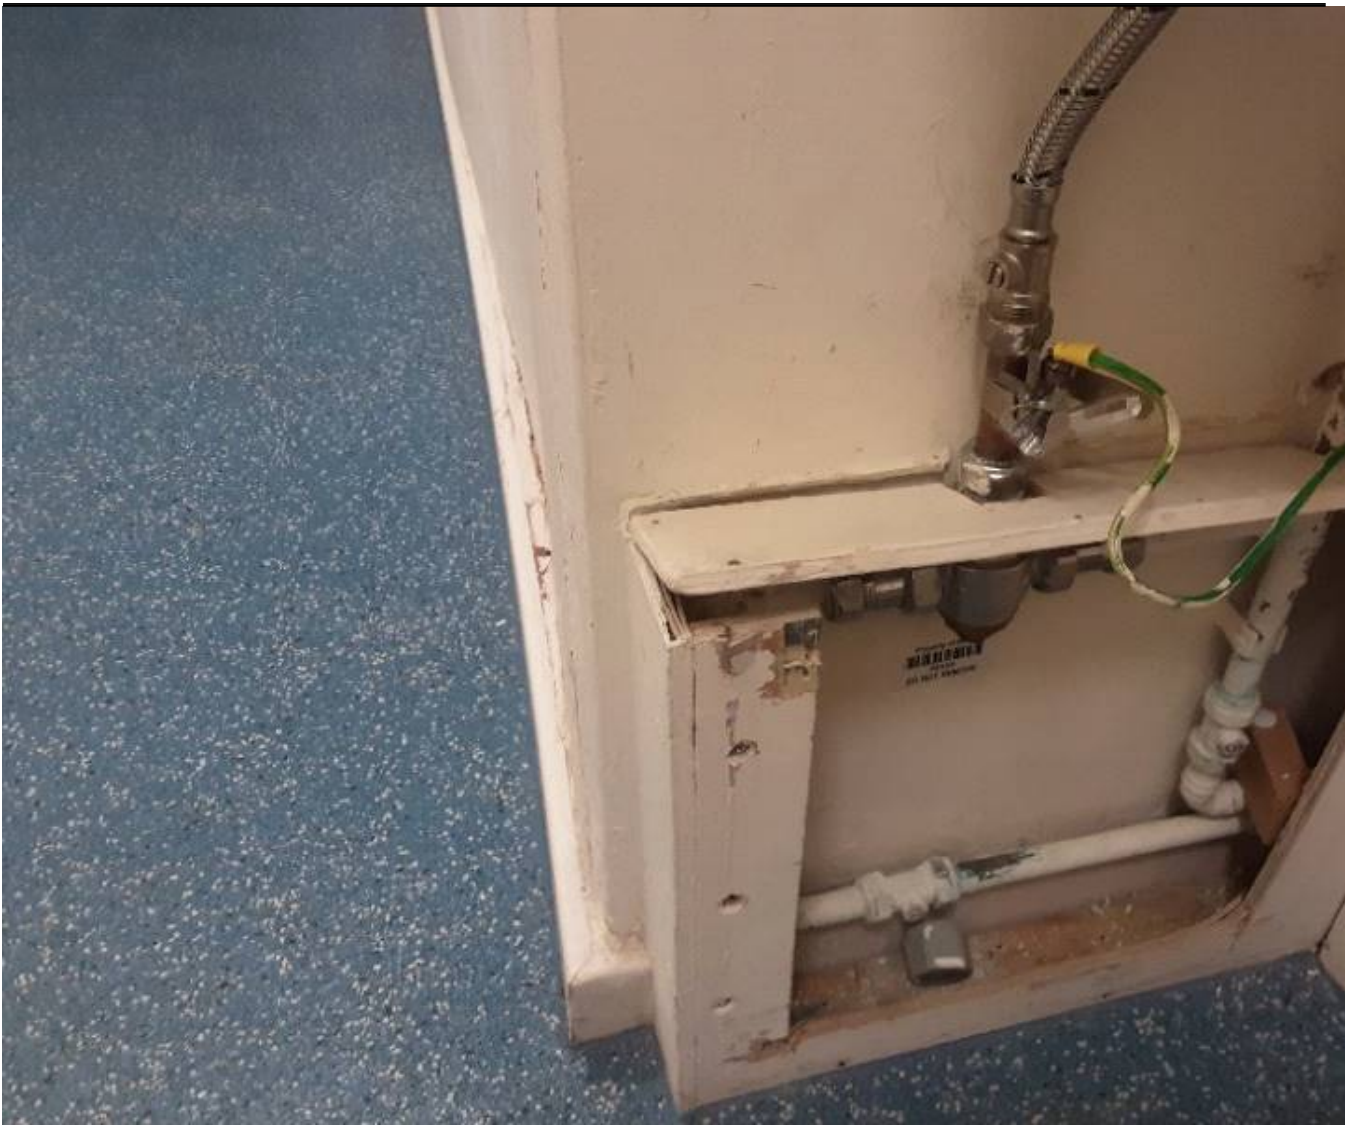
Asset No.	TMV2
Location	Female Toilet
TMV Details	
Approximate Number	1
TMV Type	TMV
Fed from Hot	Water Heater
Fed from Cold	Mains
Accessible	Yes
At Each Individual Outlet	Yes
Supplying Multiple Outlets	No
Number of outlets	1
Temperature	
Hot Supply To TMV Temperature	55.0°C
Cold Supply To TMV Temperature	16.0°C
Nearest Non-TMV Tap- Max Hot Temperature	N/A
Nearest Non-TMV Tap- Max Cold Temperature	N/A
TMV Outlet Temperature	41.0°C
Can TMV be moved closer to the POU	No
Can TMV be removed from system	No

Risk Rating	
System Risk	Low

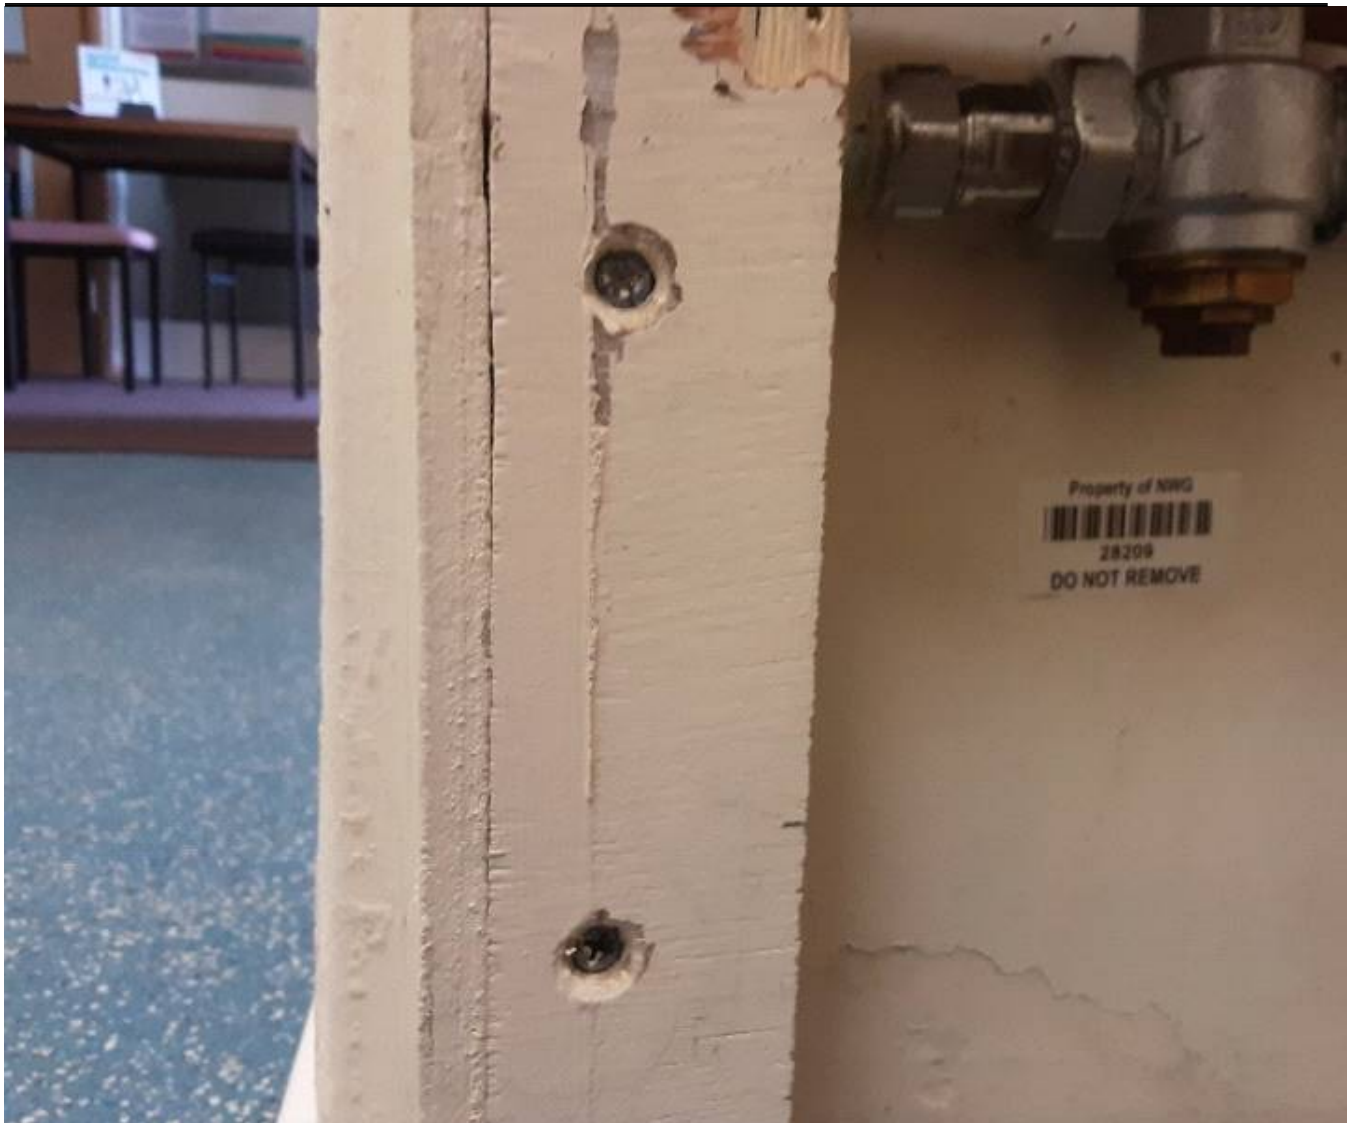
Asset No.	TMV3
Location	Male Toilet
TMV Details	
Approximate Number	1
TMV Type	TMV
Fed from Hot	Water Heater
Fed from Cold	Mains
Accessible	Yes
At Each Individual Outlet	Yes
Supplying Multiple Outlets	No
Number of outlets	1
Temperature	
Hot Supply To TMV Temperature	55.0°C
Cold Supply To TMV Temperature	16.0°C
Nearest Non-TMV Tap- Max Hot Temperature	N/A
Nearest Non-TMV Tap- Max Cold Temperature	N/A
TMV Outlet Temperature	41.0°C
Can TMV be moved closer to the POU	No
Can TMV be removed from system	No

Risk Rating	
System Risk	Low

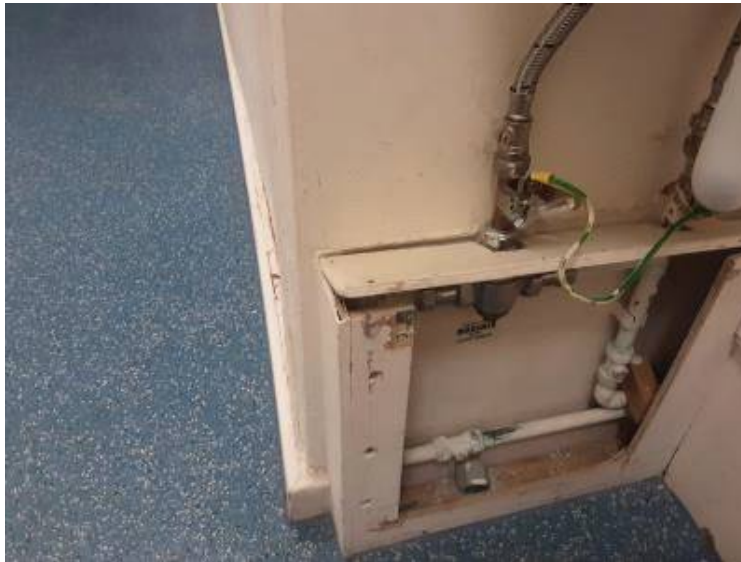
Asset No.	FH1& 2
	Location	Kitchen
General	Satisfactory	No
Fed From	Fed From	Hot and Cold
	Comments

Risk Rating	
System Risk	Medium

System Ref	General	Priority	Assigned To	Comments	Date Completed	Signed
FH1& 2, FH3 to 5, FH6 to 8, FH9 to 11	At the time of the survey the WRAS approved numbers could not be identified on the flexible hoses, site shall ensure that these are compliant and either replace or pipe in rigid copper.	Medium / Category 3

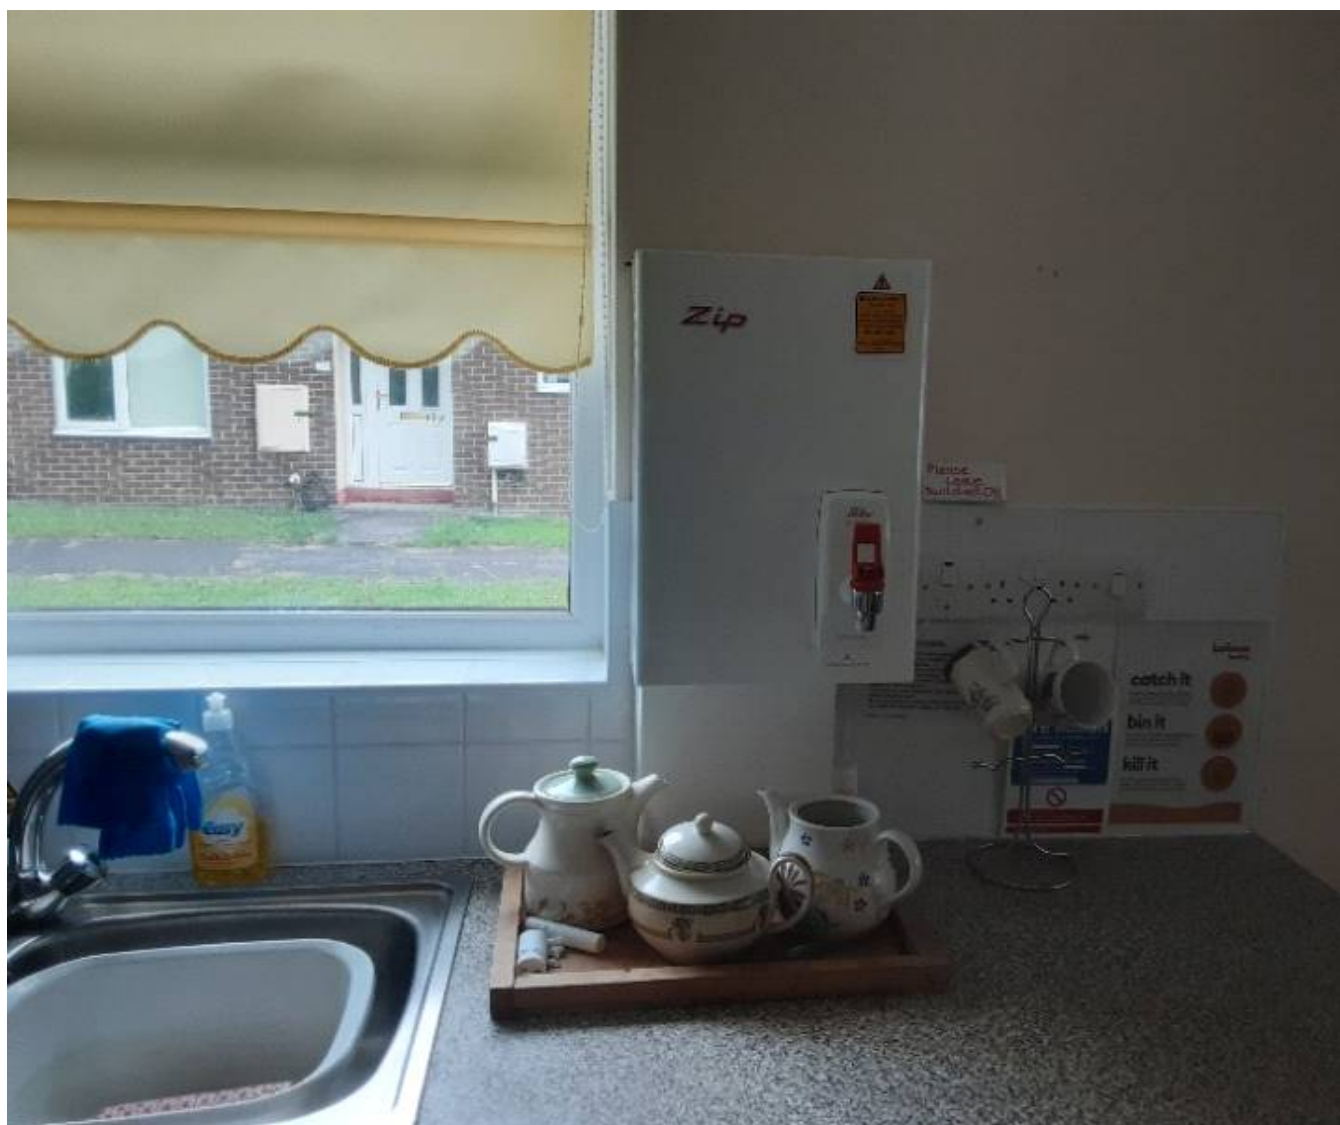
Asset No.	KE1
	Location	Kitchen
General	Satisfactory	Yes
Fed From	Fed From	Mains
	Comments	Water Boiler

Risk Rating	
System Risk	Low
