LEGIONELLA RISK ASSESSMENT

Geo Tag: ,
Customer: Believe Housing
Site: Coast House Spectrum 4 Spectrum Business Park Seaham , SR7 7TT
Date: 2nd February 2024
Risk Assessor: Carleton Waite
Report No: J052353 - 664702

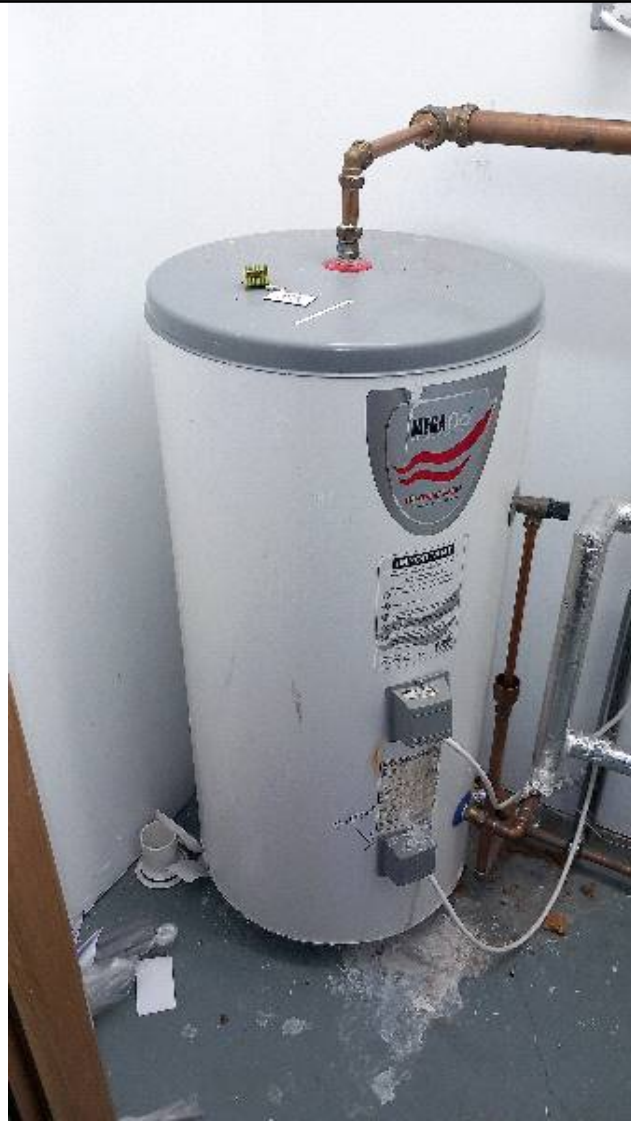
Asset No.	CAL 1
Location	2nd SW - Store
CAL Details	
Supplied from	Mains
Serving	Building
Time Of Inspection	00:00
Make and Model	Megaflo
Calorifier Orientation	Vertical
No of Calorifiers in System	1
Materials Of Construction	Stainless Steel
Capacity	115.0ltrs
Main Heat Source	Electric
Supplementary Heat Source	-
Temp & Flow	
Temperature Gauge Fitted To Calorifier / Flow	Yes
Temperature Gauge Fitted To Return	Yes
Calorifier Off Or On	On
Flow Temperature	58.0°C
Return Temperature	55.0°C
Calorifier Stratification	No
Calorifier Temperature Top	N/A
Calorifier Temperature Middle	N/A
Calorifier Temperature Bottom	N/A
Thermostat Setting	
Drain Fitted	Yes
Complete Draining Of Vessel Possible	Yes
Initial Blow down Appearance	Unable To Determine
Circulation & Insulation	
System Circulated	Yes
Pumps Alternated	N/A
Calorifier Insulation	Yes
Pipe Work Insulation	Yes
Pipe Work labelled	Yes
Open Vent Present	N/A
Safety Valve Present	Yes

Risk Rating	
System Risk	High

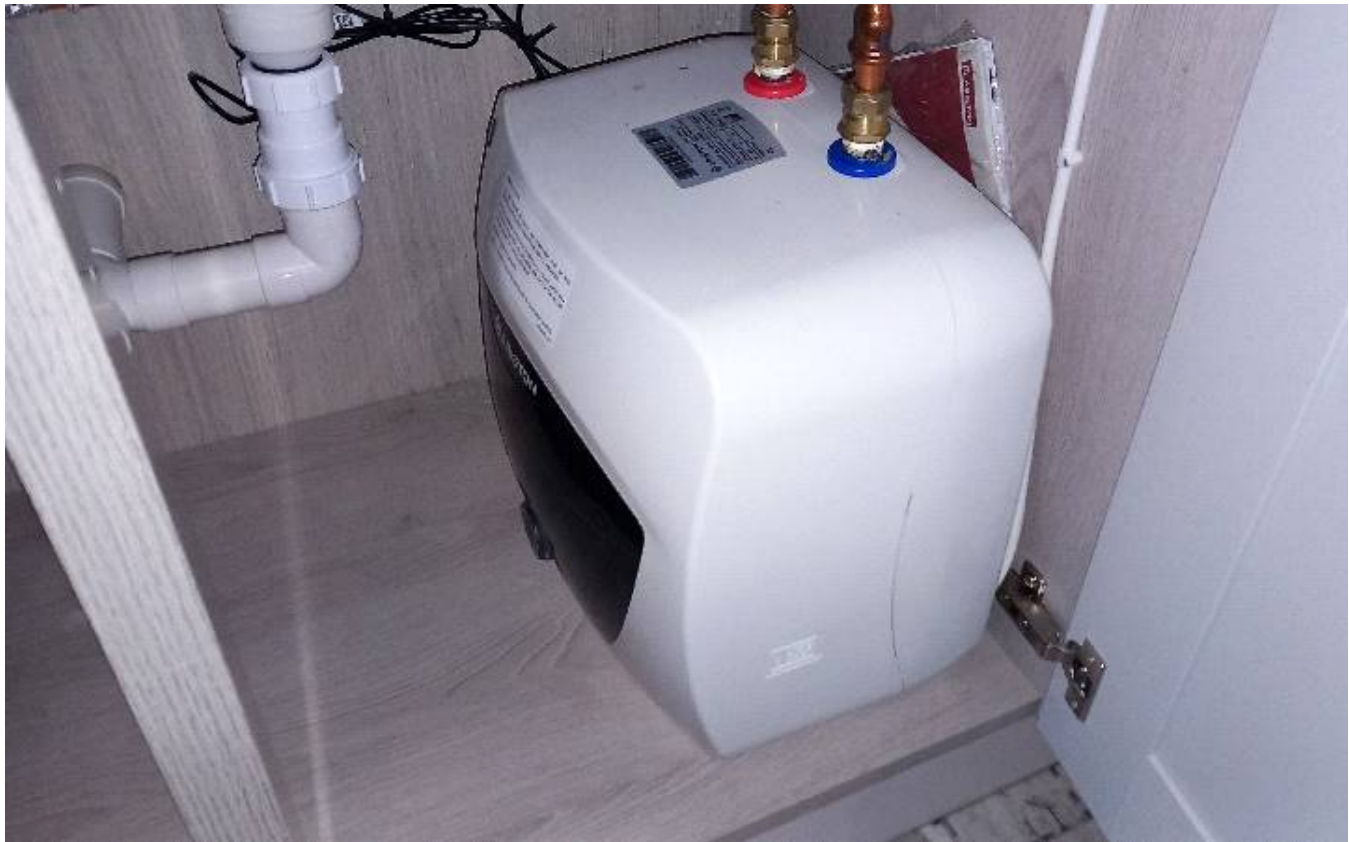
Asset No.	WH1
Location	1st PS - Kitchen
Water Heater Details	
Fed from	Mains
Heating Source	Electric
Storage	Low Storage Less 15 Ltrs
Power Supply To Units	On
Number Of Outlets	1
Max Temperature	63.0°C
WRAS Approved Materials	Yes
High Turn Over	Yes
Is Aerosol Likely	No
Condition Of Units Satisfactory	Yes
Temperatures

Risk Rating	
System Risk	Low

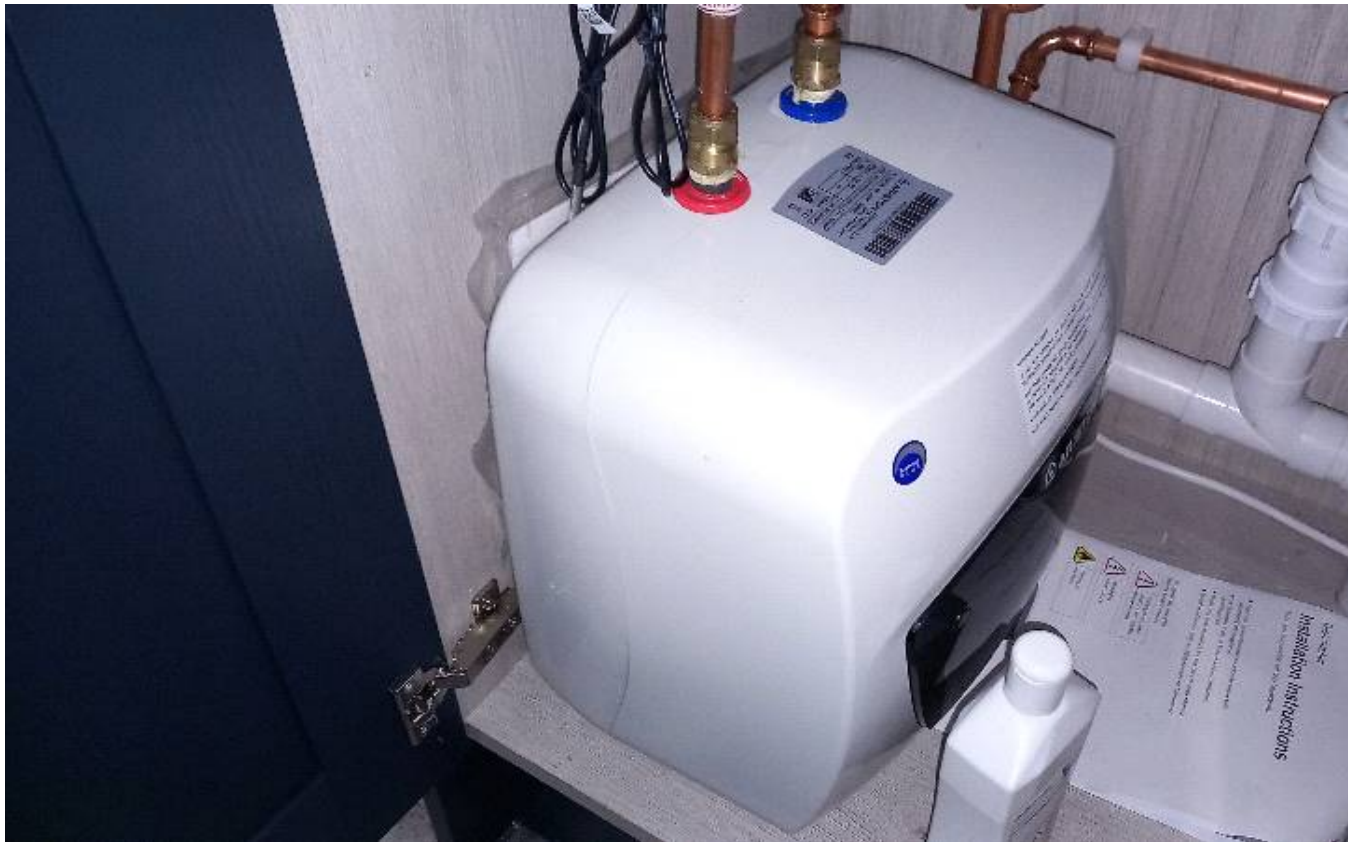
Asset No.	WH2
Location	1st PS - Left Area
Water Heater Details	
Fed from	Mains
Heating Source	Electric
Storage	Low Storage Less 15 Ltrs
Power Supply To Units	On
Number Of Outlets	2
Max Temperature	58.0°C
WRAS Approved Materials	Yes
High Turn Over	Yes
Is Aerosol Likely	No
Condition Of Units Satisfactory	Yes
Temperatures

Risk Rating	
System Risk	Low

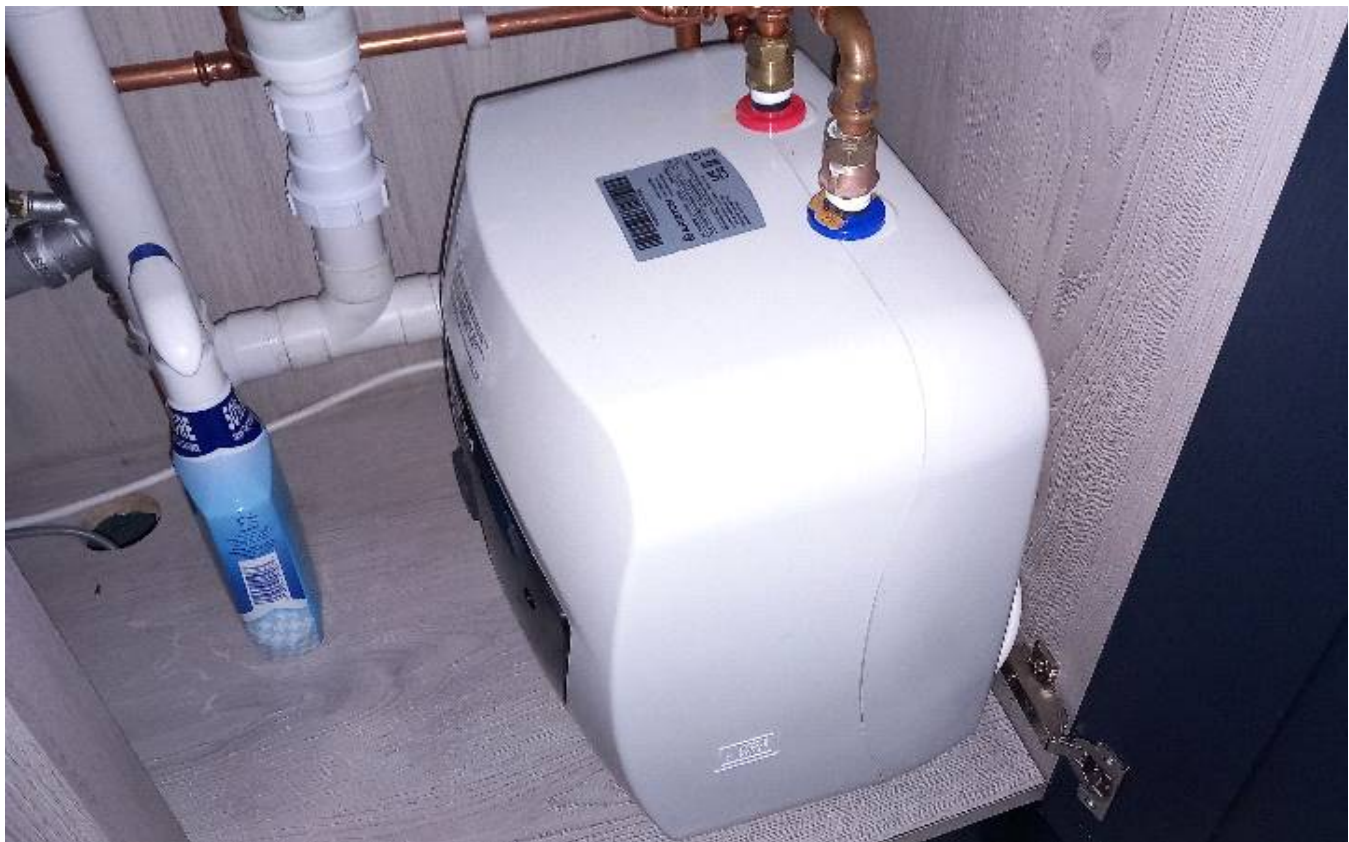
Asset No.	WH3
Location	1st PS - Right Area
Water Heater Details	
Fed from	Mains
Heating Source	Electric
Storage	Low Storage Less 15 Ltrs
Power Supply To Units	On
Number Of Outlets	2
Max Temperature	51.0°C
WRAS Approved Materials	Yes
High Turn Over	Yes
Is Aerosol Likely	No
Condition Of Units Satisfactory	Yes
Temperatures

Risk Rating	
System Risk	Low

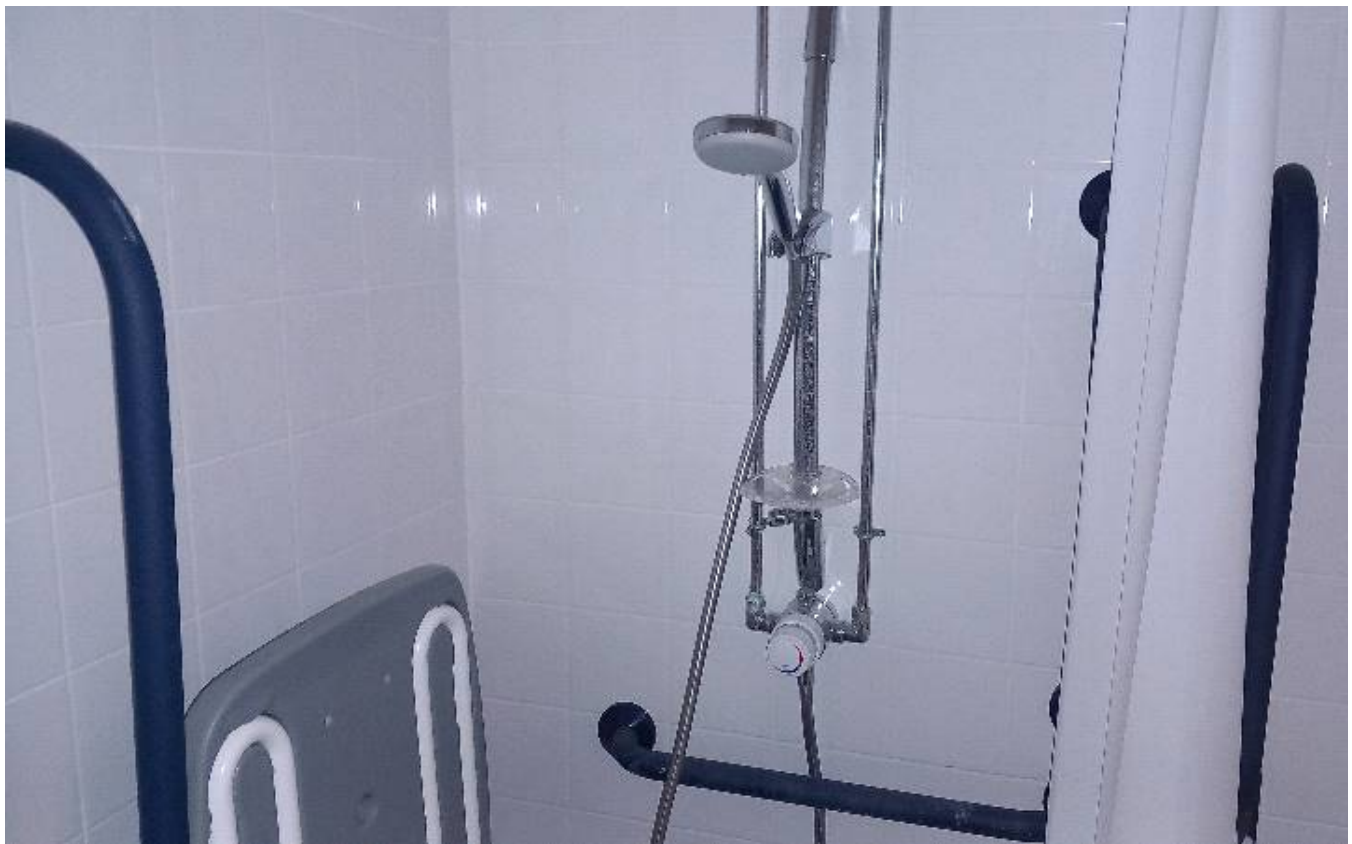
Asset No.	SH1
	Location	1st NW - Accessible Shower
SH Details	Number of Outlets	1
	Fed From Hot	Cal 1
	Fed From Cold	Mains
	Type Of Shower	Thermostatic
Unit Type	Fixed Head	No
	Hose And Handset Type	Yes
	Connected To Bath	N/A
TMV Arrangement	Accessible	N/A
	At Each Individual Shower	N/A
	Supplying Multiple Showers	N/A
Showerhead Condition	Scale Present	No
	Algae Growth Present	No
	Usage - Frequently	Yes

Risk Rating	
System Risk	Low

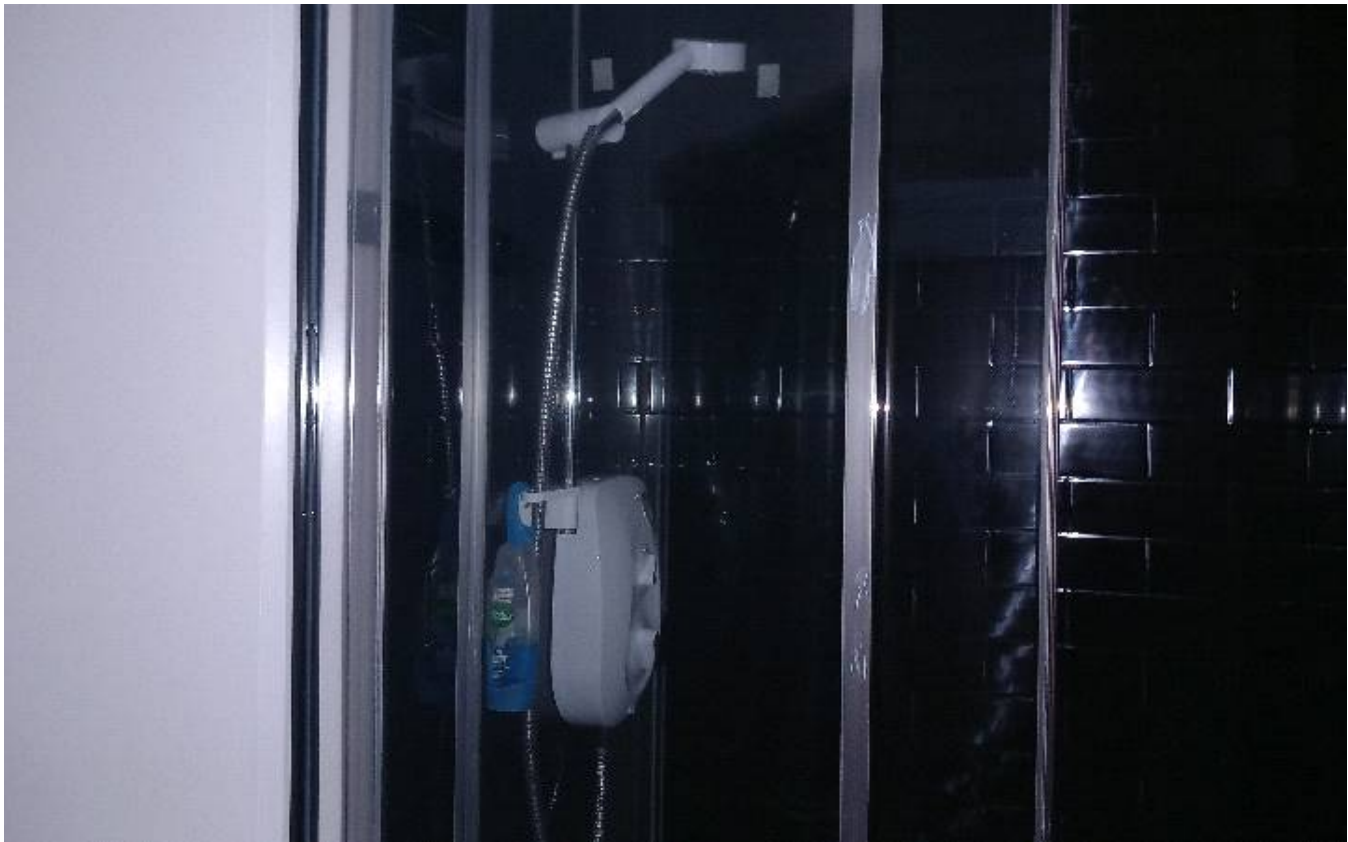
Asset No.	SH2
	Location	1st SW - Left Shower
SH Details	Number of Outlets	1
	Fed From Hot	-
	Fed From Cold	Mains
	Type Of Shower	Electric
Unit Type	Fixed Head	No
	Hose And Handset Type	Yes
	Connected To Bath	N/A
TMV Arrangement	Accessible	N/A
	At Each Individual Shower	N/A
	Supplying Multiple Showers	N/A
Showerhead Condition	Scale Present	No
	Algae Growth Present	No
	Usage - Frequently	Yes

Risk Rating	
System Risk	Low

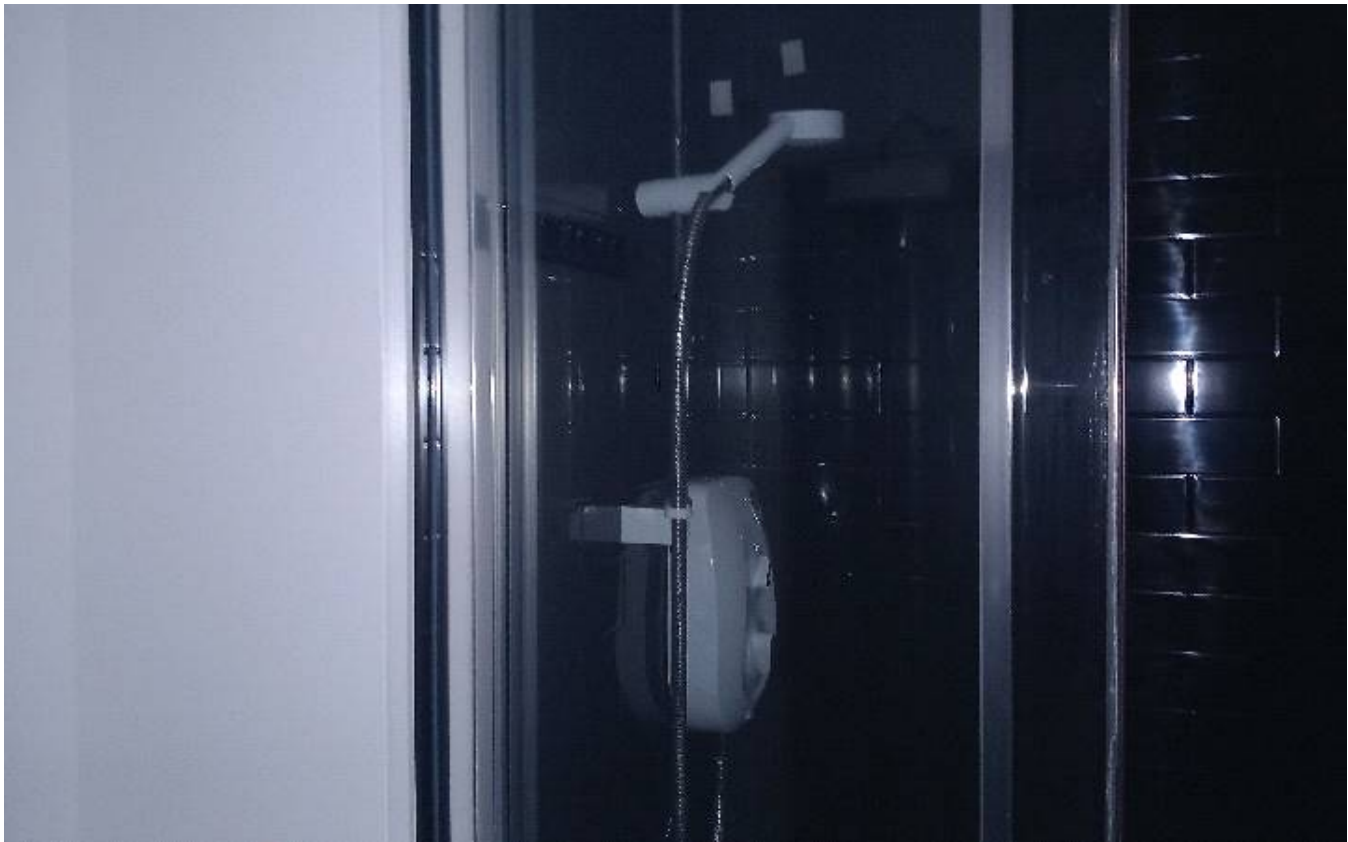
Asset No.		SH3
Location		1st SW - Middle Shower
SH Details	Number of Outlets	1
	Fed From Hot	-
	Fed From Cold	Mains
	Type Of Shower	Electric
Unit Type	Fixed Head	No
	Hose And Handset Type	Yes
	Connected To Bath	N/A
TMV Arrangement	Accessible	N/A
	At Each Individual Shower	N/A
	Supplying Multiple Showers	N/A
Showerhead Condition	Scale Present	No
	Algae Growth Present	No
	Usage - Frequently	Yes

Risk Rating	
System Risk	Low

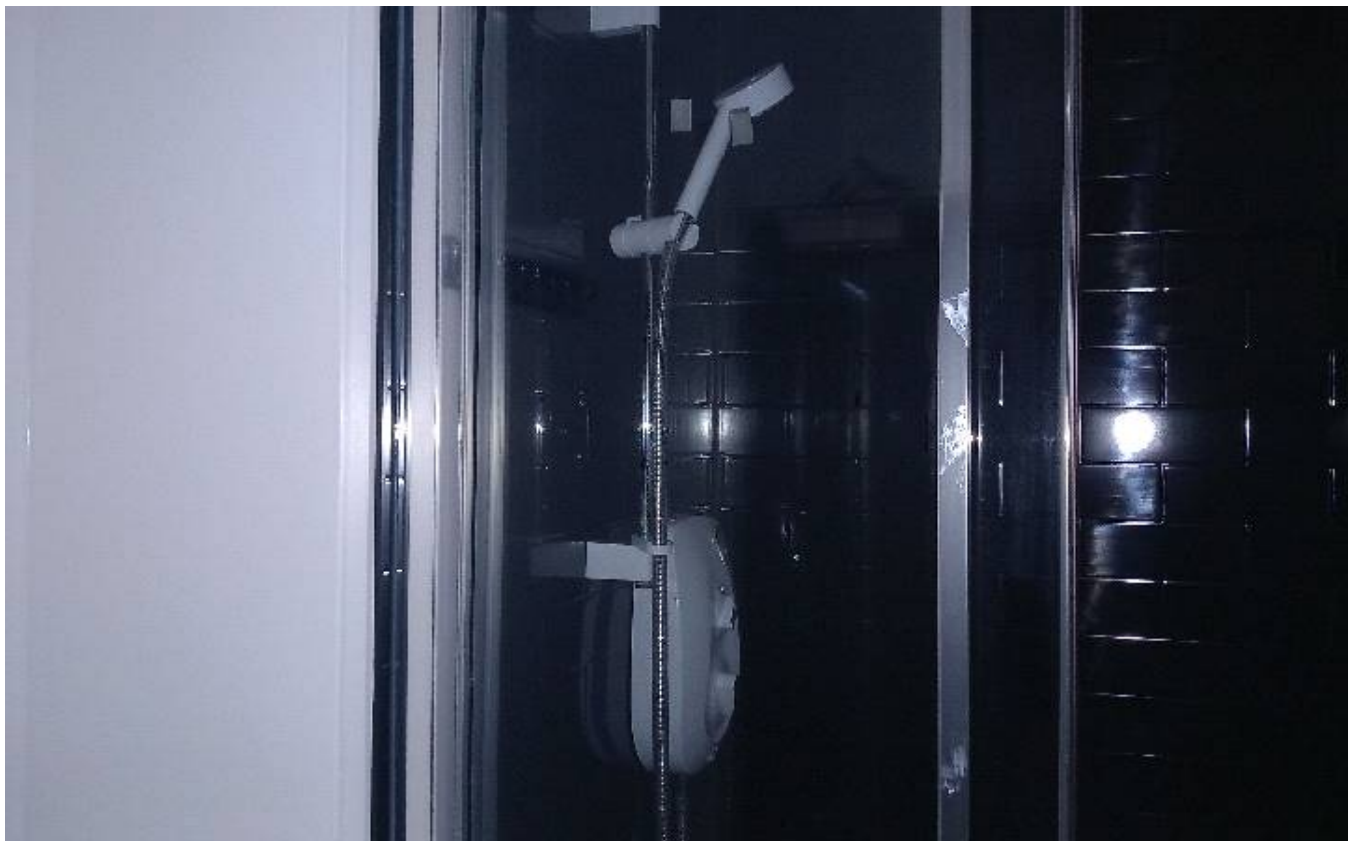
Asset No.	SH4
	Location	1st SW - Right Shower
SH Details	Number of Outlets	1
	Fed From Hot	-
	Fed From Cold	Mains
	Type Of Shower	Electric
Unit Type	Fixed Head	No
	Hose And Handset Type	Yes
	Connected To Bath	N/A
TMV Arrangement	Accessible	N/A
	At Each Individual Shower	N/A
	Supplying Multiple Showers	N/A
Showerhead Condition	Scale Present	No
	Algae Growth Present	No
	Usage - Frequently	Yes

Risk Rating	
System Risk	Low

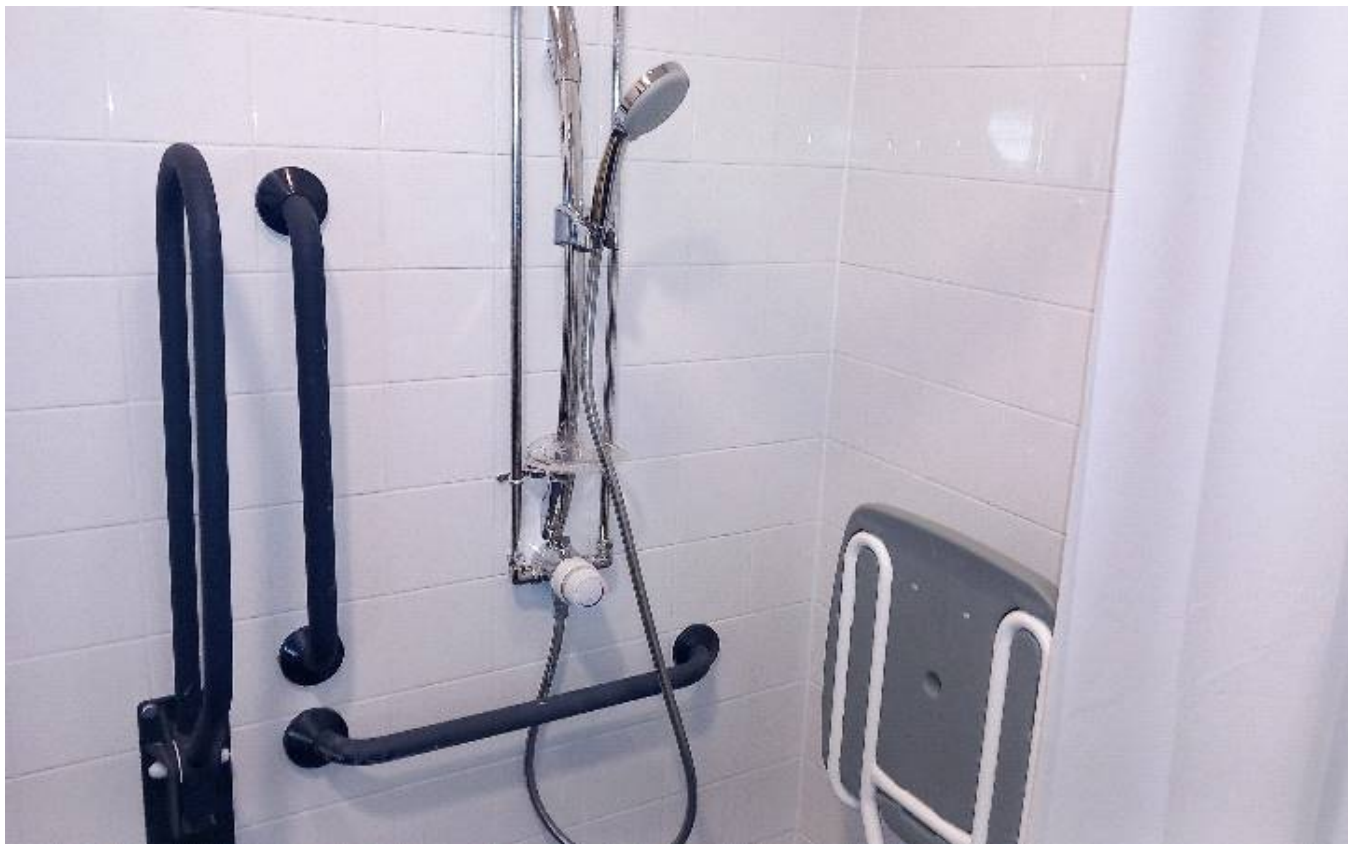
Asset No.	SH5
	Location	2nd SW - Accessible Shower
SH Details	Number of Outlets	1
	Fed From Hot	Cal 1
	Fed From Cold	Mains
	Type Of Shower	Thermostatic
Unit Type	Fixed Head	No
	Hose And Handset Type	Yes
	Connected To Bath	N/A
TMV Arrangement	Accessible	N/A
	At Each Individual Shower	N/A
	Supplying Multiple Showers	N/A
Showerhead Condition	Scale Present	No
	Algae Growth Present	No
	Usage - Frequently	Yes

Risk Rating	
System Risk	Low

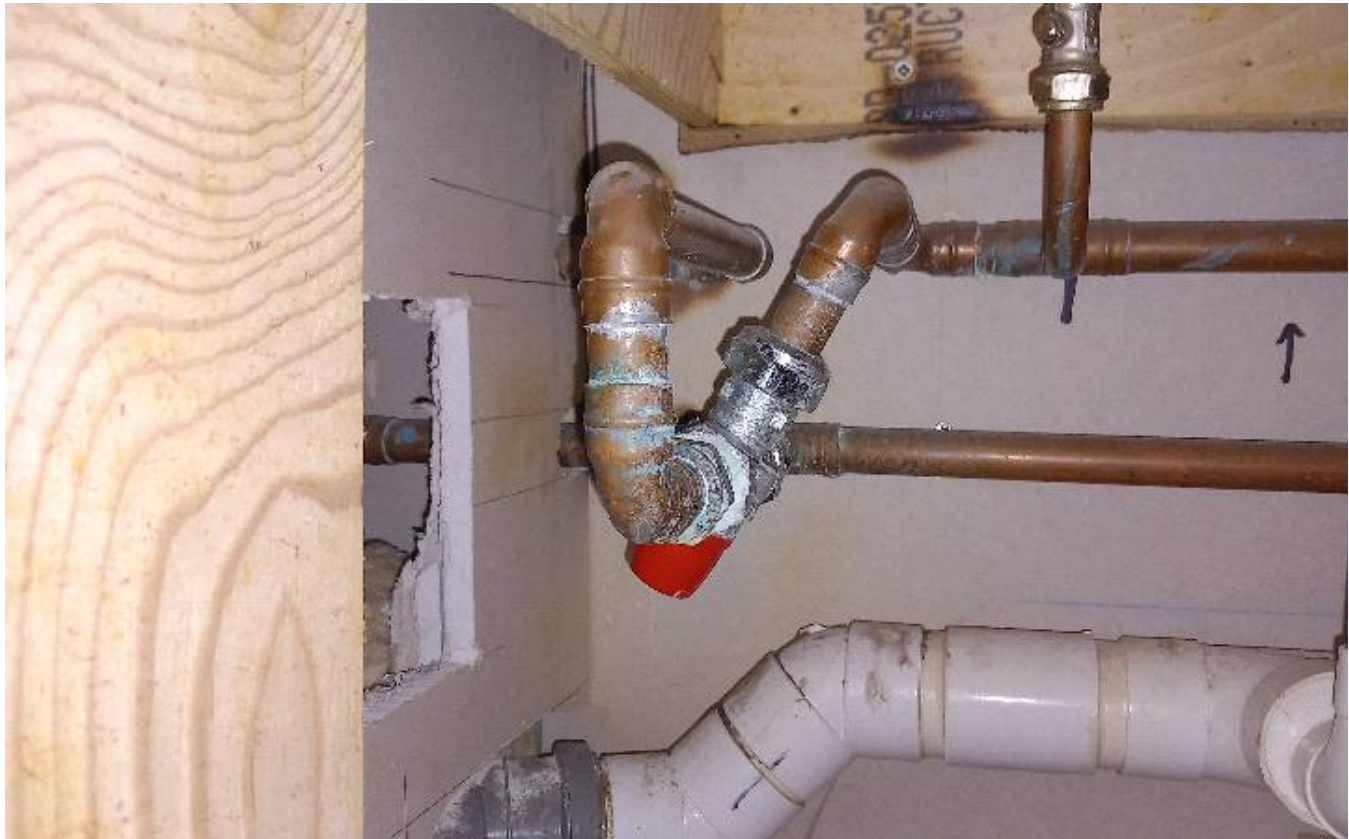
Asset No.	TMV2
	Location	GF NW - Female WC
TMV Details	Approximate Number	1
	TMV Type	TMV
	Fed from Hot	Cal 1
	Fed from Cold	Mains
	Accessible	Yes
	At Each Individual Outlet	No
	Supplying Multiple Outlets	Yes
	Number of outlets	4
Temperature	Hot Supply To TMV Temperature	56.0°C
	Cold Supply To TMV Temperature	8.0°C
	Nearest Non-TMV Tap- Max Hot Temperature	N/A
	Nearest Non-TMV Tap- Max Cold Temperature	N/A
	TMV Outlet Temperature	40.0°C
	Can TMV be moved closer to the POU	No
	Can TMV be removed from system	No

Risk Rating	
System Risk	Low

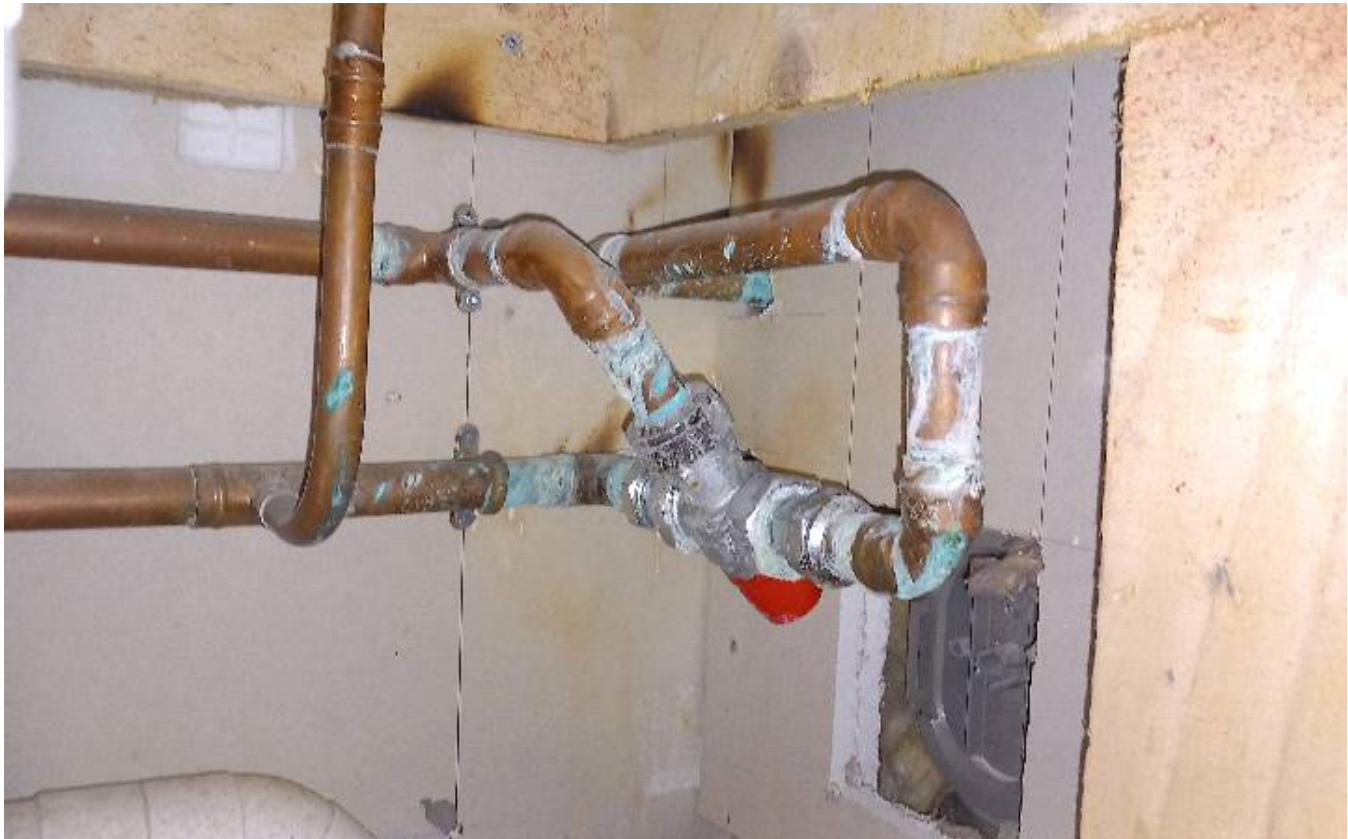
Asset No.	TMV3
Location	GF SW - Male WC
TMV Details	
Approximate Number	1
TMV Type	TMV
Fed from Hot	Cal 1
Fed from Cold	Mains
Accessible	Yes
At Each Individual Outlet	No
Supplying Multiple Outlets	Yes
Number of outlets	4
Temperature	
Hot Supply To TMV Temperature	56.0°C
Cold Supply To TMV Temperature	8.0°C
Nearest Non-TMV Tap- Max Hot Temperature	N/A
Nearest Non-TMV Tap- Max Cold Temperature	N/A
TMV Outlet Temperature	41.0°C
Can TMV be moved closer to the POU	No
Can TMV be removed from system	No

Risk Rating	
System Risk	Low

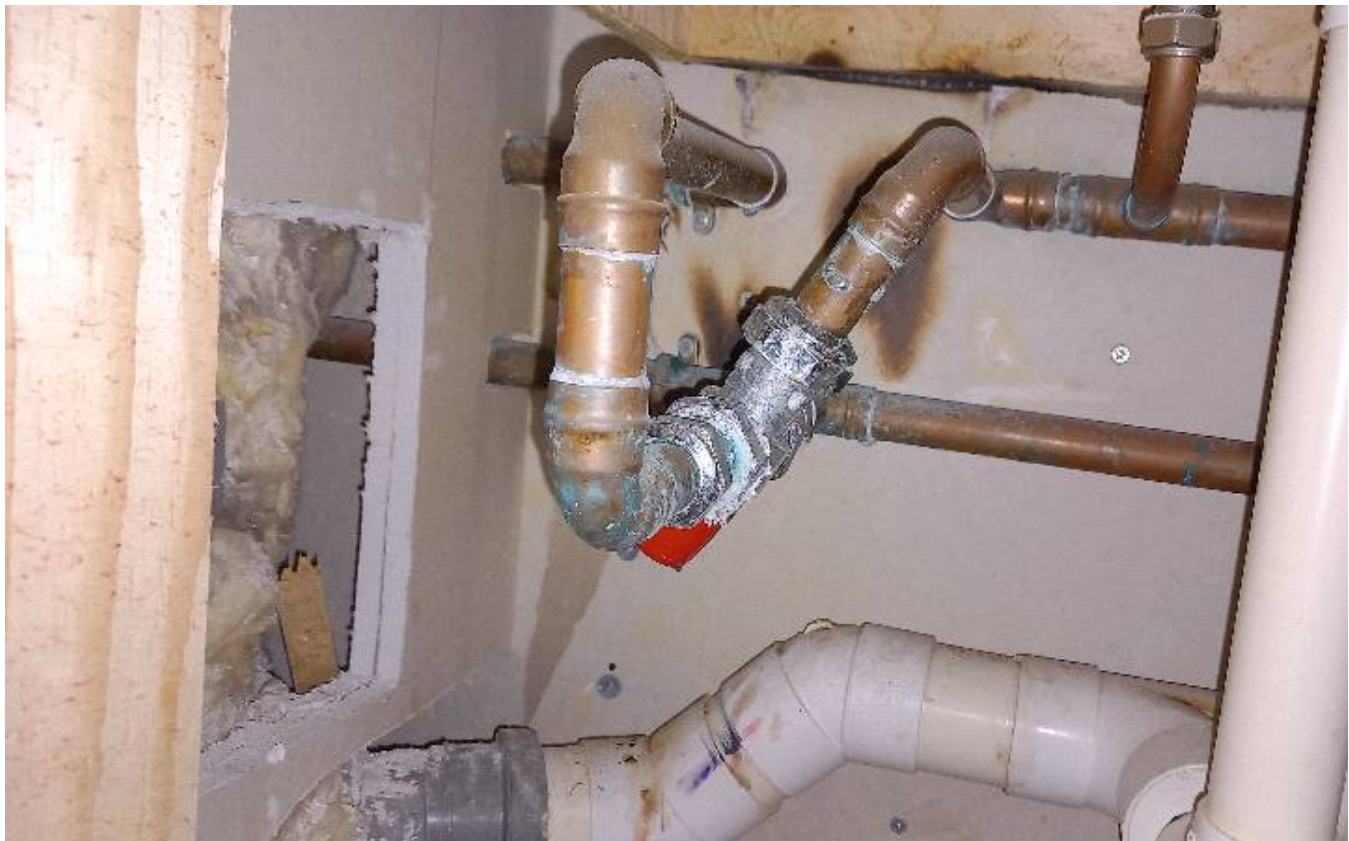
Asset No.	TMV4
	Location	1st NW - Female WC
TMV Details	Approximate Number	1
	TMV Type	TMV
	Fed from Hot	Cal 1
	Fed from Cold	Mains
	Accessible	Yes
	At Each Individual Outlet	No
	Supplying Multiple Outlets	Yes
	Number of outlets	4
Temperature	Hot Supply To TMV Temperature	57.0°C
	Cold Supply To TMV Temperature	9.0°C
	Nearest Non-TMV Tap- Max Hot Temperature	N/A
	Nearest Non-TMV Tap- Max Cold Temperature	N/A
	TMV Outlet Temperature	38.0°C
	Can TMV be moved closer to the POU	No
	Can TMV be removed from system	No

Risk Rating	
System Risk	Low

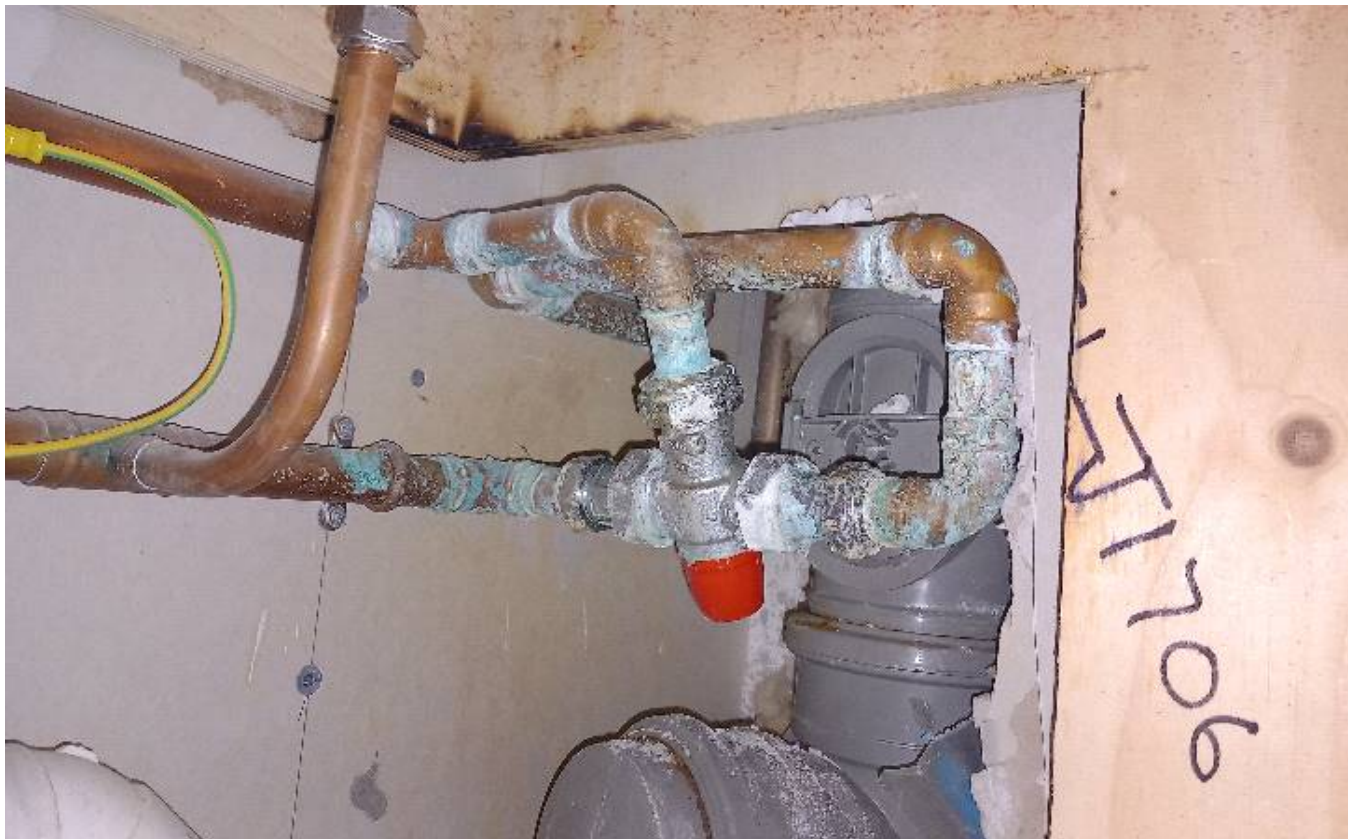
Asset No.	TMV5
	Location	1st SW - Male WC
TMV Details	Approximate Number	1
	TMV Type	TMV
	Fed from Hot	Cal 1
	Fed from Cold	Mains
	Accessible	Yes
	At Each Individual Outlet	No
	Supplying Multiple Outlets	Yes
	Number of outlets	4
Temperature	Hot Supply To TMV Temperature	56.0°C
	Cold Supply To TMV Temperature	8.0°C
	Nearest Non-TMV Tap- Max Hot Temperature	N/A
	Nearest Non-TMV Tap- Max Cold Temperature	N/A
	TMV Outlet Temperature	39.0°C
	Can TMV be moved closer to the POU	No
	Can TMV be removed from system	No

Risk Rating	
System Risk	Low

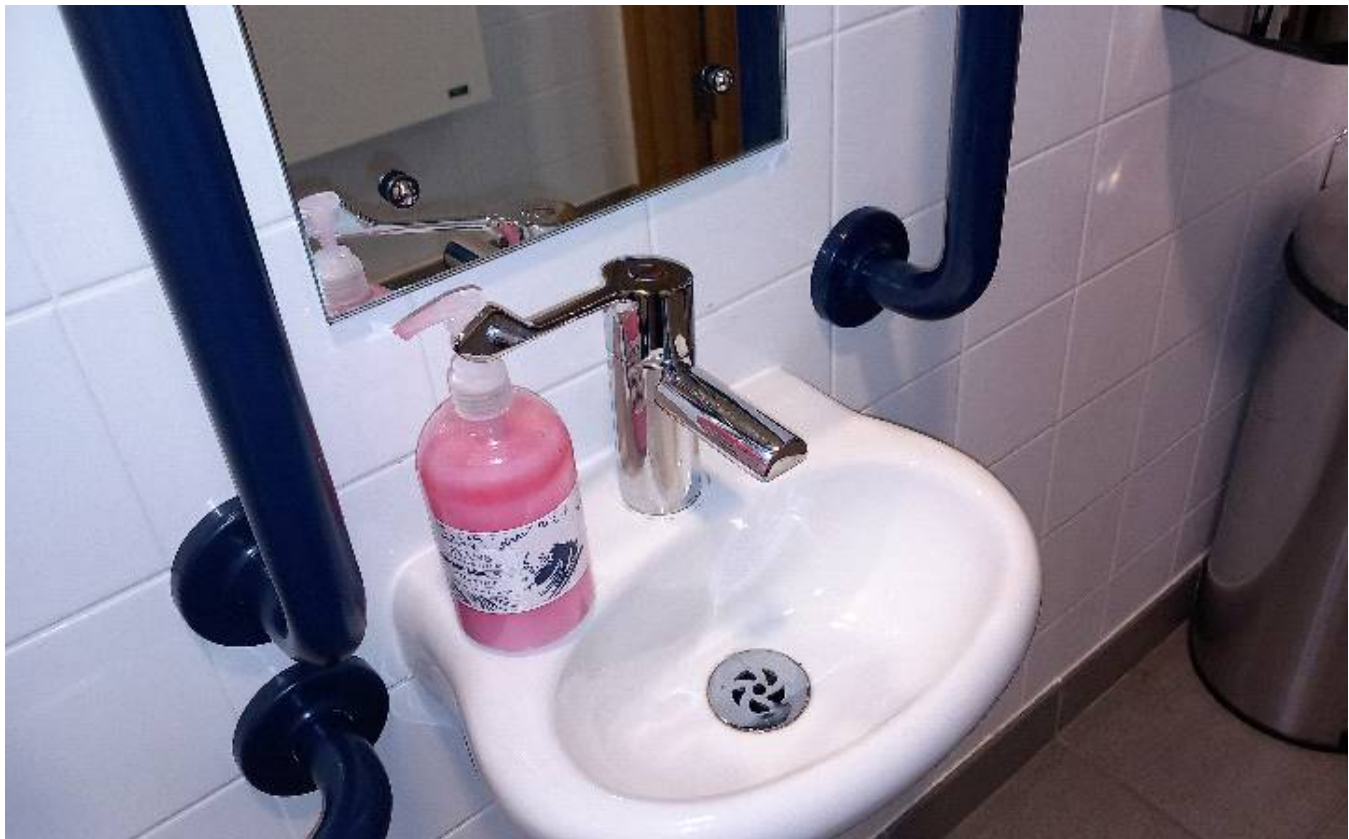
Asset No.	TMV6
	Location	1st SW - Accessible WC
TMV Details	Approximate Number	1
	TMV Type	TMV Tap
	Fed from Hot	Cal 1
	Fed from Cold	Mains
	Accessible	Yes
	At Each Individual Outlet	Yes
	Supplying Multiple Outlets	No
	Number of outlets	1
Temperature	Hot Supply To TMV Temperature	55.0°C
	Cold Supply To TMV Temperature	10.0°C
	Nearest Non-TMV Tap- Max Hot Temperature	N/A
	Nearest Non-TMV Tap- Max Cold Temperature	N/A
	TMV Outlet Temperature	41.0°C
	Can TMV be moved closer to the POU	No
	Can TMV be removed from system	No

Risk Rating	
System Risk	Low

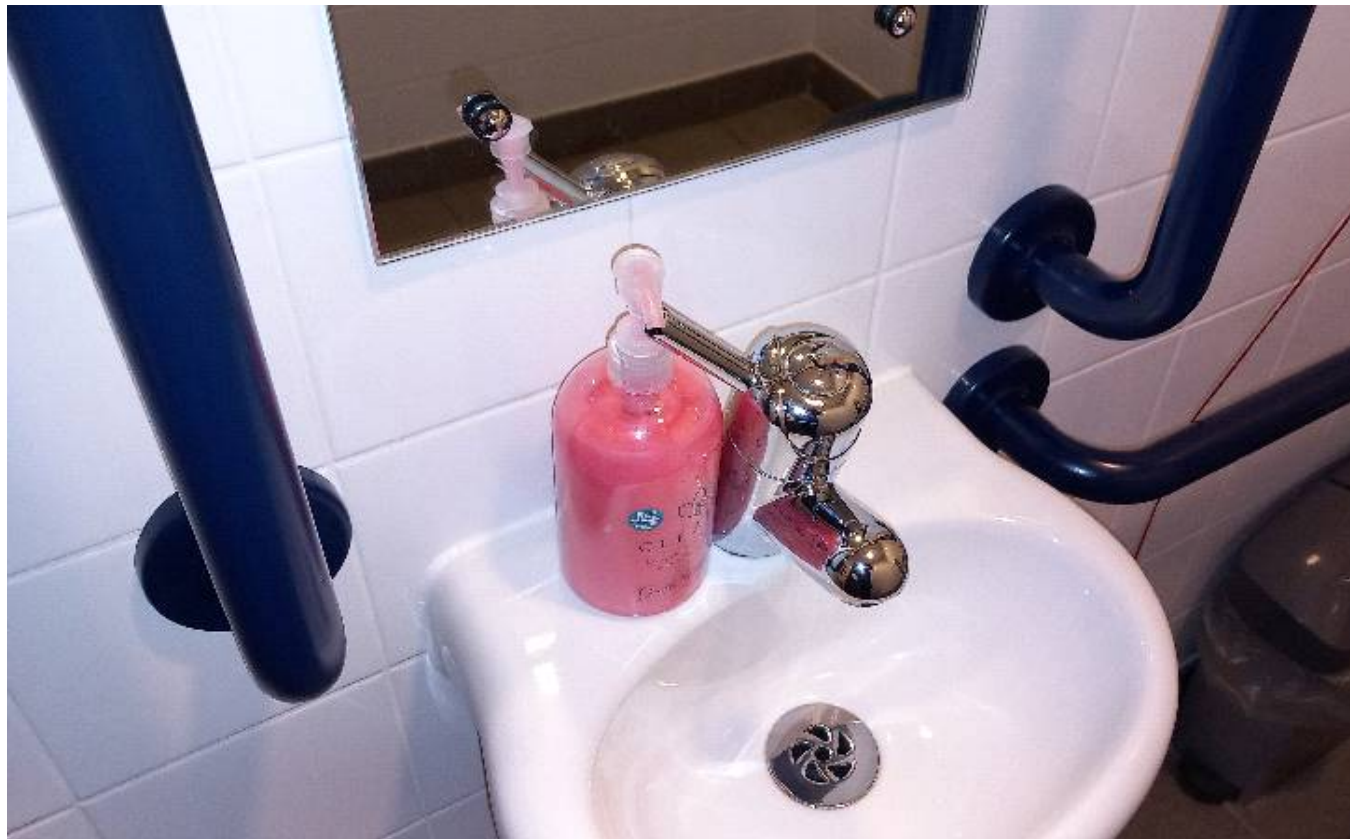
Asset No.	TMV7
	Location	2nd NW - Accessible WC
TMV Details	Approximate Number	1
	TMV Type	TMV Tap
	Fed from Hot	Cal 1
	Fed from Cold	Mains
	Accessible	Yes
	At Each Individual Outlet	Yes
	Supplying Multiple Outlets	No
	Number of outlets	1
Temperature	Hot Supply To TMV Temperature	55.0°C
	Cold Supply To TMV Temperature	10.0°C
	Nearest Non-TMV Tap- Max Hot Temperature	N/A
	Nearest Non-TMV Tap- Max Cold Temperature	N/A
	TMV Outlet Temperature	40.0°C
	Can TMV be moved closer to the POU	No
	Can TMV be removed from system	No

Risk Rating	
System Risk	Low

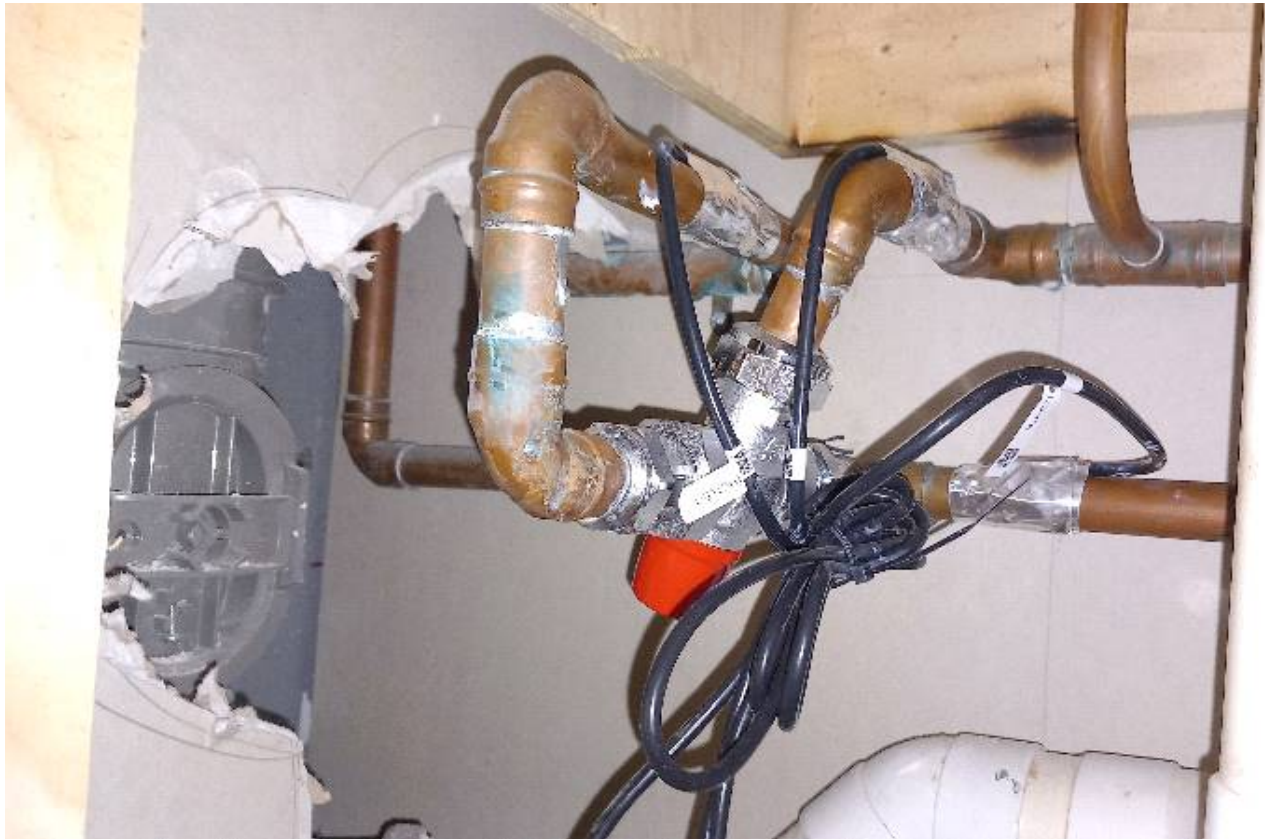
Asset No.	TMV8
	Location	2nd NW - Female WC
TMV Details	Approximate Number	1
	TMV Type	TMV
	Fed from Hot	Cal 1
	Fed from Cold	Mains
	Accessible	Yes
	At Each Individual Outlet	No
	Supplying Multiple Outlets	Yes
	Number of outlets	4
Temperature	Hot Supply To TMV Temperature	57.0°C
	Cold Supply To TMV Temperature	9.0°C
	Nearest Non-TMV Tap- Max Hot Temperature	N/A
	Nearest Non-TMV Tap- Max Cold Temperature	N/A
	TMV Outlet Temperature	39.0°C
	Can TMV be moved closer to the POU	No
	Can TMV be removed from system	No

Risk Rating	
System Risk	Low

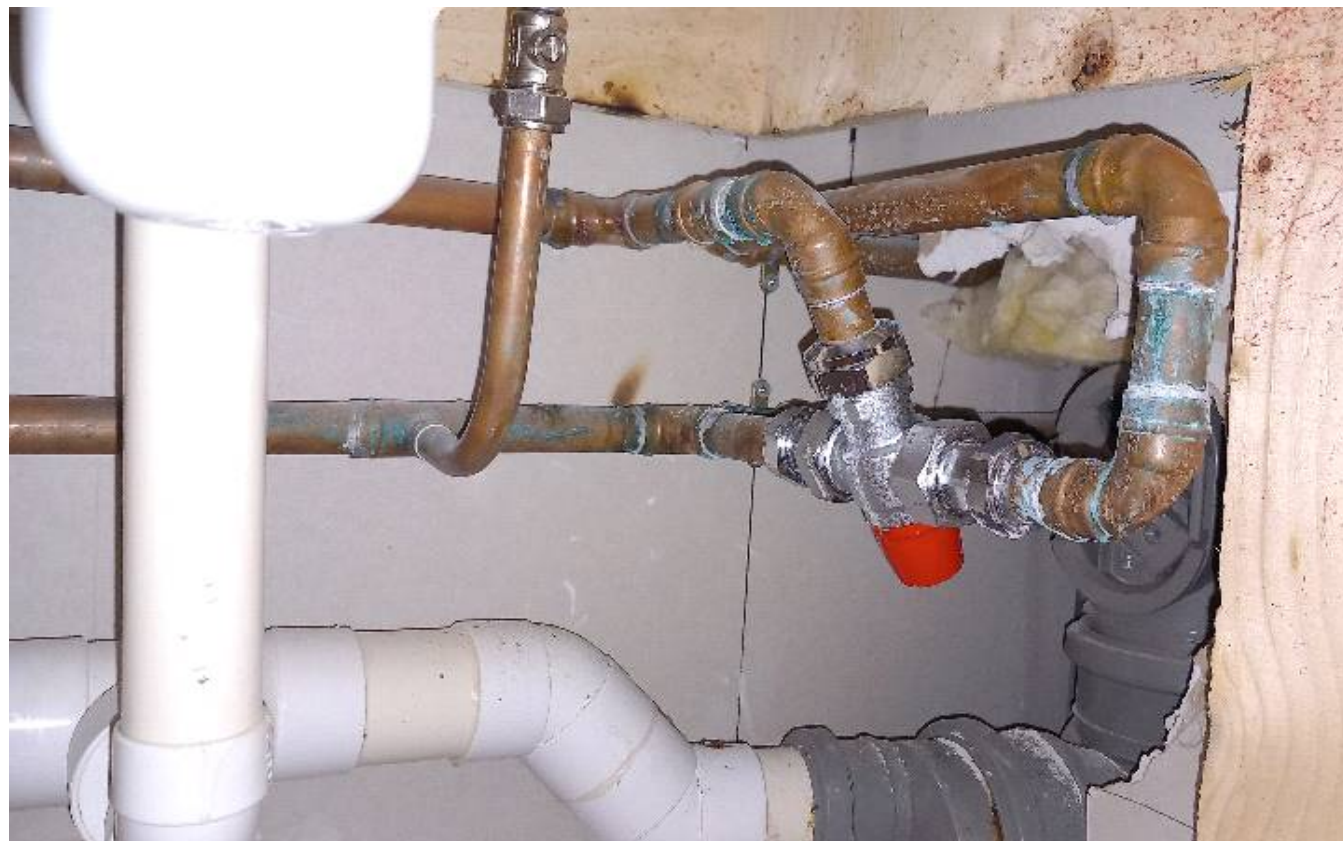
Asset No.	TMV9
	Location	2nd SW - Male WC
TMV Details	Approximate Number	1
	TMV Type	TMV
	Fed from Hot	Cal 1
	Fed from Cold	Mains
	Accessible	Yes
	At Each Individual Outlet	No
	Supplying Multiple Outlets	Yes
	Number of outlets	4
Temperature	Hot Supply To TMV Temperature	57.0°C
	Cold Supply To TMV Temperature	10.0°C
	Nearest Non-TMV Tap- Max Hot Temperature	N/A
	Nearest Non-TMV Tap- Max Cold Temperature	N/A
	TMV Outlet Temperature	42.0°C
	Can TMV be moved closer to the POU	No
	Can TMV be removed from system	No

Risk Rating	
System Risk	Low

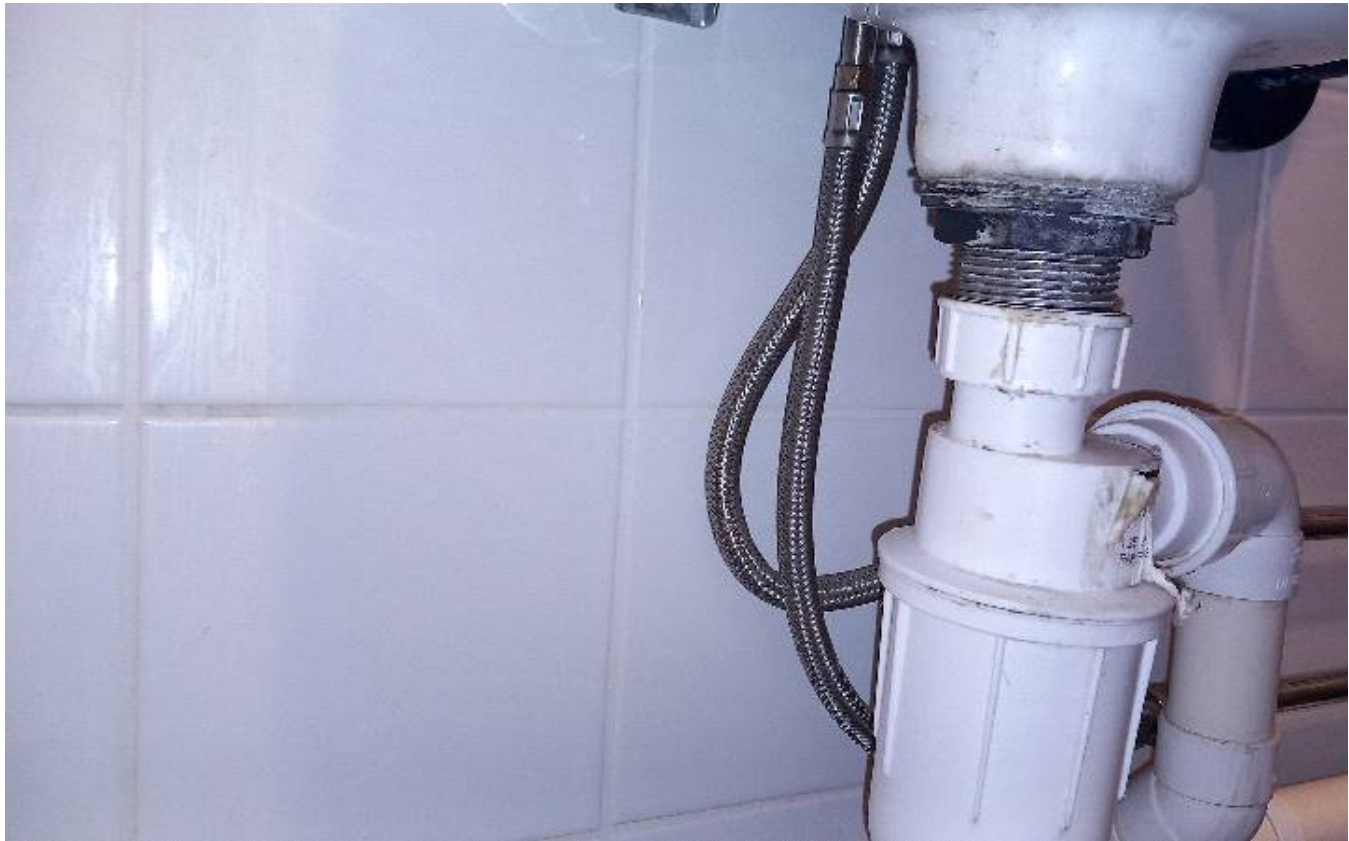
Asset No.	FH2
	Location	GF NW - Accessible WC
General	Satisfactory	No
Fed From	Fed From	Domestic
	Comments	-

Risk Rating	
System Risk	Medium

System Ref	General	Priority	Assigned To	Comments	Date Completed	Signed
FH1, FH10, FH11, FH12, FH13, FH14, FH15, FH16, FH17, FH2, FH3, FH4, FH5, FH6, FH7, FH8, FH9	At the time of the survey the WRAS approved numbers could not be identified on the flexible hoses, site shall ensure that these are compliant and either replace or pipe in rigid copper.	Medium / Category 3
