LEGIONELLA RISK ASSESSMENT

Geo Tag: ,
Customer: Believe Housing
Site: Coast House Spectrum 4 Spectrum Business Park Seaham , SR7 7TT
Date: 2nd February 2024
Risk Assessor: Carleton Waite
Report No: J052353 - 664702

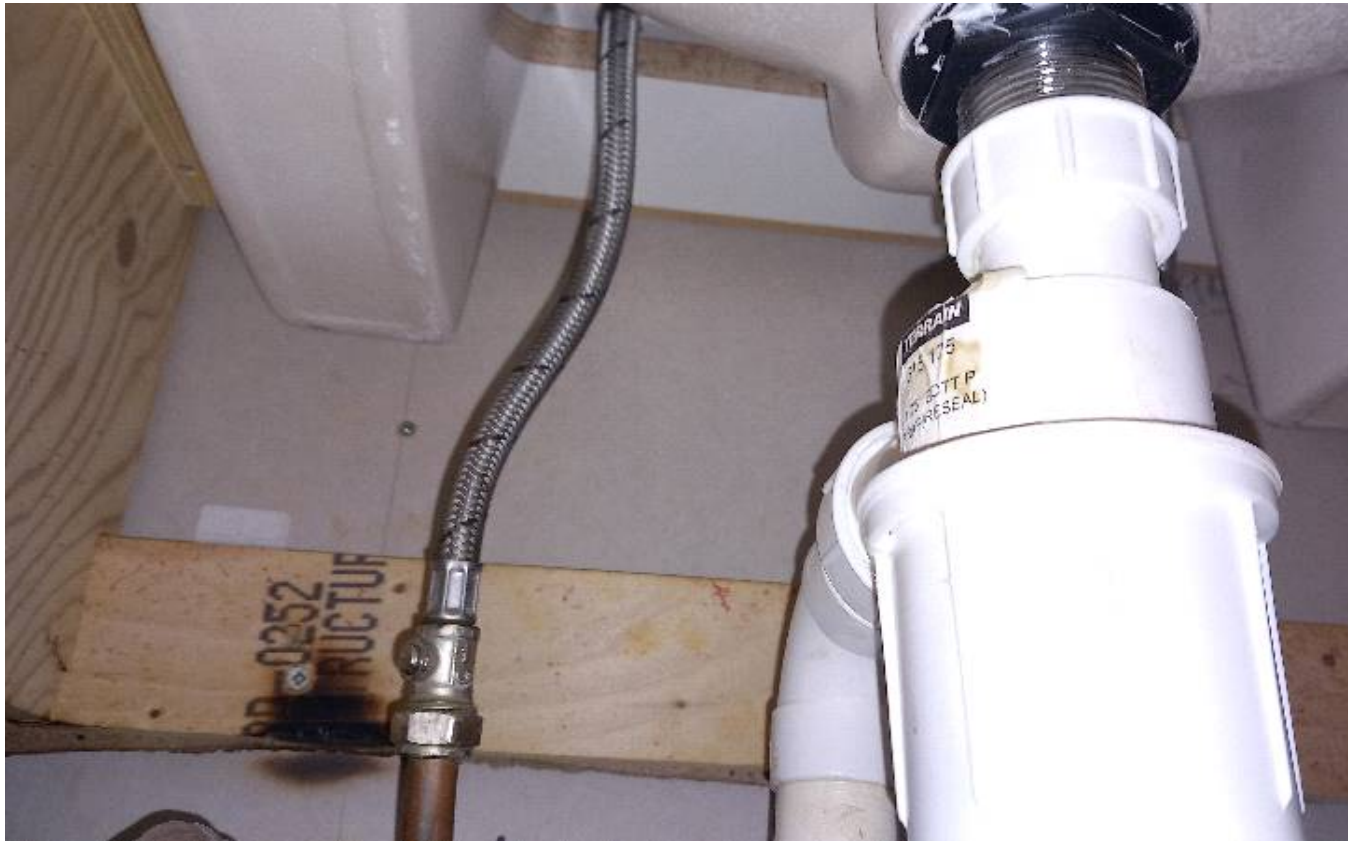
Asset No.	FH3
	Location	GF NW - Female WC
General	Satisfactory	No
Fed From	Fed From	Domestic
	Comments	-

Risk Rating	
System Risk	Medium

System Ref	General	Priority	Assigned To	Comments	Date Completed	Signed
FH1, FH10, FH11, FH12, FH13, FH14, FH15, FH16, FH17, FH2, FH3, FH4, FH5, FH6, FH7, FH8, FH9	At the time of the survey the WRAS approved numbers could not be identified on the flexible hoses, site shall ensure that these are compliant and either replace or pipe in rigid copper.	Medium / Category 3

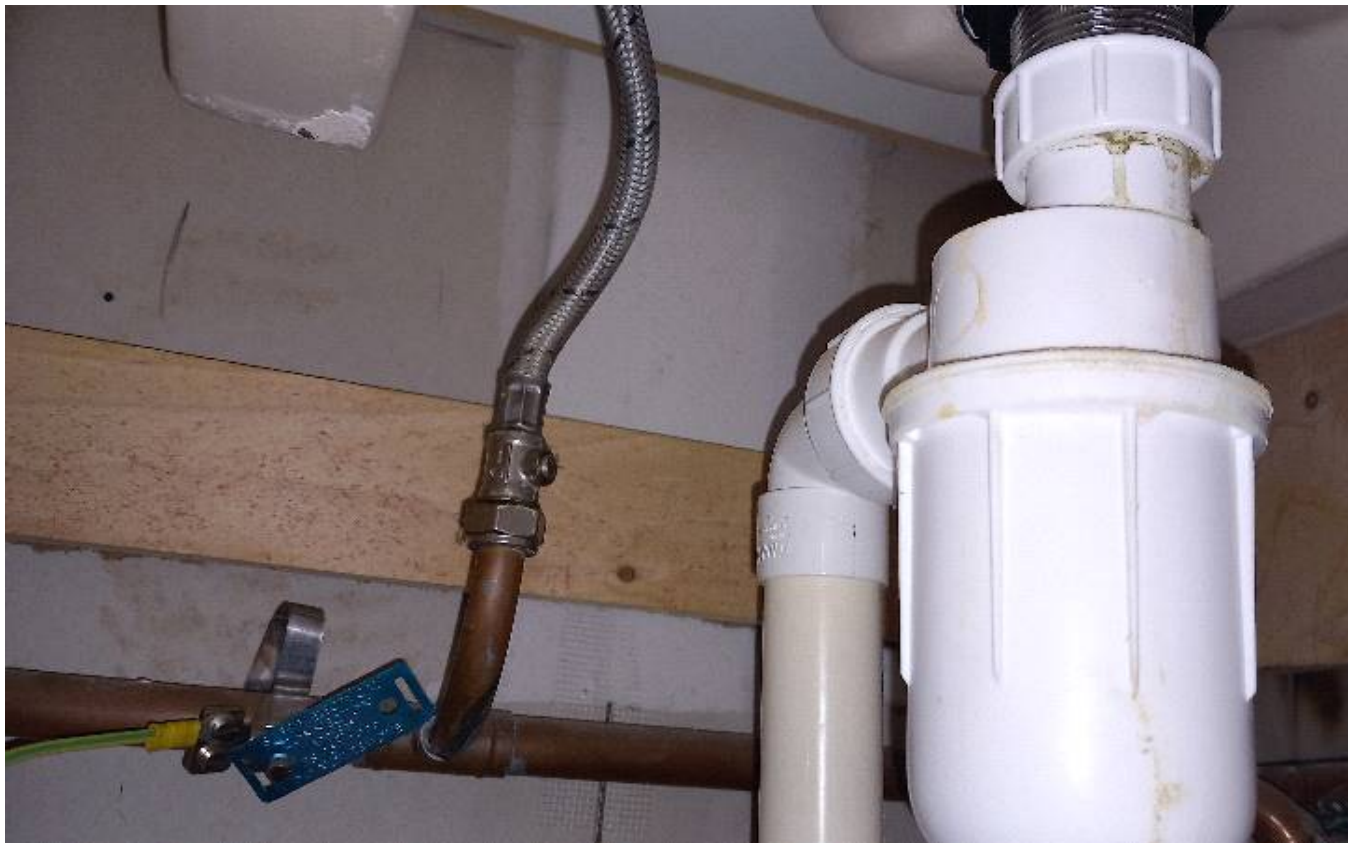
Asset No.	FH4
	Location	GF SW - Male WC
General	Satisfactory	No
Fed From	Fed From	Domestic
	Comments	-

Risk Rating	
System Risk	Medium

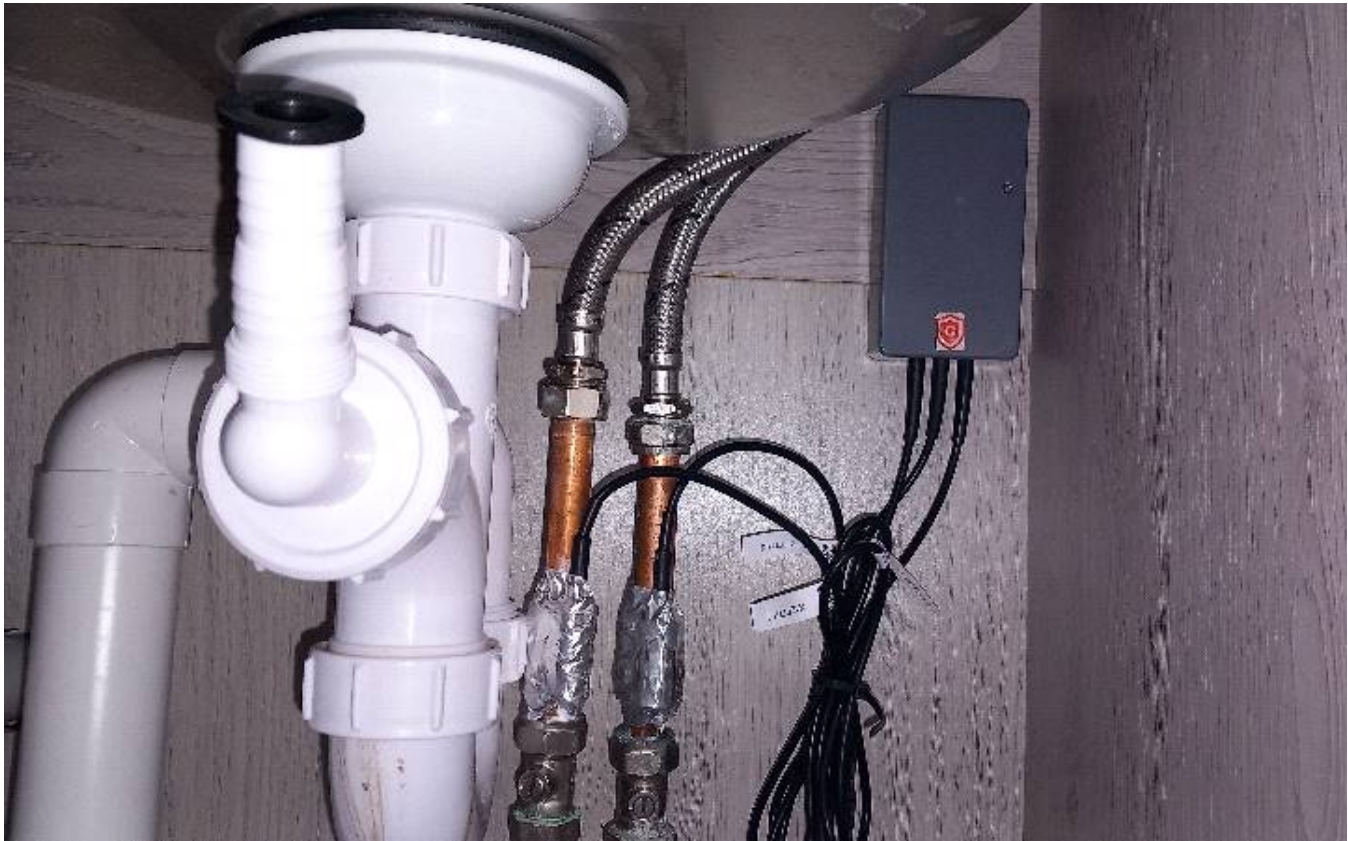
Asset No.	FH5
	Location	GF SW - Kitchen
General	Satisfactory	No
Fed From	Fed From	Domestic
	Comments	-

Risk Rating	
System Risk	Medium

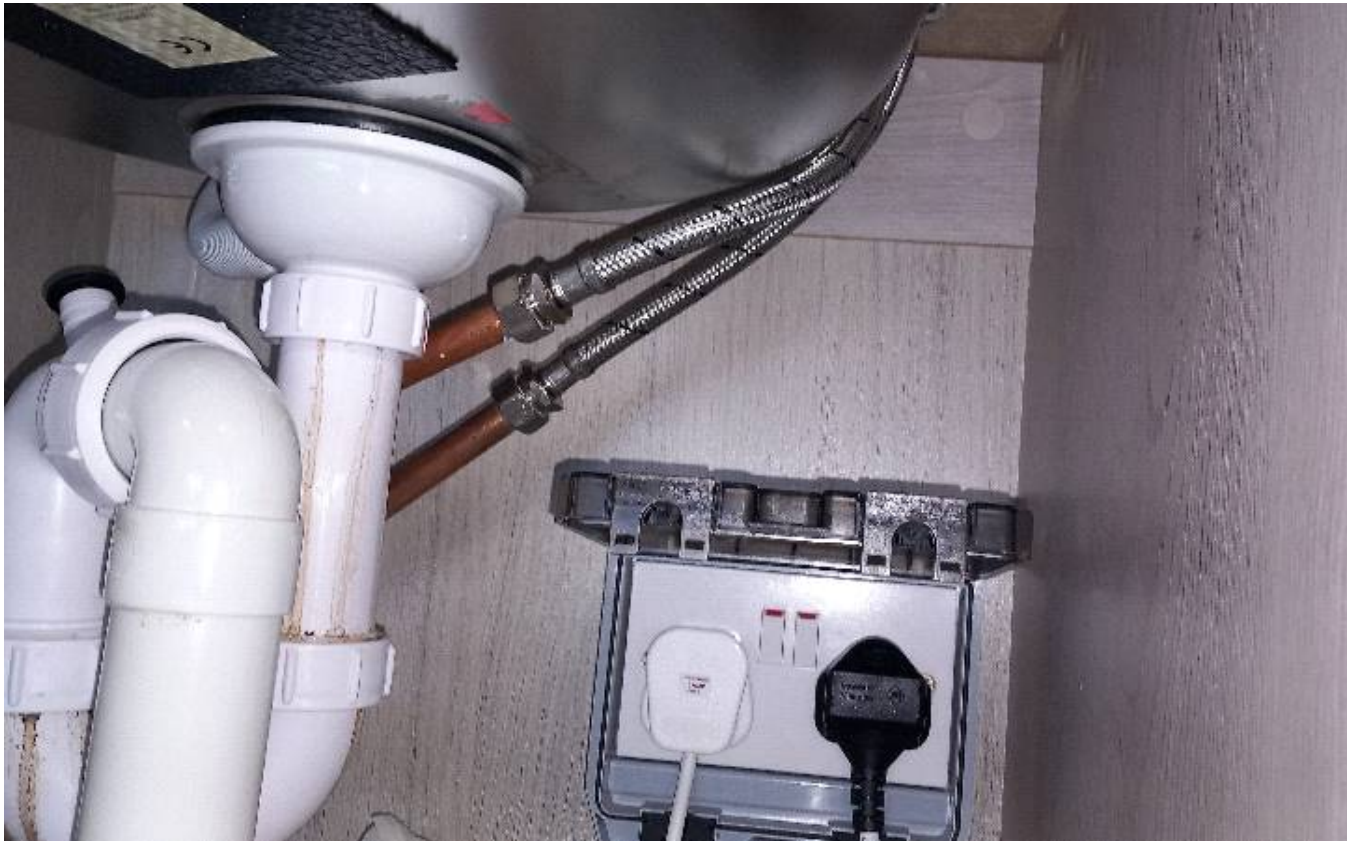
Asset No.	FH6
	Location	1st NW - Kitchen
General	Satisfactory	No
Fed From	Fed From	Domestic
	Comments	-

Risk Rating	
System Risk	Medium

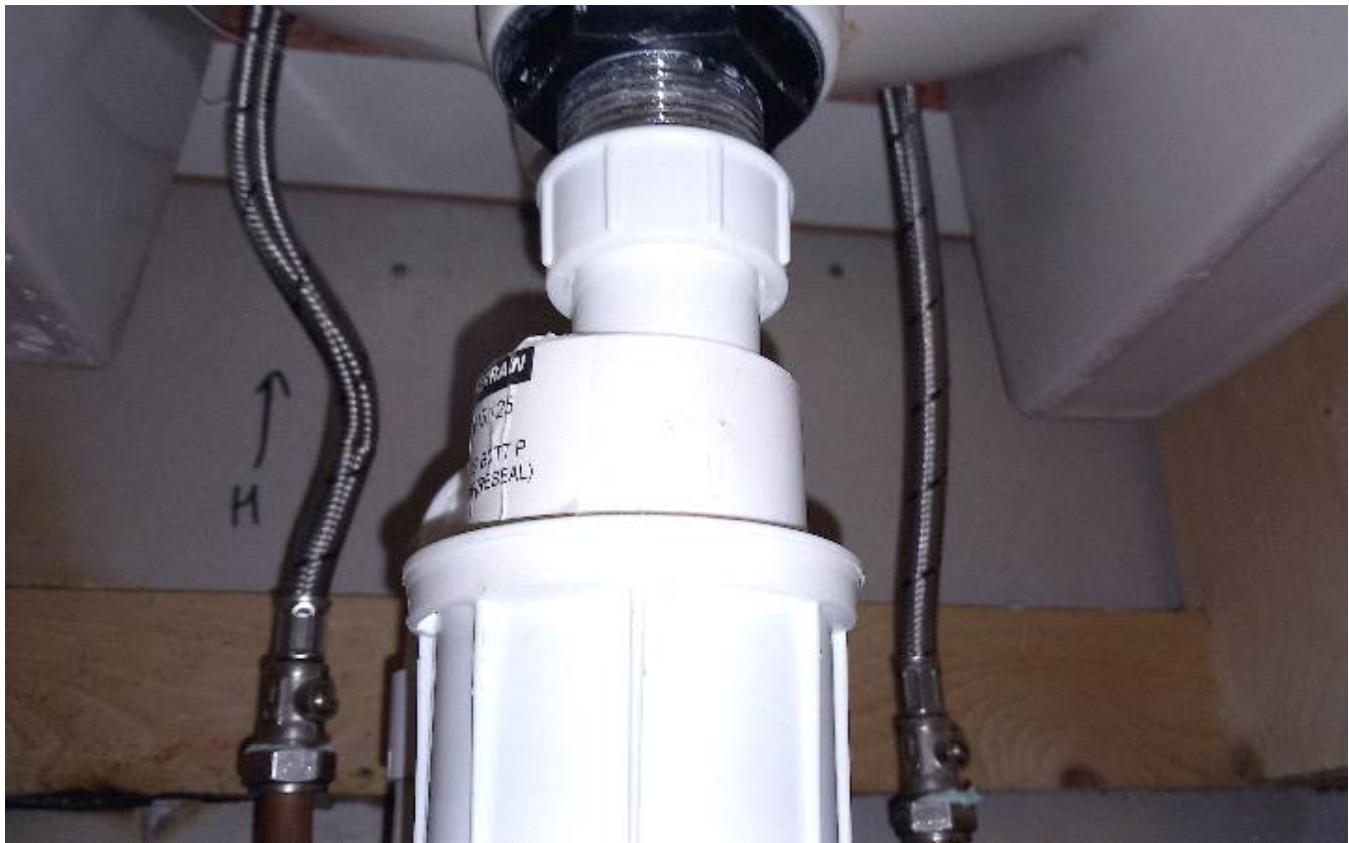
Asset No.	FH7
	Location	1st NW - Female WC
General	Satisfactory	No
Fed From	Fed From	Domestic
	Comments	-

Risk Rating	
System Risk	Medium

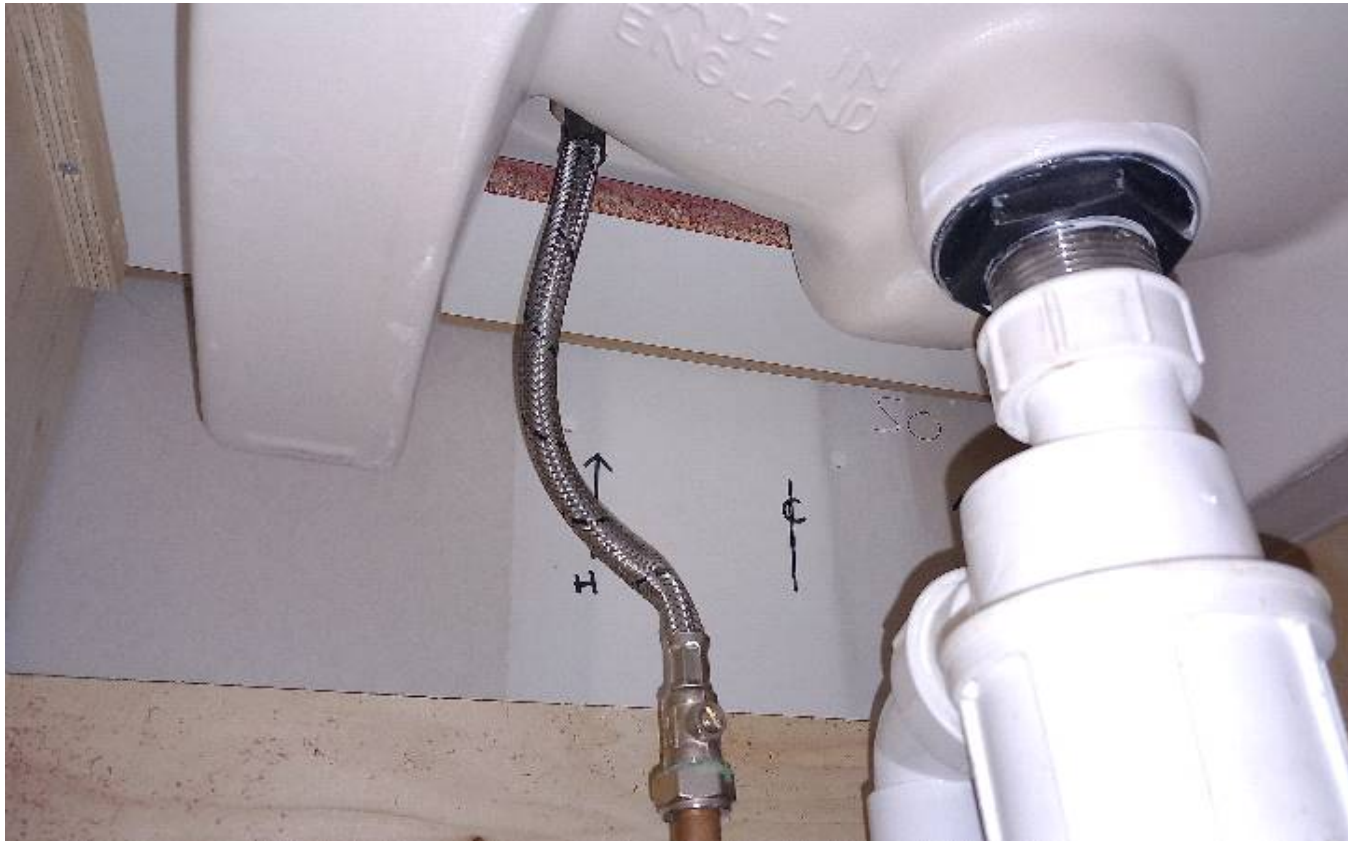
Asset No.	FH8
	Location	1st SW - Male WC
General	Satisfactory	No
Fed From	Fed From	Domestic
	Comments	-

Risk Rating	
System Risk	Medium

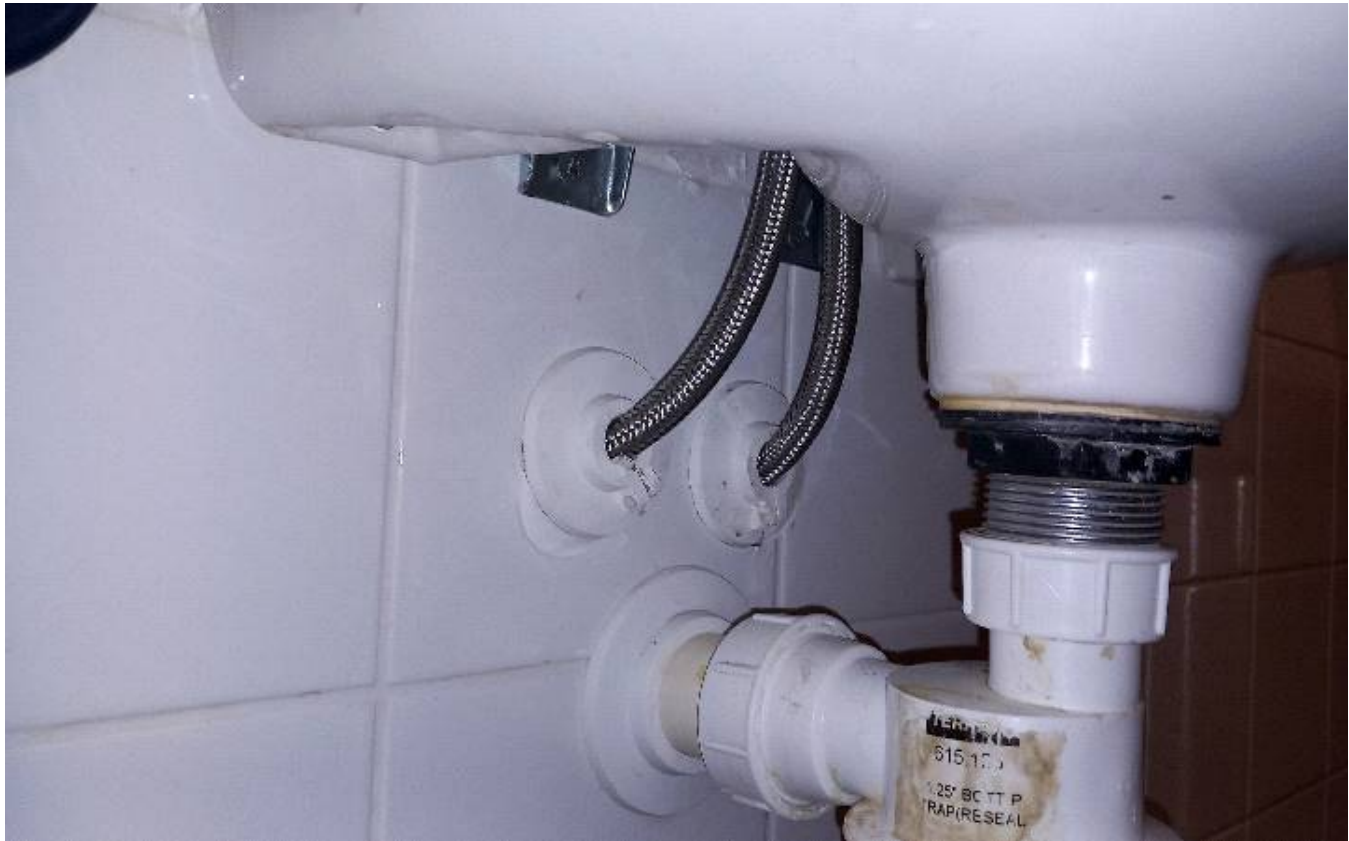
Asset No.	FH9
	Location	1st SW - Accessible WC
General	Satisfactory	No
Fed From	Fed From	Domestic
	Comments	-

Risk Rating	
System Risk	Medium

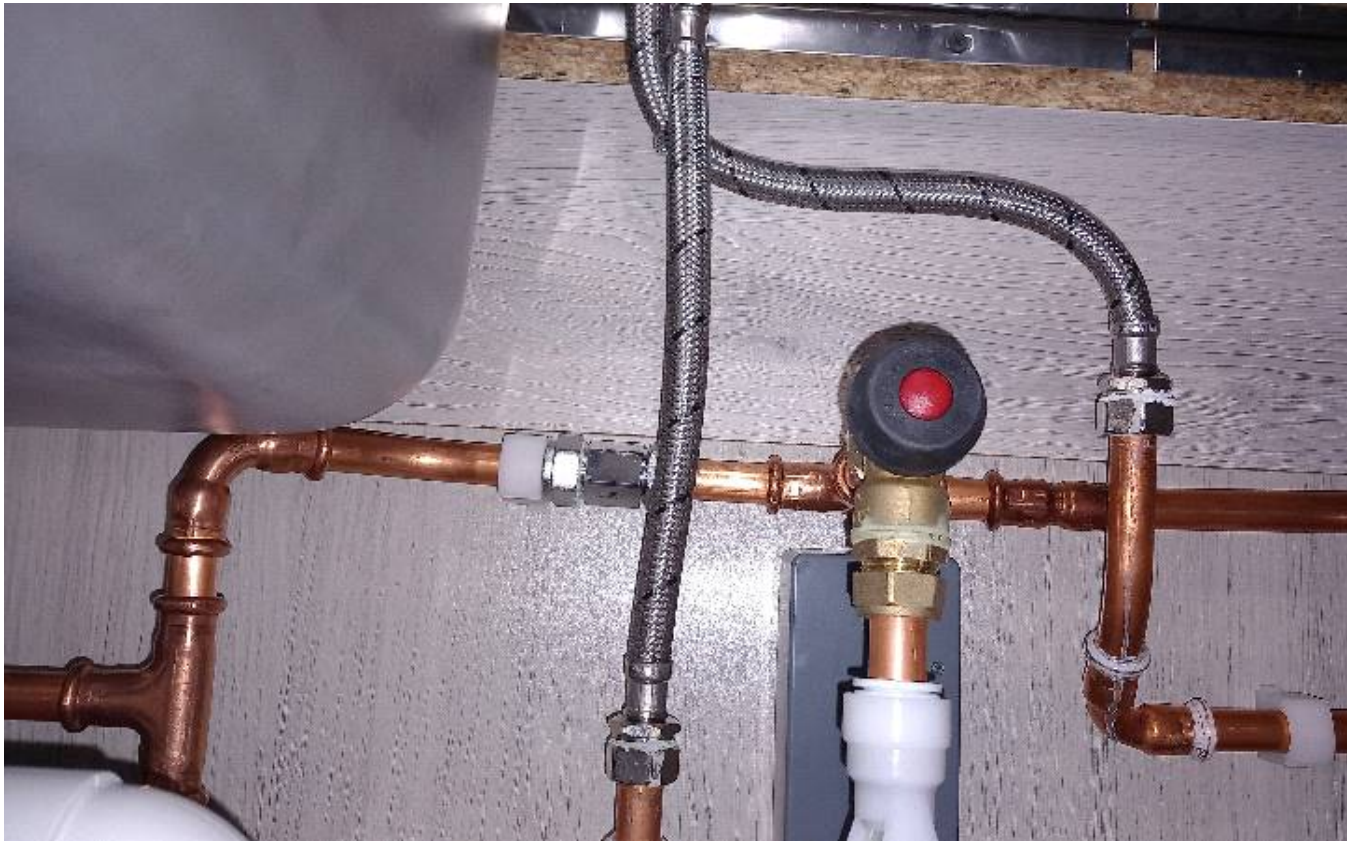
Asset No.	FH10
	Location	1st PS - Kitchen
General	Satisfactory	No
Fed From	Fed From	Domestic
	Comments	-

Risk Rating	
System Risk	Medium

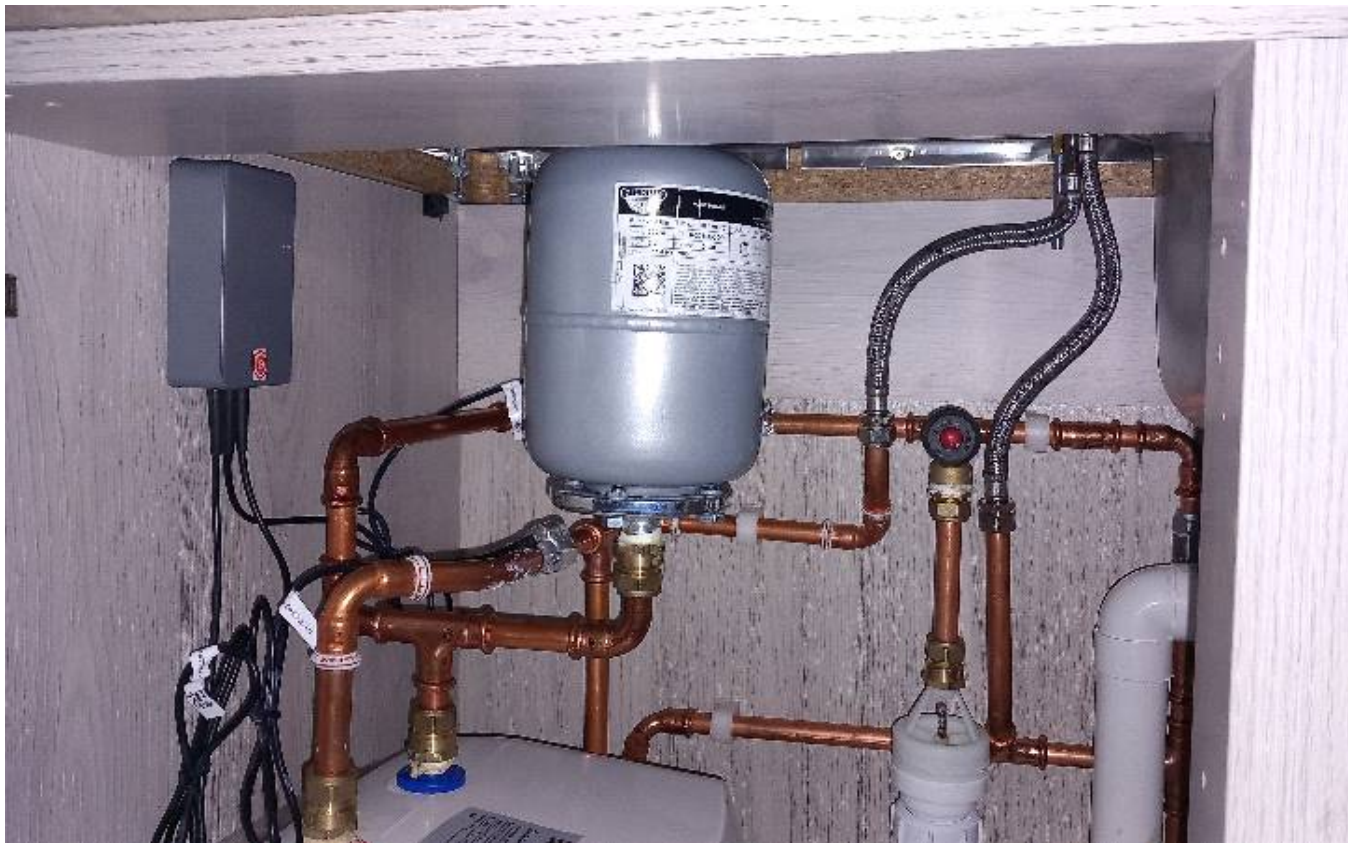
Asset No.	FH11
	Location	1st PS - Left Area
General	Satisfactory	No
Fed From	Fed From	Domestic
	Comments	-

Risk Rating	
System Risk	Medium

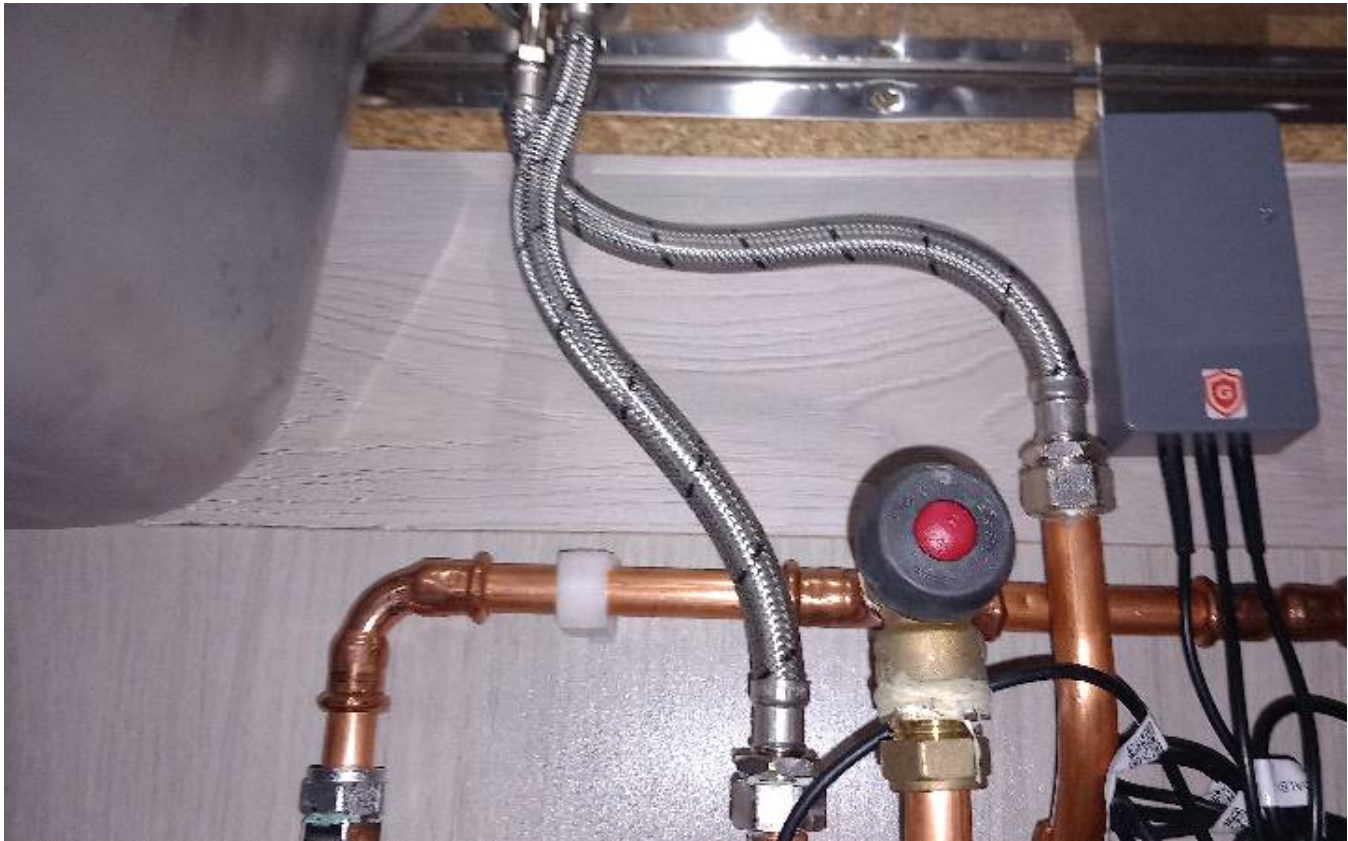
Asset No.	FH12
	Location	1st PS - Right Area
General	Satisfactory	No
Fed From	Fed From	Domestic
	Comments	-

Risk Rating	
System Risk	Medium

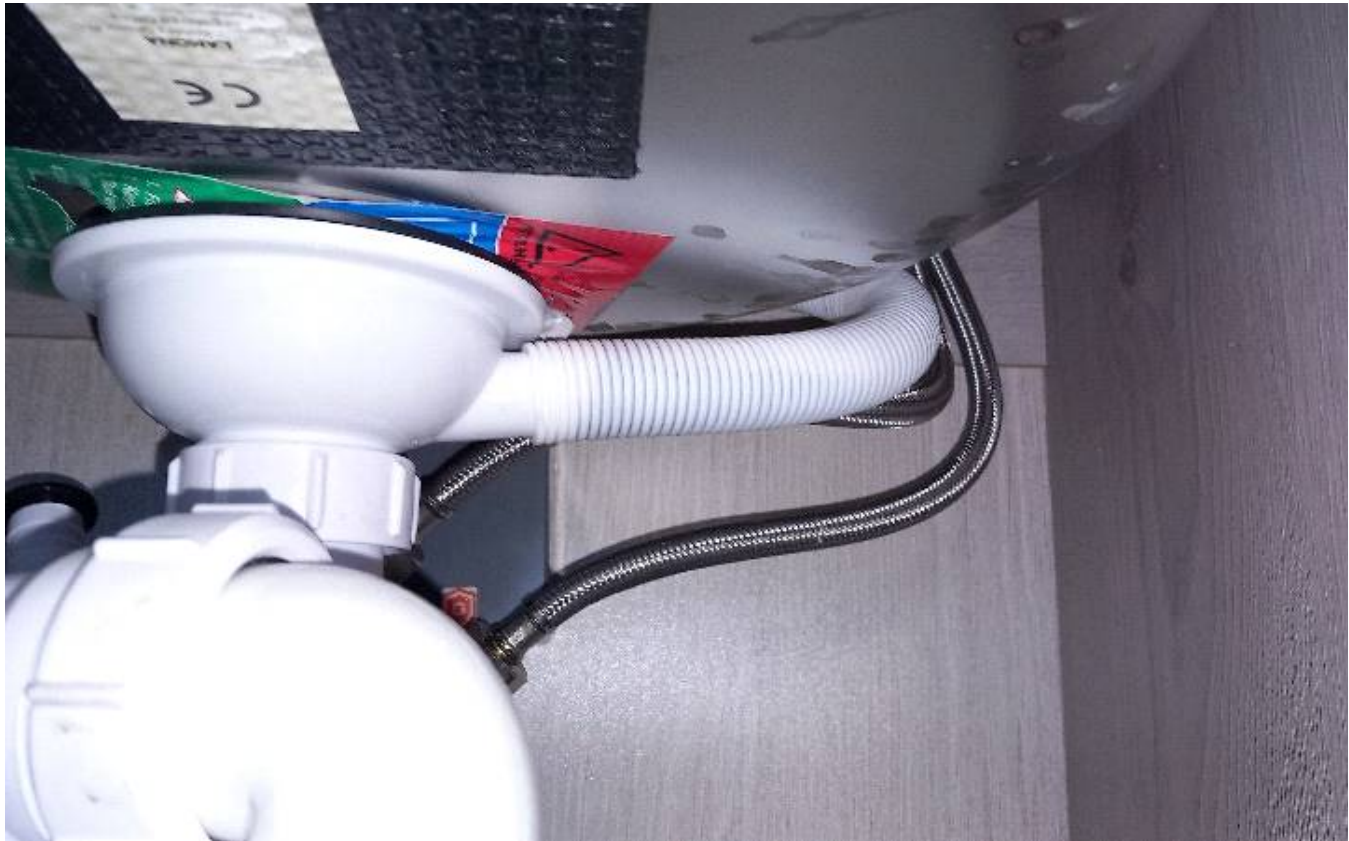
Asset No.	FH13
	Location	2nd NW - Kitchen
General	Satisfactory	No
Fed From	Fed From	Domestic
	Comments	-

Risk Rating	
System Risk	Medium

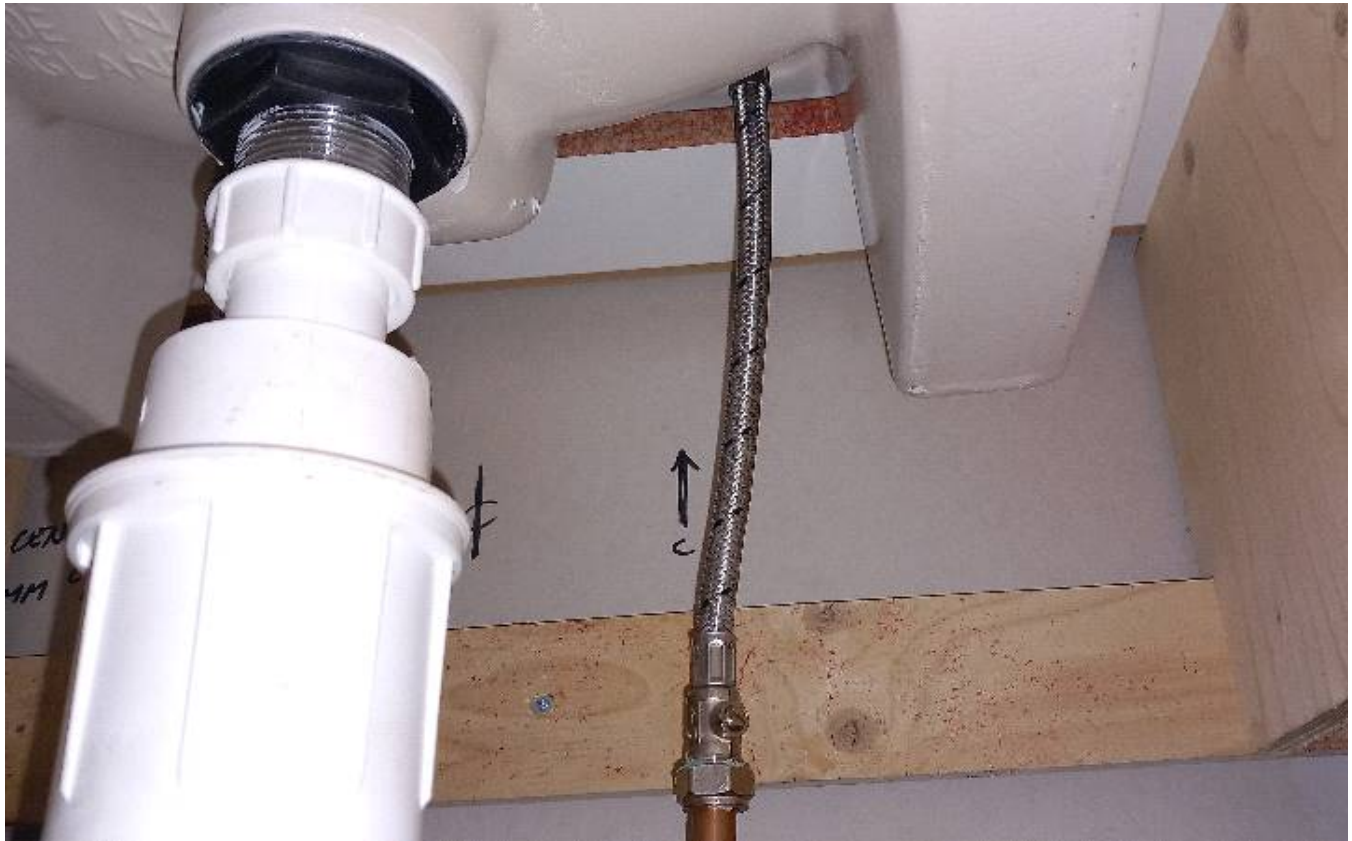
Asset No.	FH14
	Location	2nd NW - Female WC
General	Satisfactory	No
Fed From	Fed From	Domestic
	Comments	-

Risk Rating	
System Risk	Medium

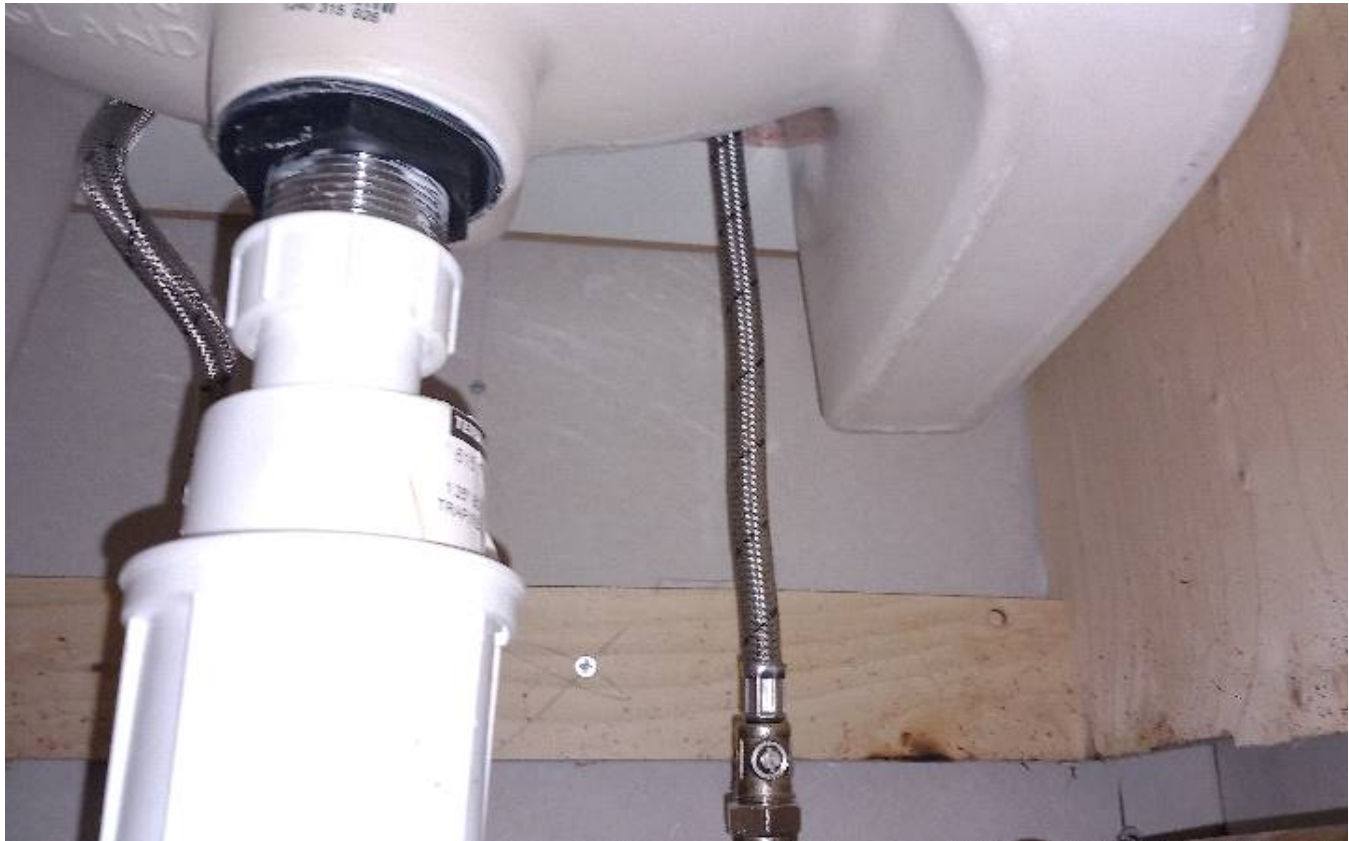
Asset No.	FH15
	Location	2nd SW - Male WC
General	Satisfactory	No
Fed From	Fed From	Domestic
	Comments	-

Risk Rating	
System Risk	Medium

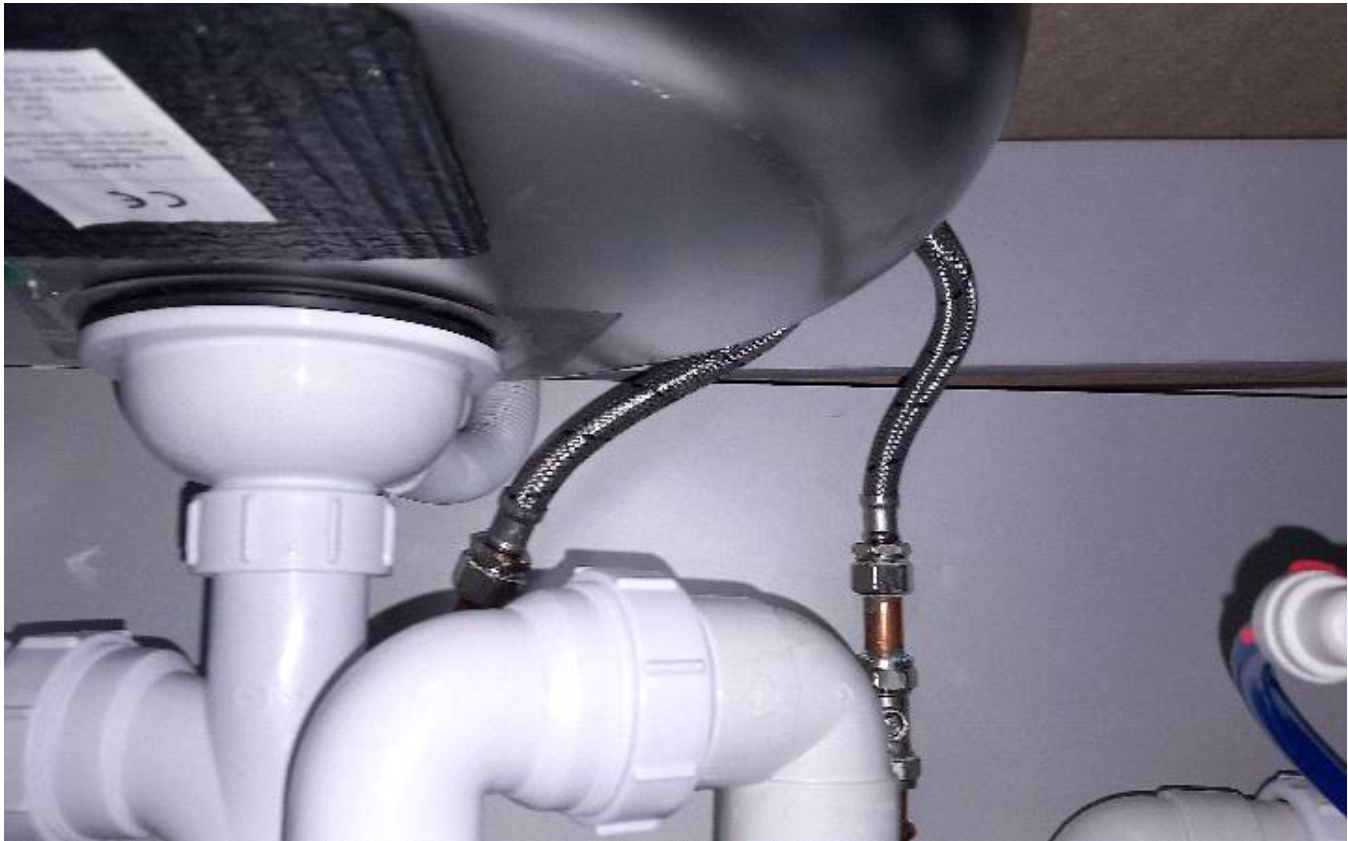
Asset No.	FH16
	Location	2nd SW - Kitchen
General	Satisfactory	No
Fed From	Fed From	Domestic
	Comments	-

Risk Rating	
System Risk	Medium

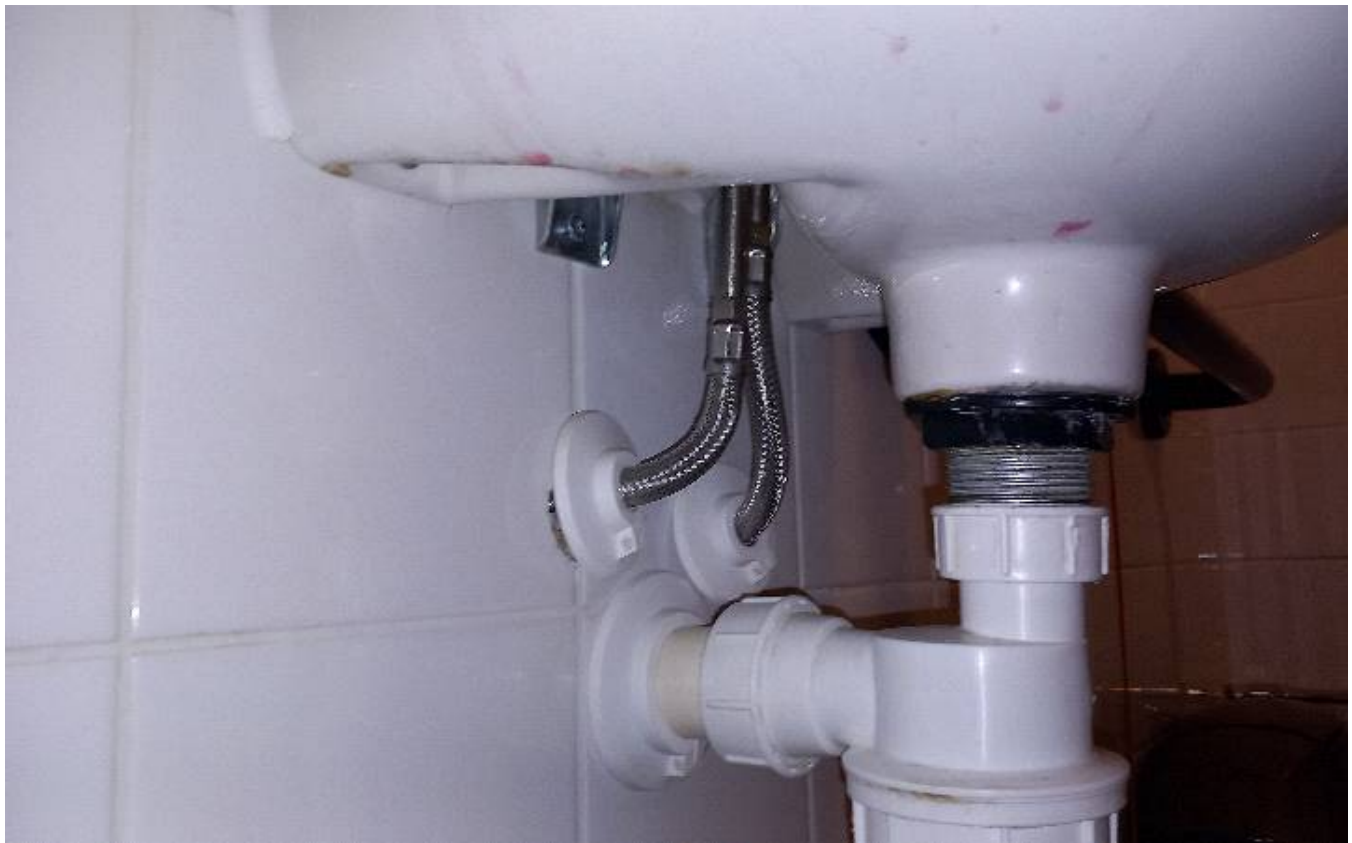
Asset No.	FH17
	Location	2nd NW - Accessible WC
General	Satisfactory	No
Fed From	Fed From	Domestic
	Comments	-

Risk Rating	
System Risk	Medium

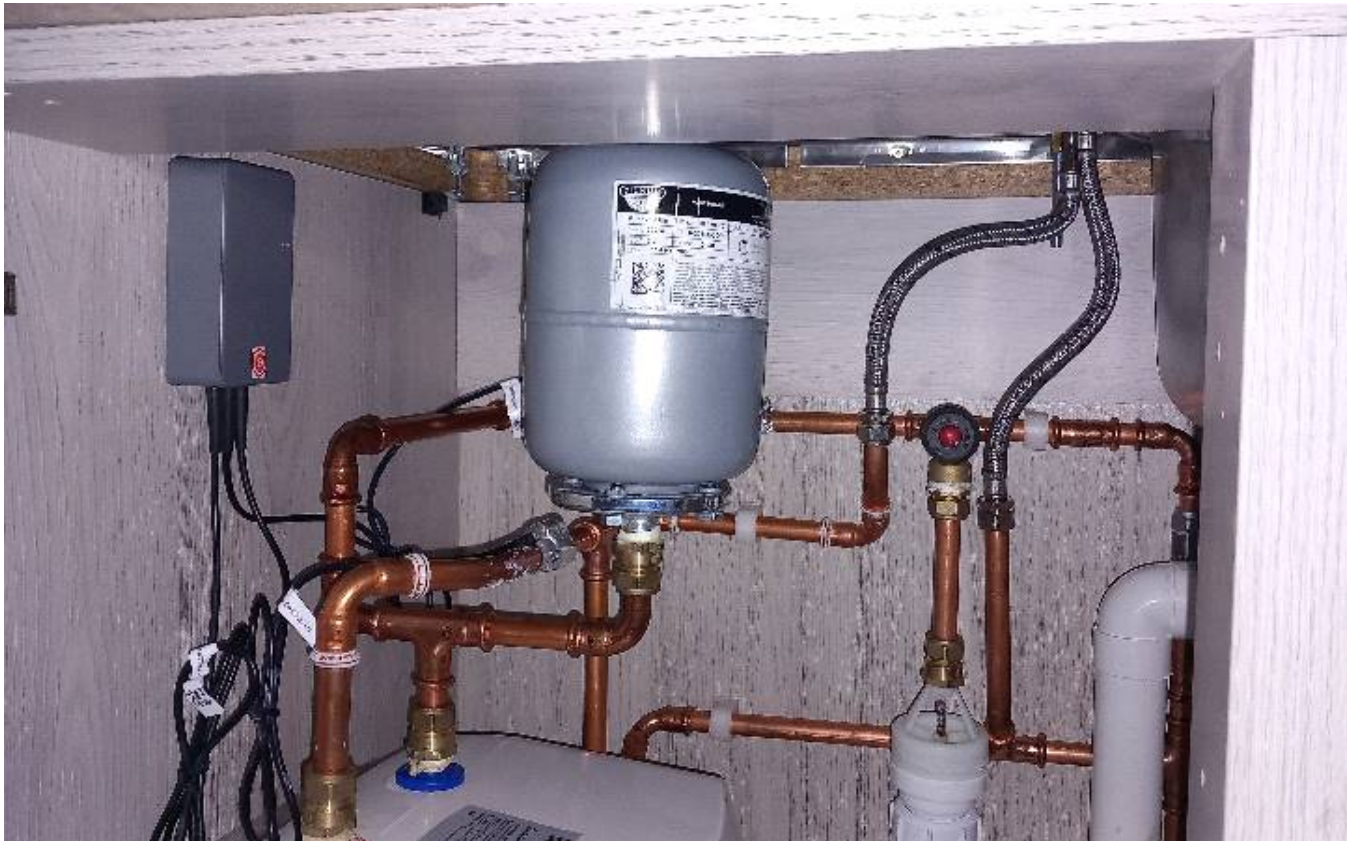
Asset No.	PV2
	Location	1st PS - Left Area
General	Satisfactory	No
Fed From	Fed From	Mains
	Comments	-

Risk Rating	
System Risk	High

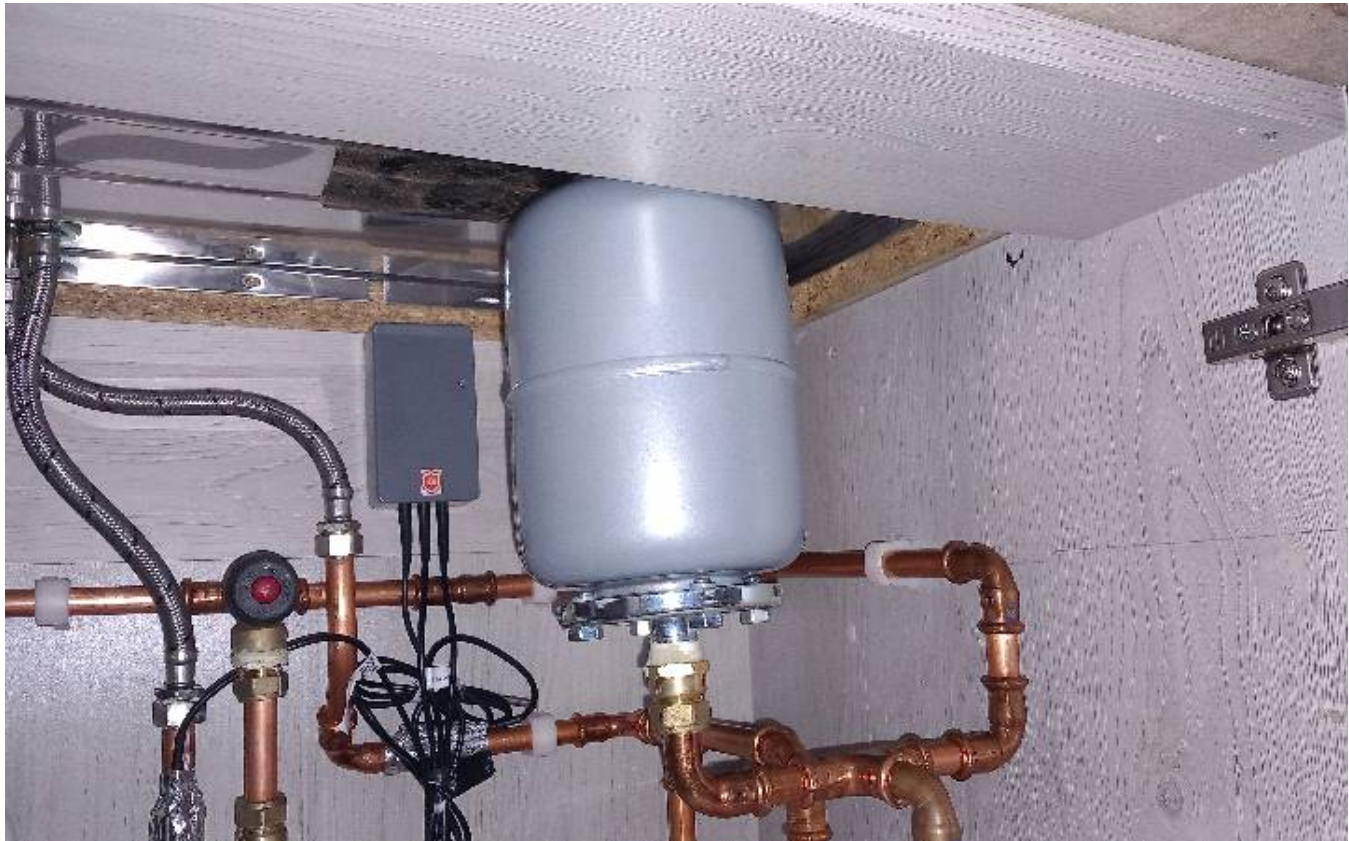
Asset No.	PV3
	Location	1st PS - Right Area
General	Satisfactory	No
Fed From	Fed From	Mains
	Comments	-

Risk Rating	
System Risk	High

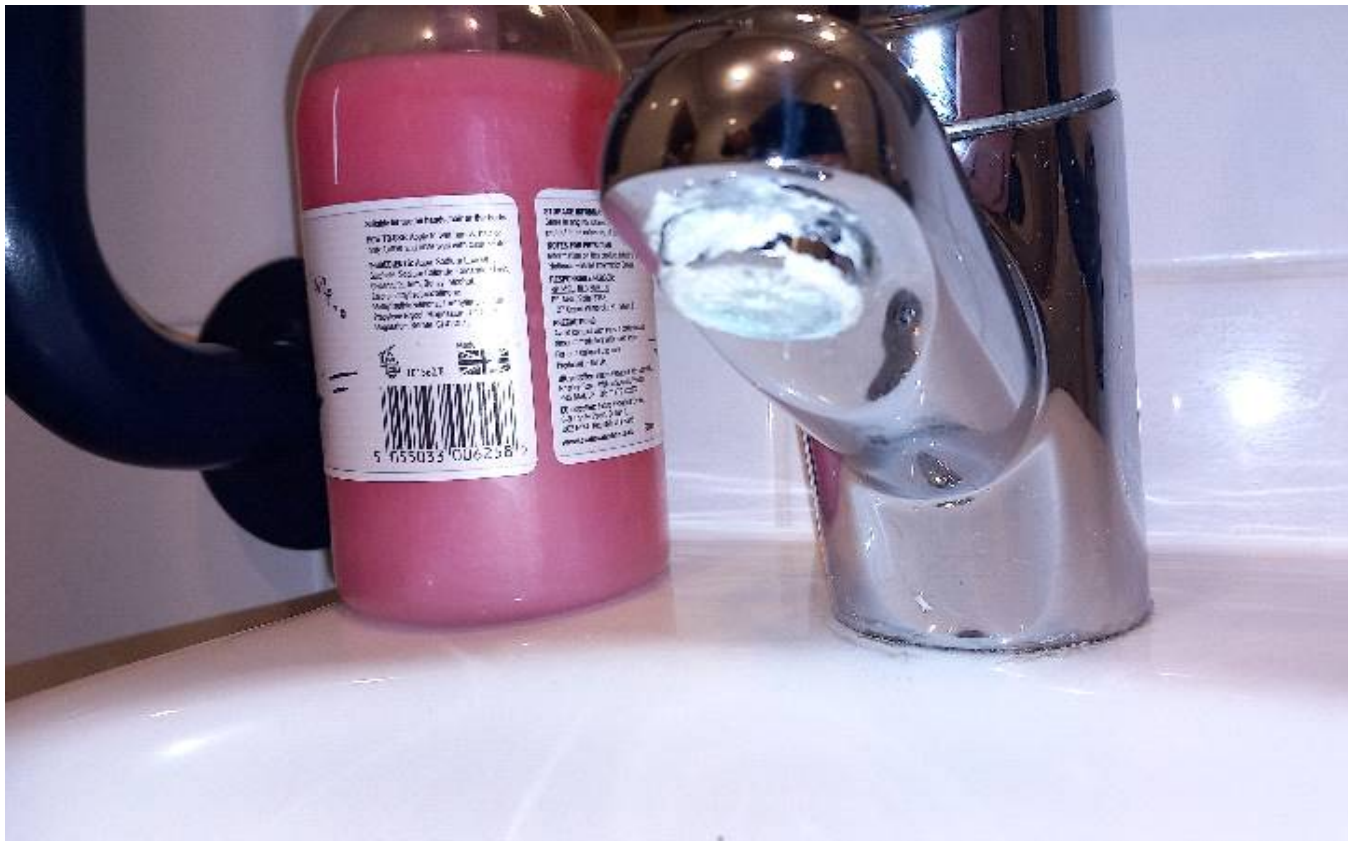
Asset No.	SOT2
	Location	GF NW - Accessible WC
General	Satisfactory	No
Fed From	Fed From	Domestic
	Comments	-

Risk Rating	
System Risk	Medium

System Ref	General	Priority	Assigned To	Comments	Date Completed	Signed
<p>SOT1, SOT10, SOT11, SOT12, SOT13, SOT14, SOT2, SOT3, SOT4, SOT5, SOT6, SOT7, SOT8, SOT9</p>	<p>Site should clean, disinfect and descale taps which are affected on a quarterly basis. This frequency can be reviewed depending on condition of the outlets.</p>	<p>Medium / Category 3</p>
